NATIONAL RIVERS AUTHORITY

RIVER COLE
FISHERIES SURVEY
1992

COMPILED BY SIMON HUGHES

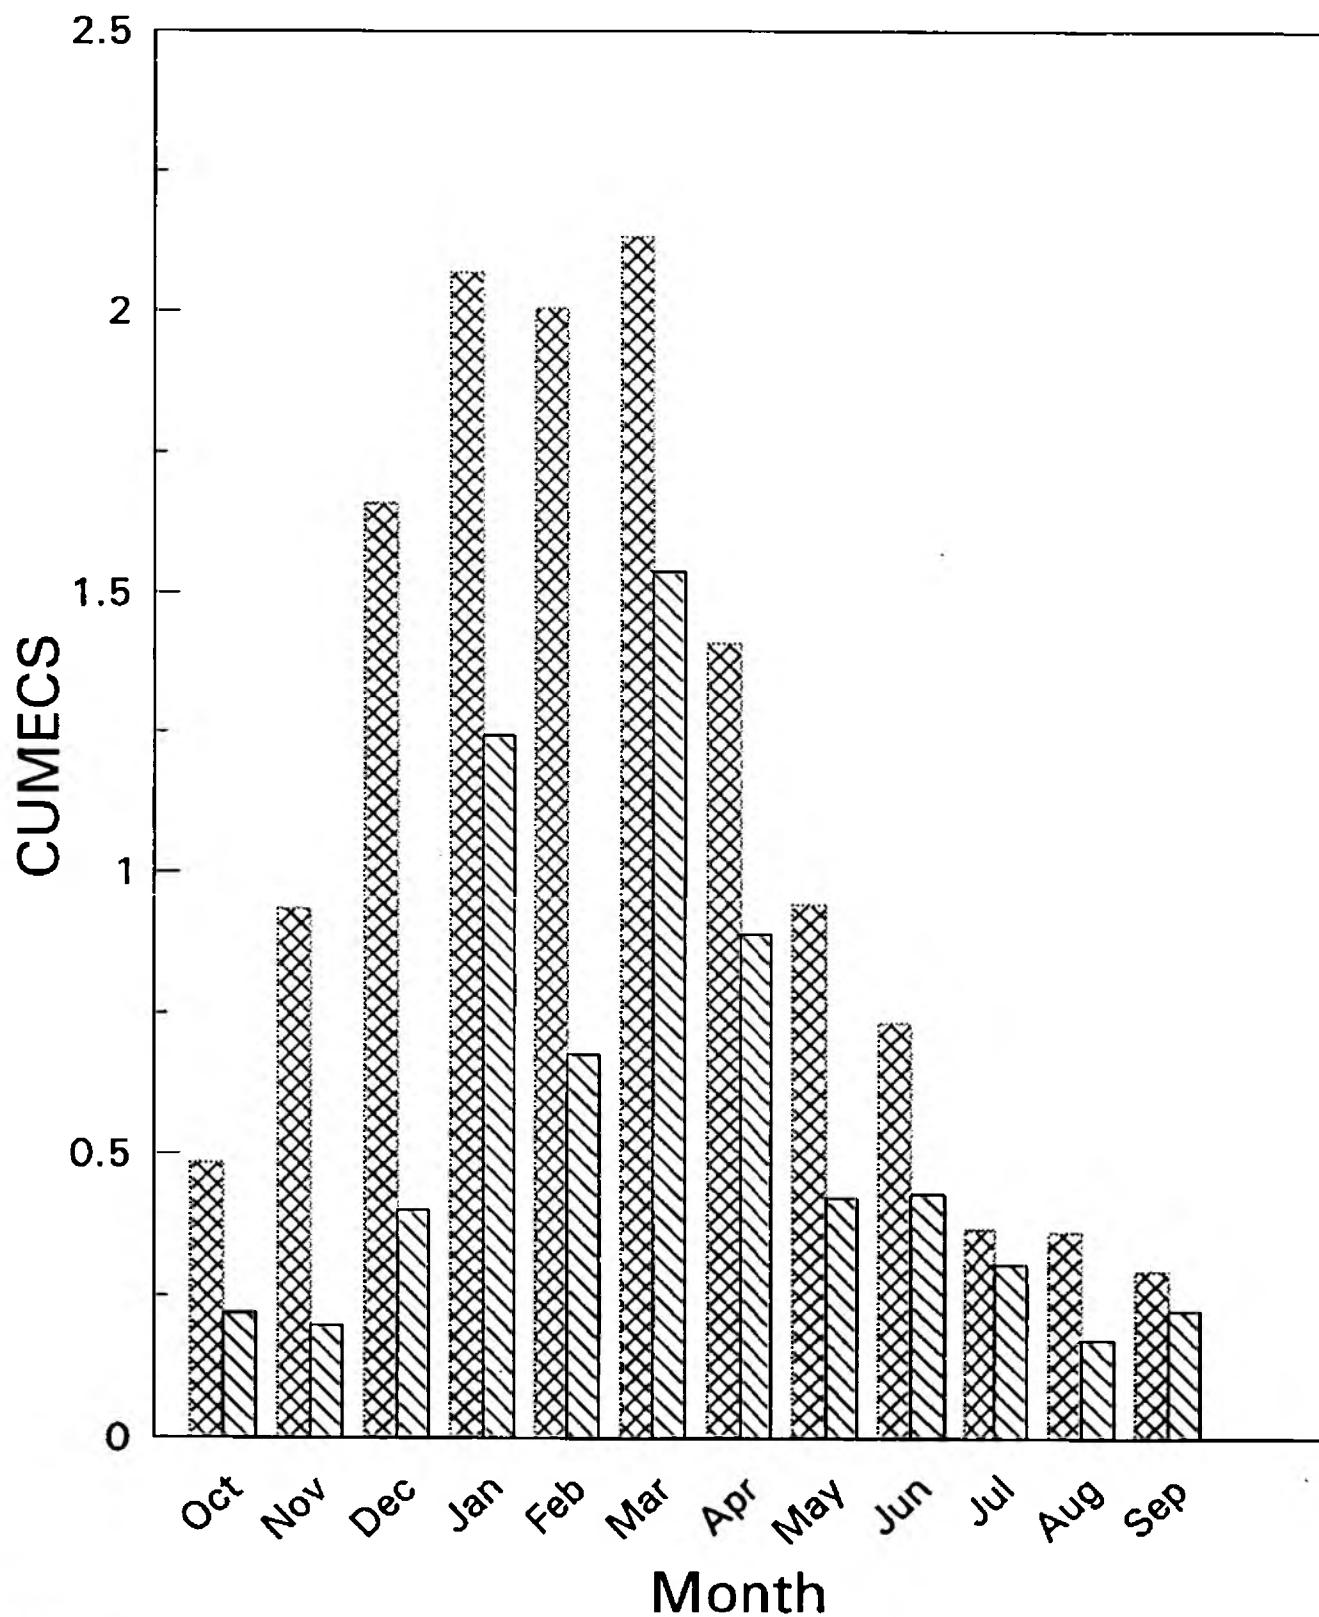
Fig 2.31 River Cole Monthly Mean River Flow At Inglesham Gauging Station (cumeecs).

Figure 2.31 shows mean monthly river flow for the long term and water year 1990/91 at Inglesham gauging station, immediately upstream of the division of the river into two channels. The annual net river flow for water year 1990/91 was significantly lower than the long term mean. Figure 2.32 shows daily flows at Inglesham for water year 1990/91, and shows the extremely flashy flow regime during this period; a characteristic of the largely impermeable clay catchment. Mean daily flow at Inglesham gauging station for the water year 1990/91 was $0.561 \text{ m}^3\text{s}^{-1}$. During this time, licensed discharges could amount to a total of $0.08 \text{ m}^3\text{s}^{-1}$ or 14% of mean daily flow. Licensed abstractions from the catchment total $0.01 \text{ m}^3\text{s}^{-1}$.

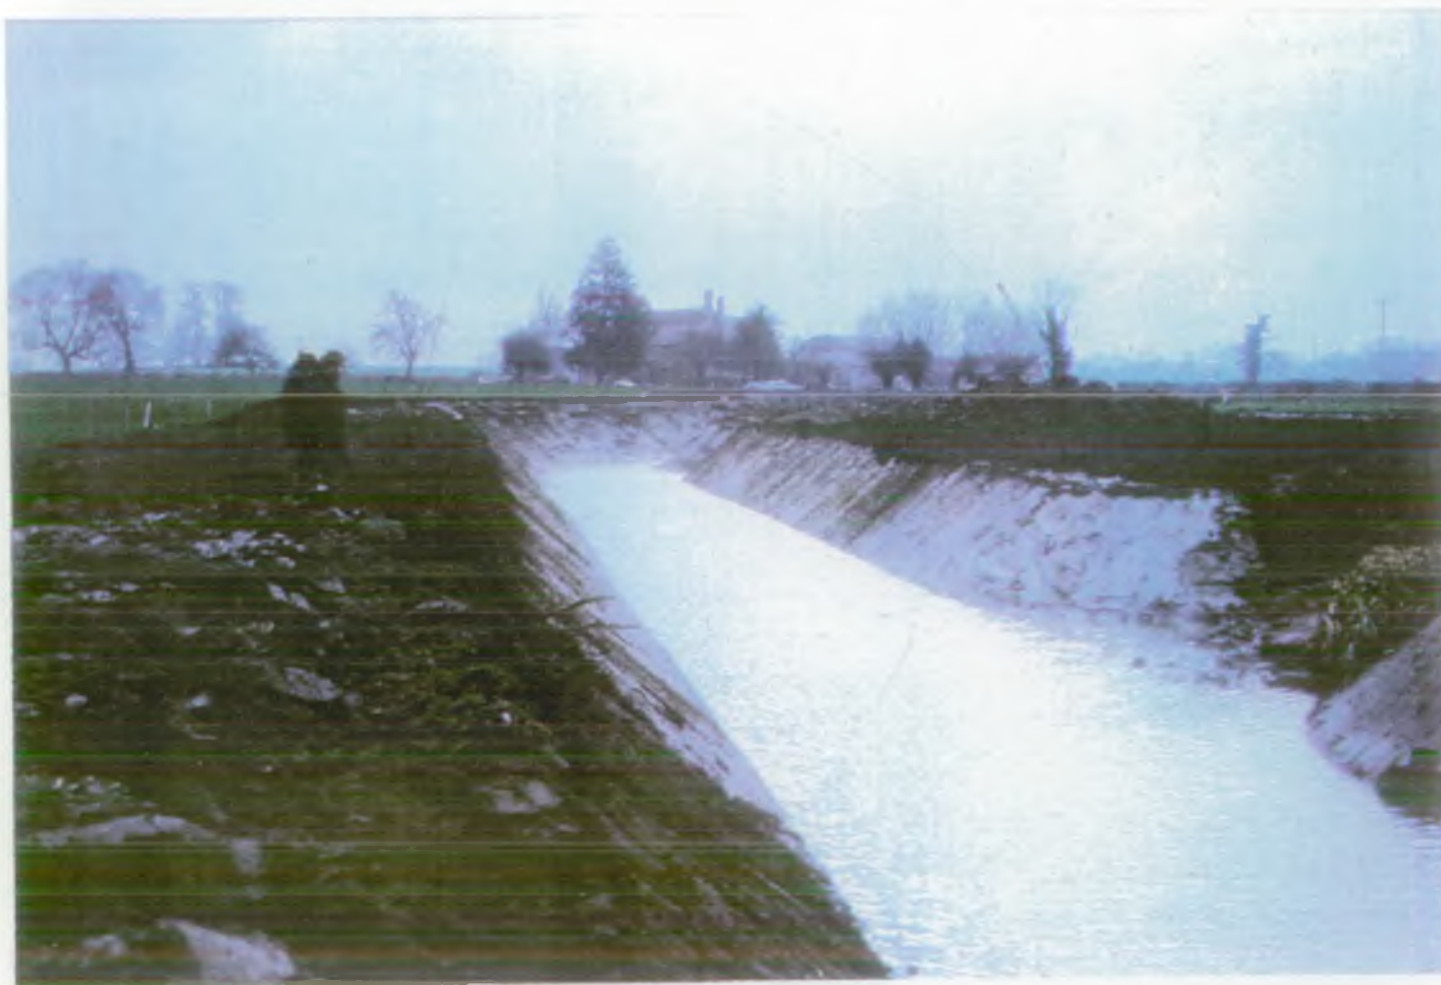
Figure 2.7 The River Cole Downstream of Lynt Bridge following Channel Re-profiling (March 1976)

To decrease the incidence of summer and annual winter flooding of natural flood meadows and therefore release land for intensive arable culture, the former Thames Conservancy prepared a major land drainage scheme which was implemented by its successor the Thames Water Authority in 1975/6. The scheme involved regrading and re-aligning about four miles of river from Coleshill downstream to the River Thames. The result of this was to alter a natural, sinuous channel with established pool riffle sequence and excellent bankside shelter and shade bordered by established flood meadows with considerable conservation value. The finished channel was straight, wide and canalised in places and contained between steep, high banks with a bare clay substrate following the complete removal of the existing gravel (see Fig 2.7).

Apart from the complete lack of environmental input to the design, fundamental errors were made in the management of the scheme, resulting in the lower section (immediately upstream of the weir at Inglesham) being dredged well below the optimum grade line, and a steep gradient was therefore required to meet with the invert of Coleshill Bridge. The result of this was to exacerbate torrential flows immediately downstream of Coleshill Bridge, and very sluggish flows upstream of Lynt Bridge. In addition to the dredging, a replacement weir was built at Lynt Bridge that diverts a maximum of two thirds of flow down the Barkers Brook and one third down the Cole, reversing the natural division of flow. (Jenkins, DG., 1980)

Results of a fisheries survey carried out immediately before and shortly after the completion of the project illustrated a 90% reduction of chub and 95% reduction of dace populations (in terms of biomass), despite significant efforts to rehabilitate this section of the river through re-stocking and habitat enhancement. (Anon 1980).

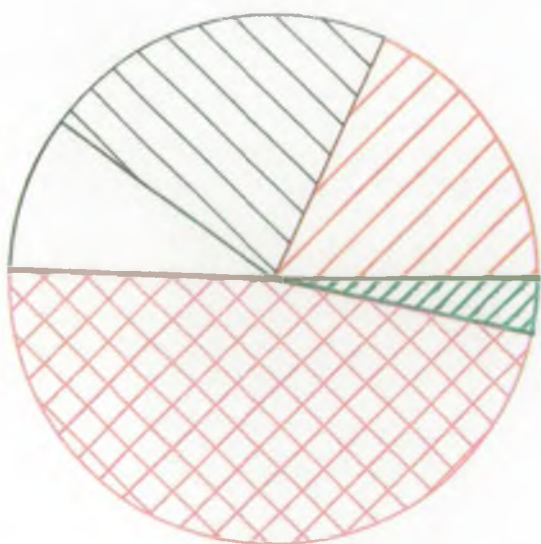
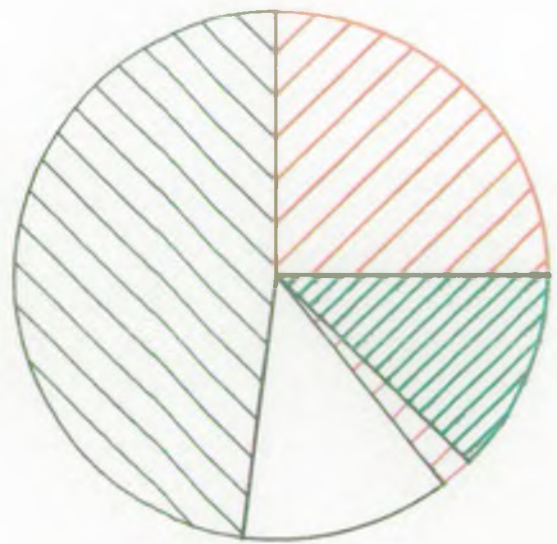
Fig 5.11 Site CLF 1 Biomass and Density.

CATCH: This site fails to meet the NRA Thames Region target biomass for EC designated coarse fisheries and the paucity of suitable instream habitat must be a factor. Of the minor species stone loach were common and minnows, stickleback and bullhead were present. An upstream run of 105 m by 5.7 m gave a weight of 9.5 kg which equals a biomass of 15.9gm², including two chub and better quality dace. This result reflects the improved habitat present in the upstream section.

The site at Acorn Bridge (CLF1) marks the upstream extent of the EC fishery designation (1B cyprinid) of this river. The physical characteristics of the site were dominated by a quantity of stone spread about the river bed that had fallen from the railway line and bridge, apart from this the substrate of the survey section was mostly bare clay with mud and silt margins. Disappointing biomass (12.8 gm^{-2}) and density (0.200 nm^{-2}) results were dominated by pike (6.1 gm^{-2}) and gudgeon (0.096 nm^{-2}). A similar biomass of 15.9 gm^{-2} was found in an upstream run of 105 m. Small roach and dace in the length frequency results show that there has been successful recruitment to these species.

These results fall short of the NRA TR minimum biomass target of 20 gm^{-2} for EC designated cyprinid fisheries. Four tributaries join the River Cole upstream of this site, of these the Liden Brook and the Lenta Brook have failed their RQO in the past five years. These four tributaries receive discharges greater than $10 \text{ m}^3\text{d}^{-1}$ from five sources, two of which have failed to meet their discharge consent conditions on occasions in the past five years (Poplars Hotel STW and Bishopstone STW). The biological scores for this site corroborate the fisheries survey results that indicate a reduction in water quality, probably caused by a combination of discharges upstream and the urban nature of the headwaters discussed above. Despite these indicators, the River Cole from East Walcot to confluence of the Tuckmill Brook attained an RQO of 1A in 1991 and up to June 1992. There is no recorded history of significant fish mortalities on this part of the river, so intermittent acute pollutions seem unlikely. On the other hand, long term chronic pollution should be picked up by RQO sampling. It is possible that point sources of pollutant enter the river within the urban section (ie Greenbridge Industrial Estate) and are not subsequently detected by chemical sampling. Further investigation is necessary to clarify the water quality situation.

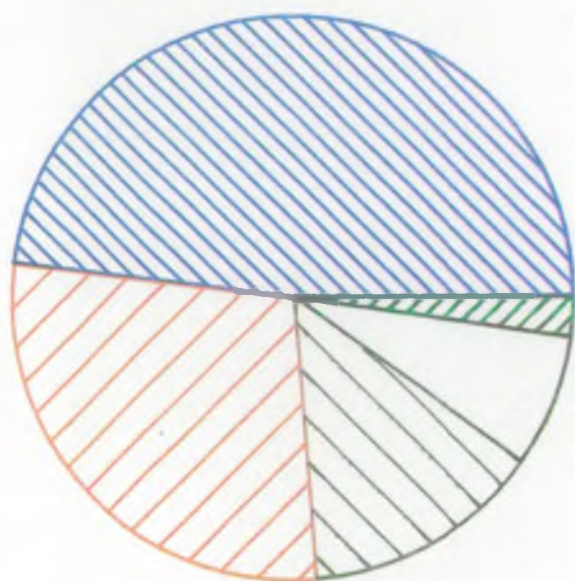
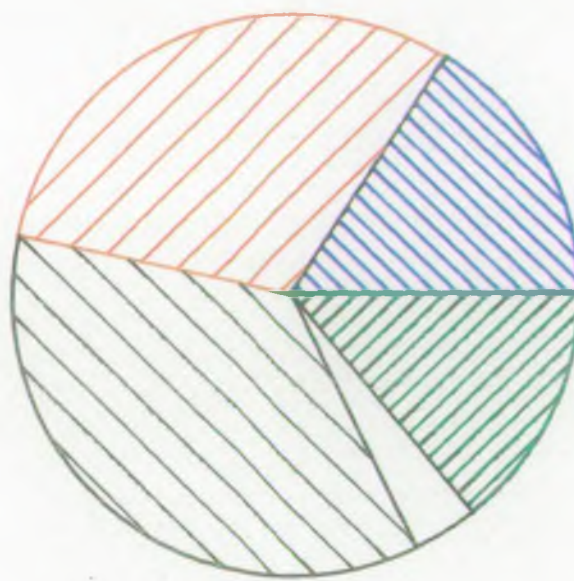
Fig 5.12 Site CLF2 Biomass and Density.

CATCH: This site fails to meet the NRA Thames Region target biomass for EC designated coarse fisheries and the lack of suitable instream habitat must be a factor: most of the fish were found under overhanging bushes, floating debris mats, or in the limited emergent weed. Of the minor species, stone loach were very abundant, and stickleback, minnow and bullhead were abundant throughout the survey and upstream sections. The upstream run of 104 by 4.4m gave a weight of 4kg of similar species which equals a biomass of 8.7gm⁻².

The poor survey results (which do not meet the NRA TR target) are likely to be a function of the paucity of suitable instream fisheries habitat at the site, although problems with water quality cannot be ruled out. The majority of the fish were caught within a short distance of the few instream features: emergent vegetation, fallen bushes and floating debris mats. The only fish caught in the upstream run were found in a small pool at its upstream extent, and during the sampling operation only a few fish were visible moving ahead of the team. It is possible that the mixing of water of inferior quality from the Lenta Brook (East) may influence the fish population at this site.

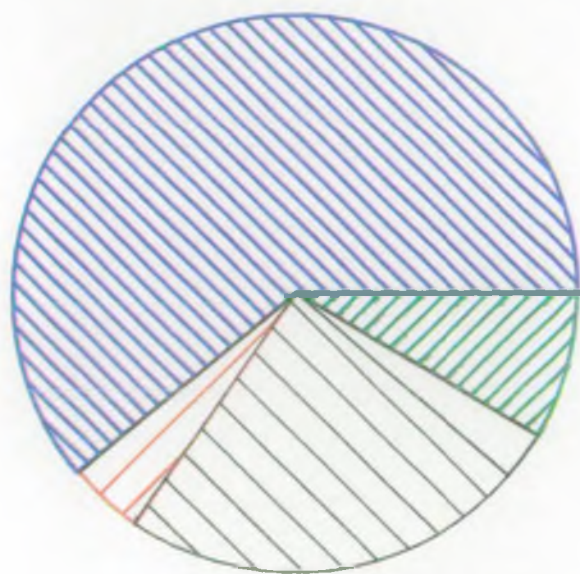
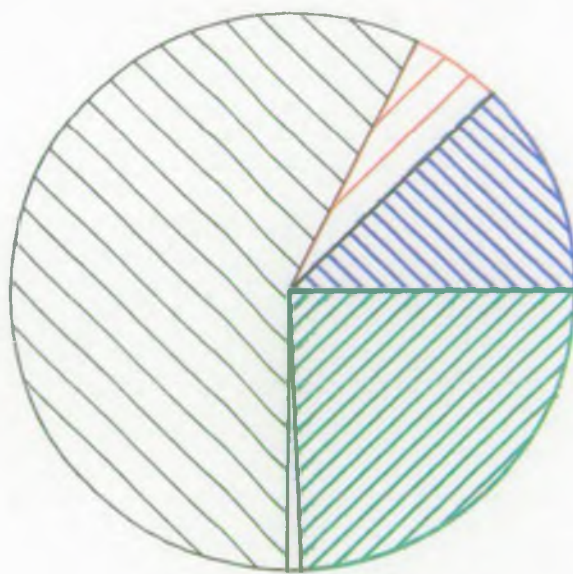
Fig 5.13 Site CLF3 Biomass and Density.

CATCH: An excellent biomass with good species diversity. most fish were caught around sunken trees and emergent weed. Of the minor species, stoneloach, bullhead and minnow were present. All fish appeared to be in excellent condition except for a slight *Piscicola sp.* and blackspot infestation on some roach. An upstream run of 61m by 5.8m gave a weight of 9.5 kg including one pike and several larger bream and equalling a biomass of 26.9 gm². A sample of 34 fish of 4 species was collected and sent for analysis of parasite fauna.

Site CLF3 at Friar's Farm had good fisheries habitat, a steep gradient and therefore faster river flows. The meandering section surveyed had a predominately bare clay substrate, in common with the sites upstream. The range of instream features combined to create a diversity of flow types from fast riffles to glides and eddies. Not surprisingly excellent biomass (40.6 gm⁻²) and density (0.622 nm⁻²) results were found, dominated by chub (24.8 gm⁻²) and an excellent gudgeon population (0.356 nm⁻²). An upstream run of 61 m gave a minimum estimate of biomass of 26.9 gm⁻², dominated by pike and bream. Length frequencies show some evidence of successful recruitment to the roach population, and illustrate the bias of the chub population towards larger and therefore older fish.

Compared with those upstream, the results from this site reflect the importance of suitable habitat for good fish biomass and density results. The habitat available at this site is better than found upstream, but by no means excellent. The fisheries survey results are supported by the BMWP score of 111 directly upstream of the survey site (Table 5.51) reflecting improved water quality. This improvement is likely to be a reflection of the distance downstream from the more urban headwaters and tributaries carrying effluent, combined with the aerating effect of a steeper channel gradient.

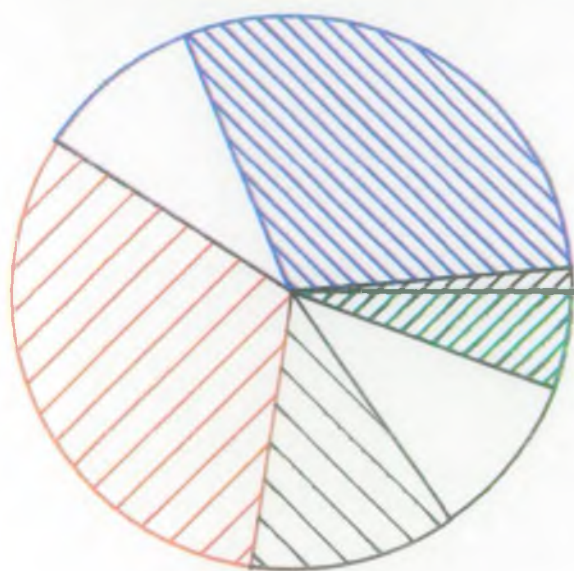
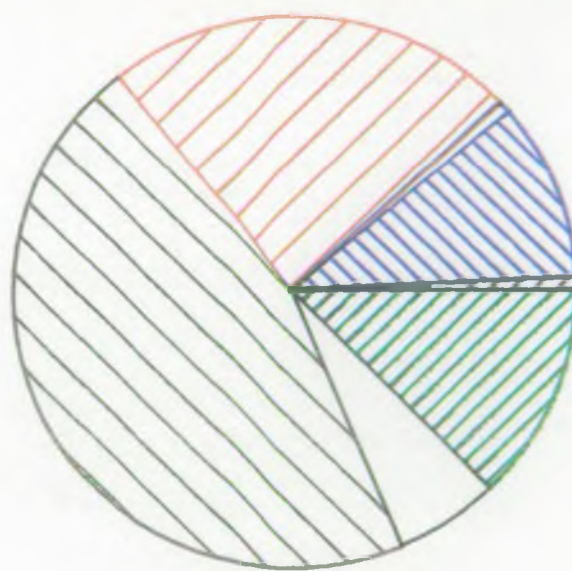
Fig 5.14 Site CLF4 Biomass and Density.

CATCH: This site failed to meet the NRA Thames Region target biomass for EC designated coarse fisheries. Most of the fish were caught in one deeper pool at the upstream extent of the survey section immediately below a riffle. Of the minor species bullhead were abundant and minnow, stoneloach and stickleback were present. No upstream run was carried out due to access problems. A sample of 30 fish of 3 species was taken for analysis of parasite fauna.

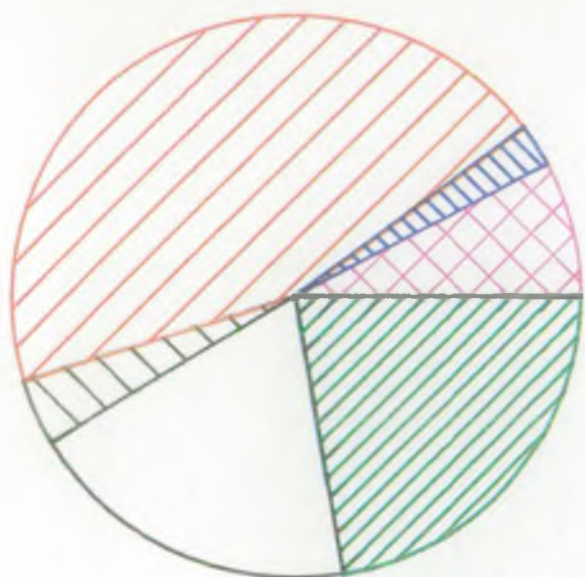
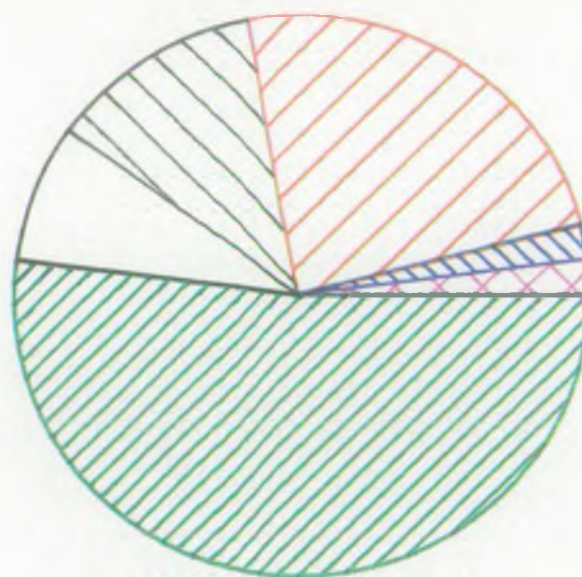
Fig 5.15 Site CLF5 Biomass and Density.

CATCH: This site fails to meet the NRA Thames Region target biomass for EC designated coarse fisheries; the paucity of suitable instream habitat must be a factor. Of the minor species only stone loach and stickleback were present. The upstream run of 10.5m by 180m gave a total weight of 15kg of similar species which equates to a biomass of 7.9gm².

Site CLF5 upstream of the impoundment at Coleshill park was marked by the very poor fisheries habitat available. The channel here is very wide, straight and canalised with almost imperceptible flow except in flood conditions. There were no instream features or variations in width and depth, and the substrate was almost exclusively mud and silt. A rich submerged and emergent plant community existed in the upper part of the survey section and throughout the upstream run section, which one would expect to provide suitable habitat for roach, carp and bream, a number of which were stocked into this part of the river in 1989 (Appendix Vb).

The biomass (5.8 gm⁻²) and density (0.100 nm⁻²) results for this site are the worst for the whole of the River Cole, and are corroborated by an upstream run that produced a minimum estimate of biomass of 7.9 gm⁻². Length frequencies for roach show successful recruitment to this population.

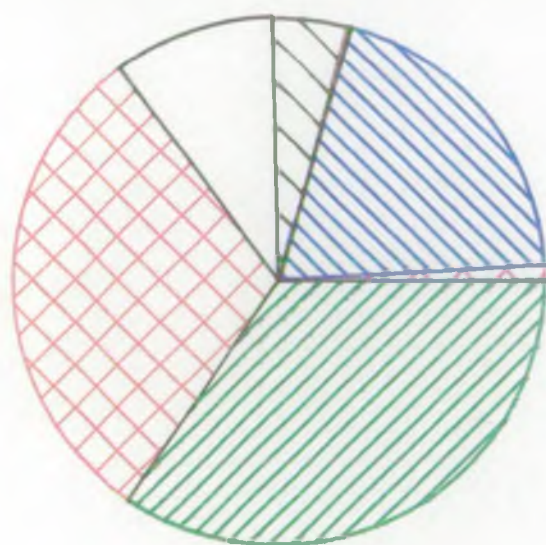
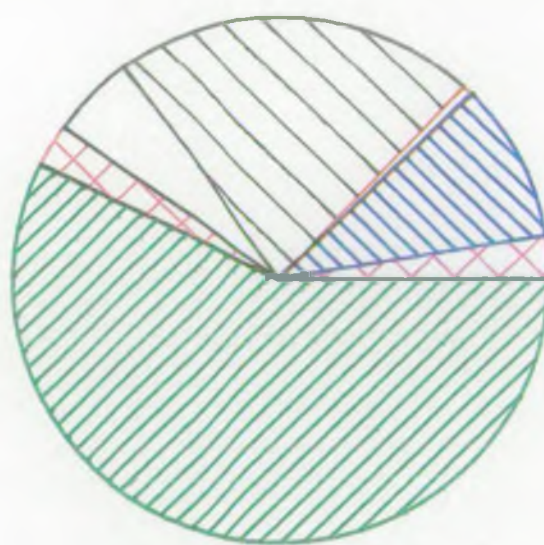
Fig 5.16 Site CLF6 Biomass and Density.

CATCH: This site fails to meet the NRA Thames Region target biomass for EC designated coarse fisheries. Of the minor species, stoneloach and bullhead were present and minnows were abundant.

The biomass (10.4 gm^{-2}) and density (0.154 nm^{-2}) results were very poor, failing to meet the NRA TR target biomass for EC designated cyprinid fisheries, despite the presence of seven major and three minor fish species. The catch was dominated by roach (3.6 gm^{-2} , 0.088 nm^{-2}) and pike (3.5 gm^{-2}), no upstream run was carried out. Length frequencies for roach and gudgeon showed successful recruitment, and the chub population exhibited a wide range of size (and therefore age) classes.

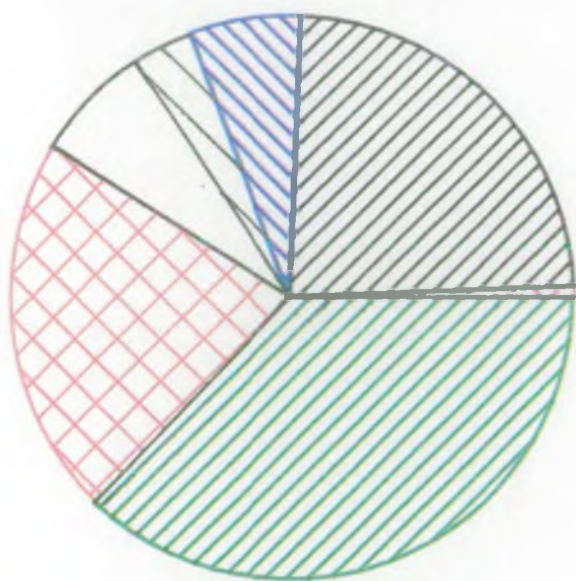
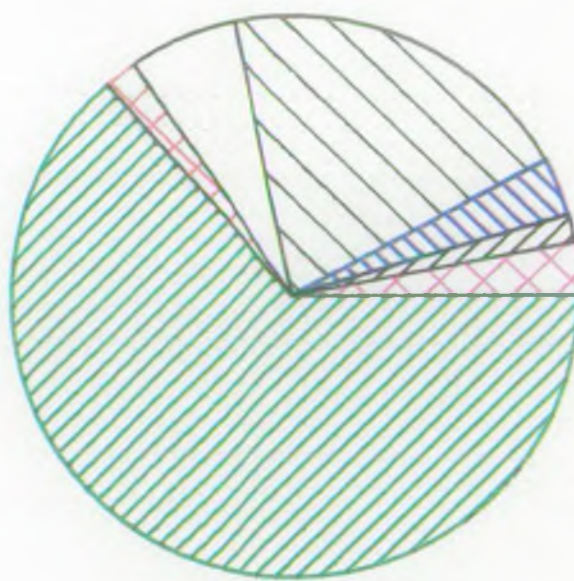
Fig 5.17 Site CLF7 Biomass and Density.

CATCH: A good biomass of several species most showing successful recruitment, which is surprising considering the remarks above. Most fish were associated with the few instream features, and all appeared to be in good condition although *Piscicola sp.* was common. Of the minor species minnow, bullhead and stone loach were present. An upstream run of 117m by 6.5m gave a weight of 20 kg of a similar species mix equalling a biomass of 26.3 gm².

are so good. The fisheries habitat was poor, yet the roach, perch, gudgeon, pike and chub populations all appear to be stable and self sustaining. A clue is provided by results from the upstream run which are much lower than for the survey section. It is likely that an aggregation of fish was sampled at this site, which would therefore give disproportionately large density and biomass values. The fisheries results corroborate the apparently excellent results of chemical and biological measures of water quality for this part of the river.

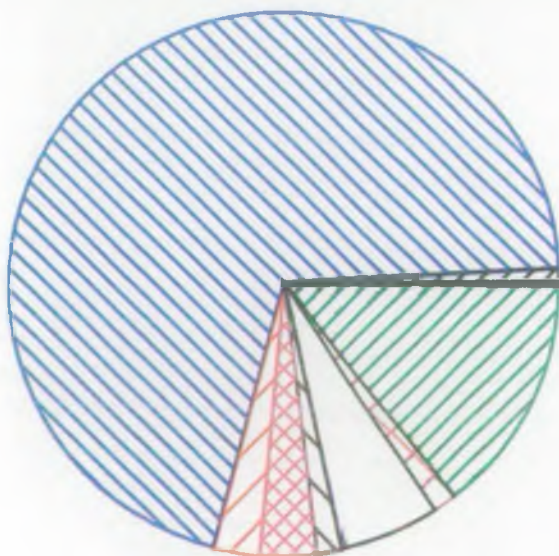
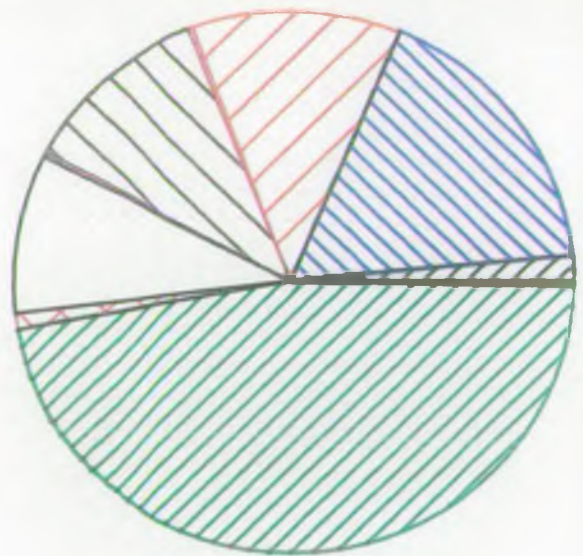
Fig 5.18 Site CLF8 Biomass and Density.

CATCH: This site gave an excellent biomass and density with a total of 10 major and 5 minor species present. The superior habitat provided by the site must be a significant factor and indicates the potential for the whole of this watercourse. The larger fish were taken from one large pool halfway along the site. Of the minor species, stickleback and lamprey were present, bullhead and stone loach were common and minnow were abundant in such numbers to contribute significantly to the biomass. All fish appeared to be in good condition, one *Piscicola* sp. (fish leech) and one *Argulus* sp. (fish louse) were found. No upstream run was carried out due to access restrictions.

These results illustrate the rôle of suitable fisheries habitat in supporting good fish populations, and reveal the fisheries potential of this river where the appropriate conditions are allowed to exist. A number of the fish caught are likely to have originated from the River Thames, and this reach of the river is probably a key spawning area for gravel spawning species (chub, dace, barbel).

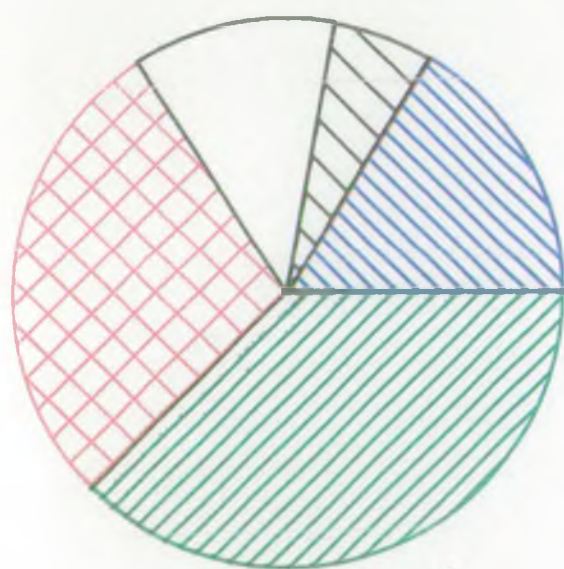
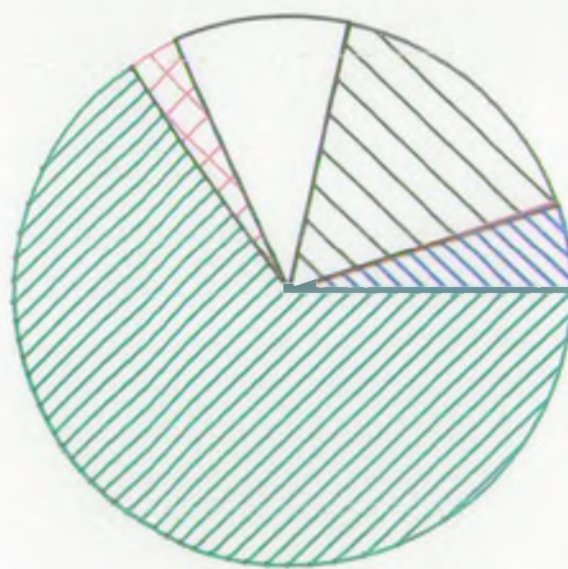
Fig 5.19 Site CLF9 Biomass and Density.

CATCH: This site gave a good biomass and high density of smaller fish with a good species mix. Each species appeared to show successful recruitment and the reach is likely to be an important spawning and shelter area for fish moving up from the River Thames. Along with large quantities of cyprinid fry, stoneloach, stickleback, minnow and bullhead were present. All fish appeared to be in fair to good condition although some had slight *Piscicola sp.* infestation. No upstream run was carried out due to access difficulties, but similar shoals of small fish were observed upstream of the survey site.

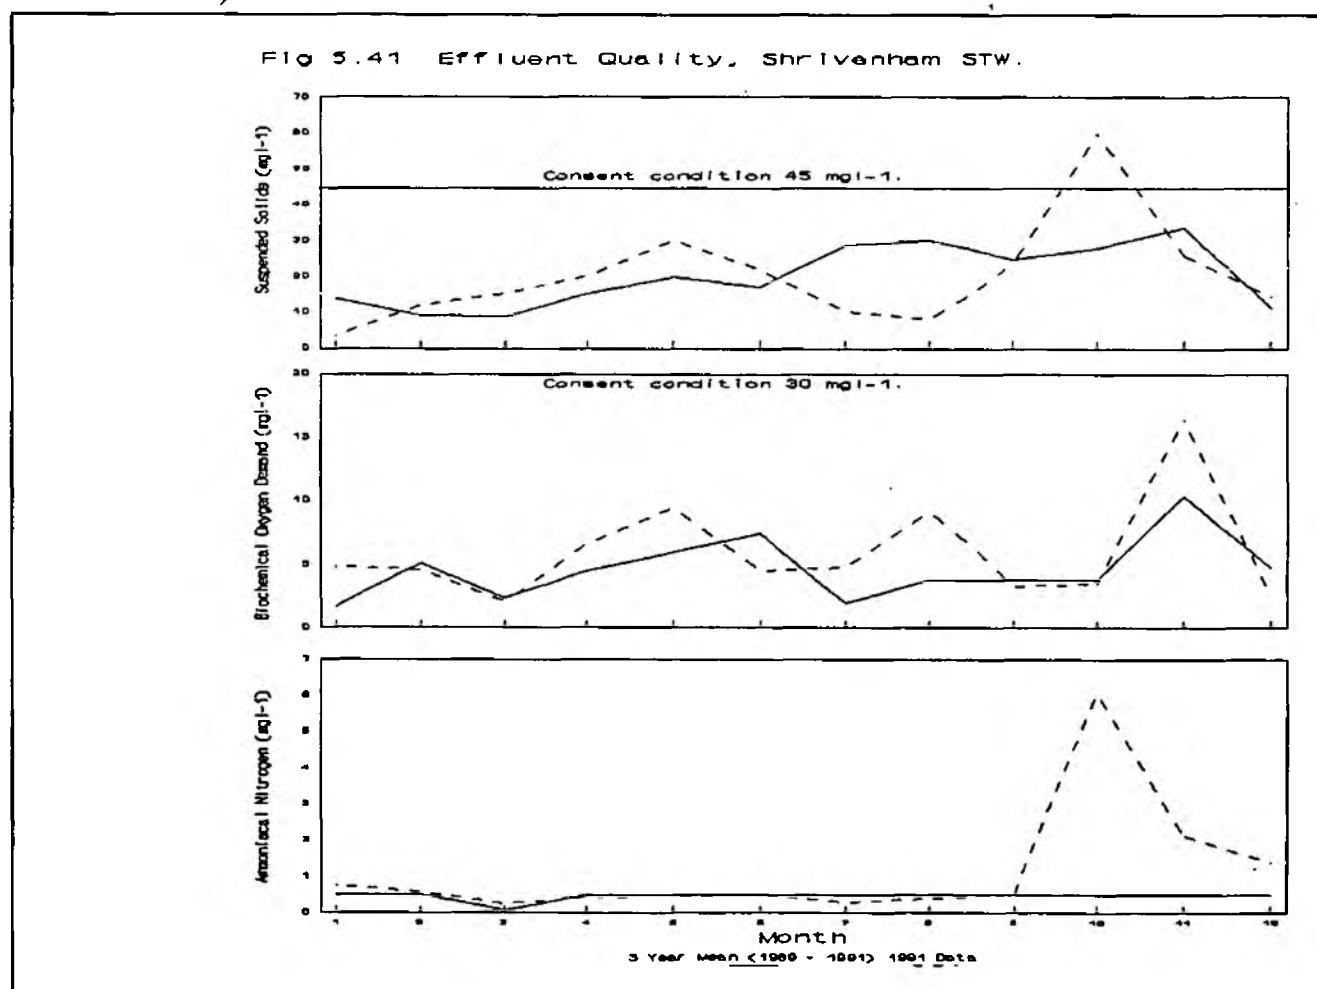
Figure 5.41 shows effluent quality for Shrivenham STW (The largest discharging into the River Cole catchment).

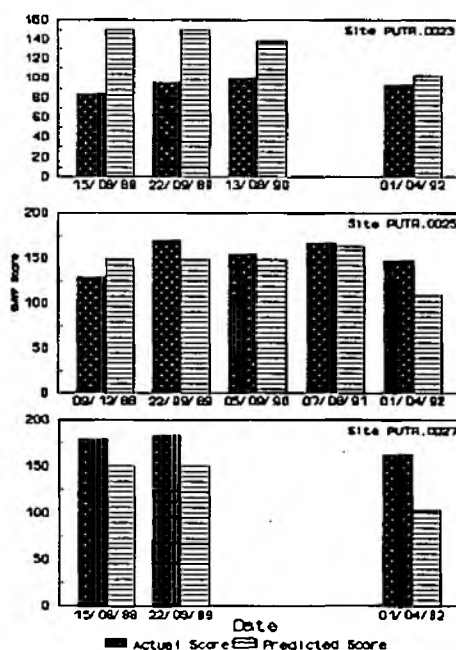
Fig 5.52 BMWP Score for Three Sites Over Time.

These results show that biological quality in the river is generally high, although there is evidence that the headwaters are stressed due to their urban nature. Biological sampling indicates that the river should be capable of supporting a healthy fishery, albeit restricted upstream of Coleshill. Table 5.52 below shows changes in and differences between predicted and observed BMWP scores for three sites on the River Cole. These data are also presented in figure 5.52.
