Bath Sewer Overflow Study

NWI/99/159-b

**Final Report
North Wessex Investigations Team**

February 2000

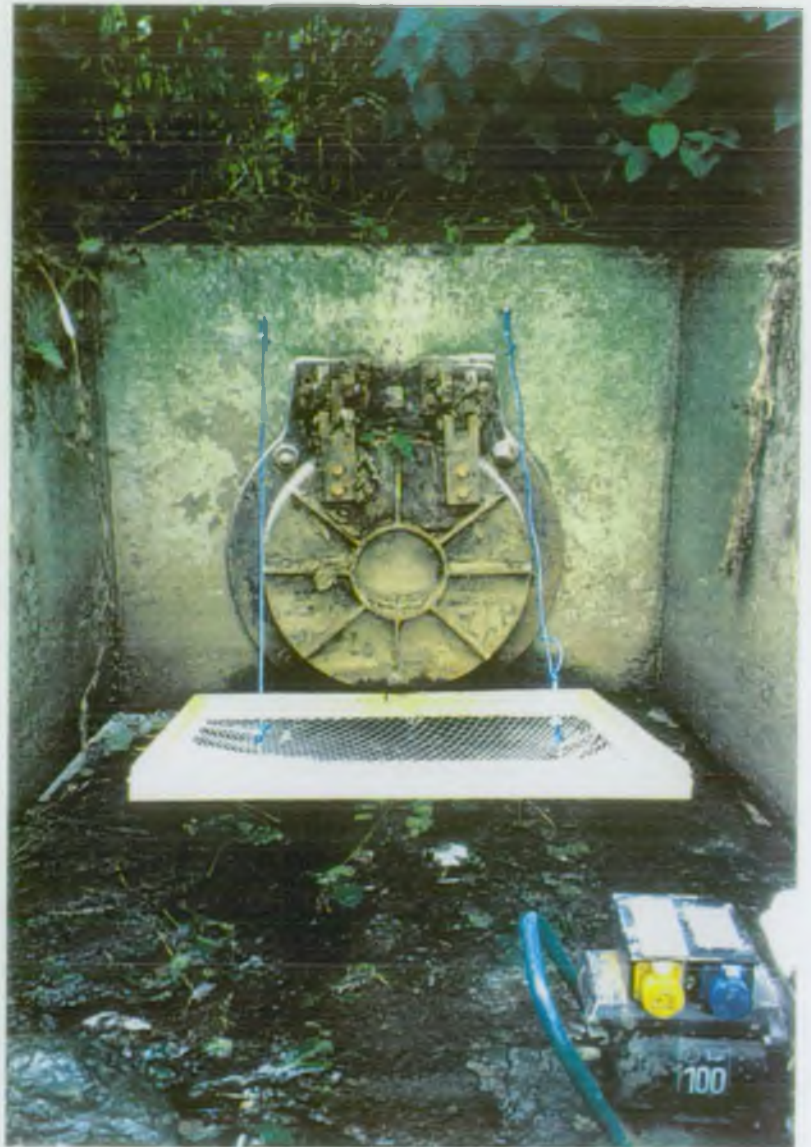
London Road West, Lambridge
Screen in-situ below CSO. →

London Road West (Lambridge). One metre square heavy duty wooden frame with one inch netting fixed between, fitted at a shallow angle below the outfall pipe using cables fixed to header wall (see photo).

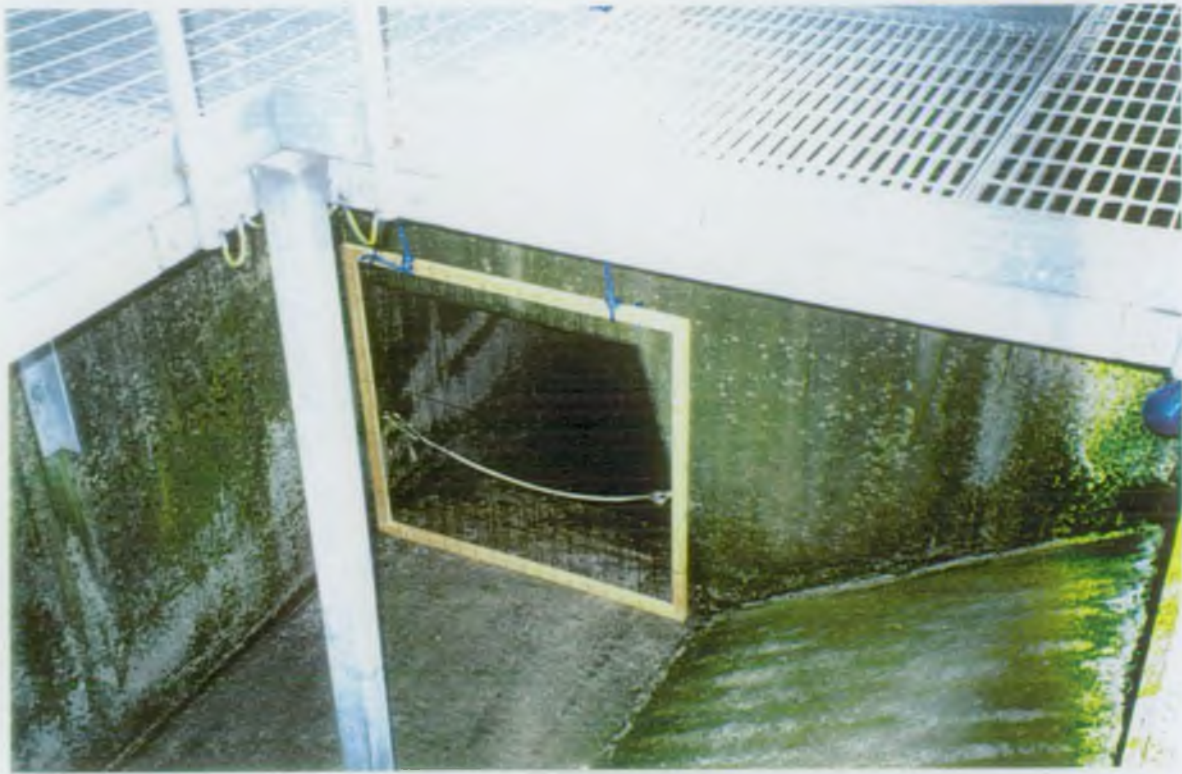
Norfolk Crescent
Screen in-situ over CSO. ↓

Norfolk Crescent. Sixty centimetre Square frame, with one inch netting forming a long 'sock' which was clamped at the end to allow access. Bolted to header wall allowing unhindered operation of flap on outfall (see photo).

The screen was replaced and longer bolts used to fix it to the wall. Although June and July were seasonally dry, considerable amounts of debris were found in the screen. On more than one occasion the volume of debris rendered it impossible to quantify the contents of the screen. On 21 July Environment Protection staff tripartite sampled the CSO when it was found to be discharging in dry weather. Within three weeks the pipe had been bunged and contractors brought in to jet the sewer. This is a process where sediment that has built up within the sewer pipe is removed and the pipe restored to its designed capacity.

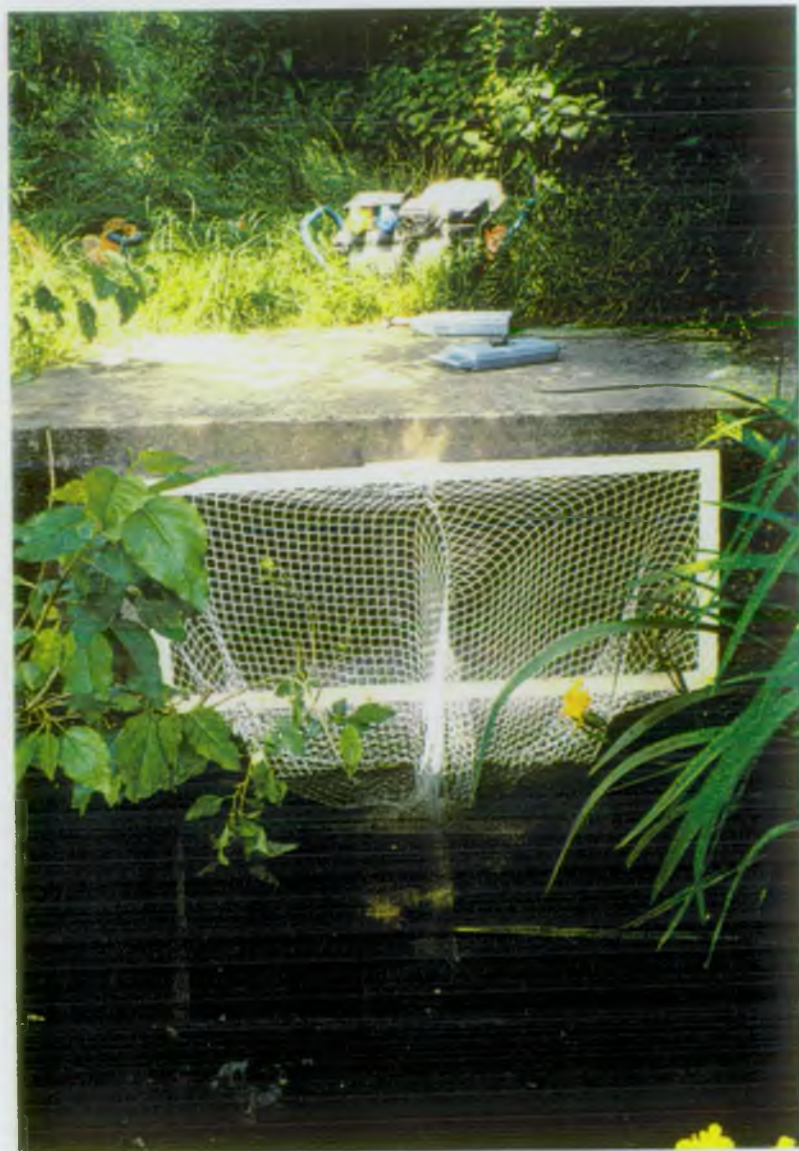
Twerton Storm Unscreened
Bypass Channel
Screen in-situ. ↑

Twerton Storm Tanks. Wooden frame fixed over the exit of the unscreened channel, a wire mesh six centimetres apart on the vertical was created with much wider horizontal spacing only for support (see photo).

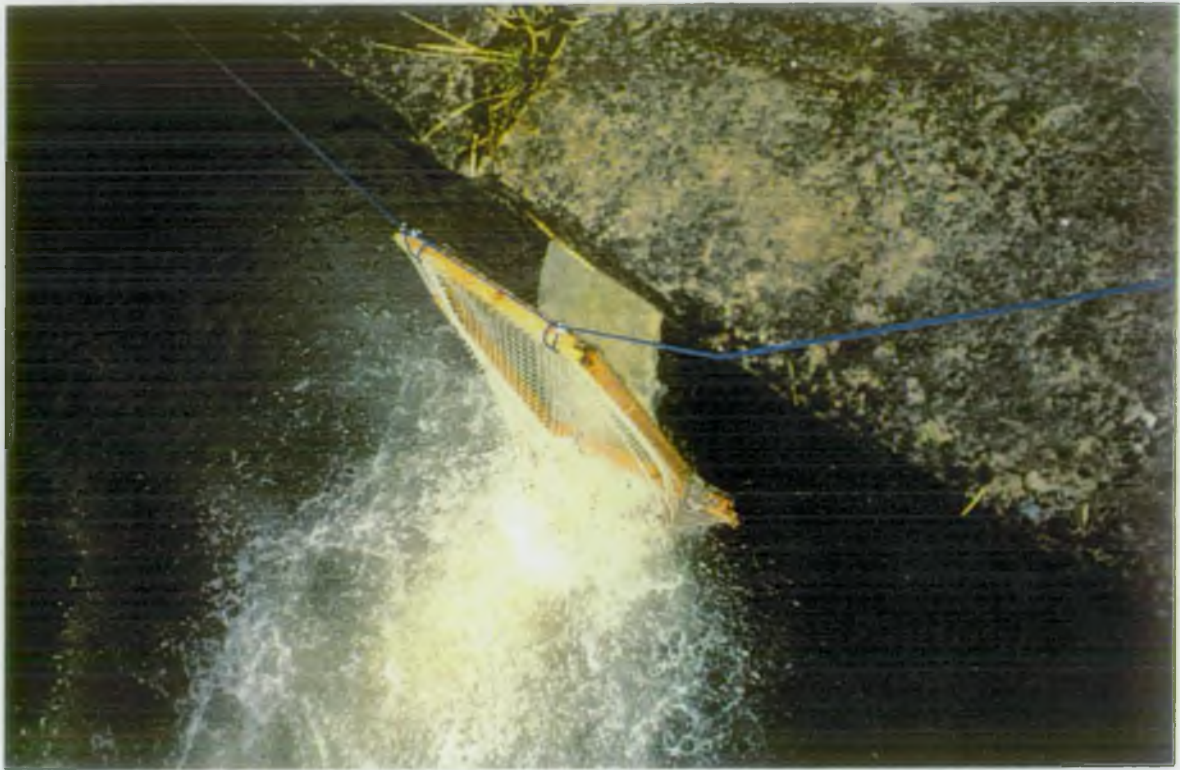
Locksbrook Overflow
Screen in-situ. ↓

Locksbrook Overflow. Heavy duty wooden frame fitted to bottom half of security screen at end of pipe again using 'sock' and clamp to catch debris (see photo).

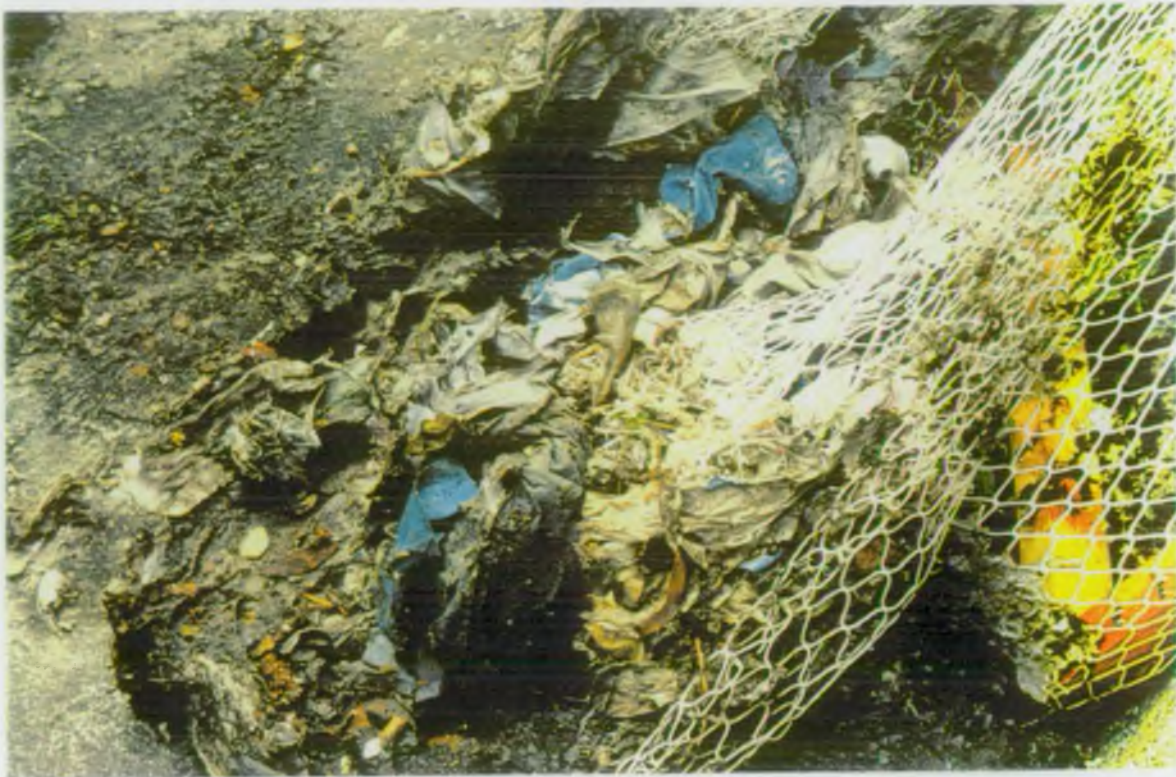
Windsor Villas Upstream
Discharging on 9 August. ↑→

Local residents commented that this CSO often discharged large amounts of sewage to the river during wet and dry weather conditions.

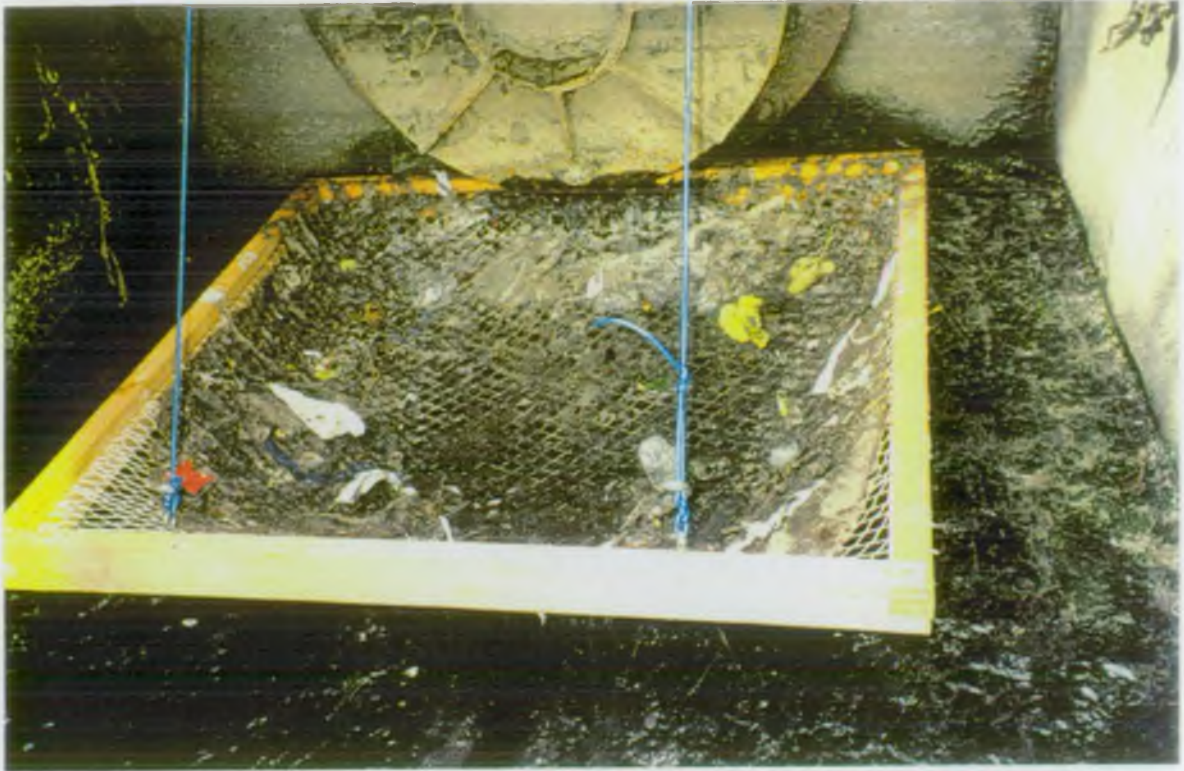
Windsor Villas Downstream
Collected debris different events.

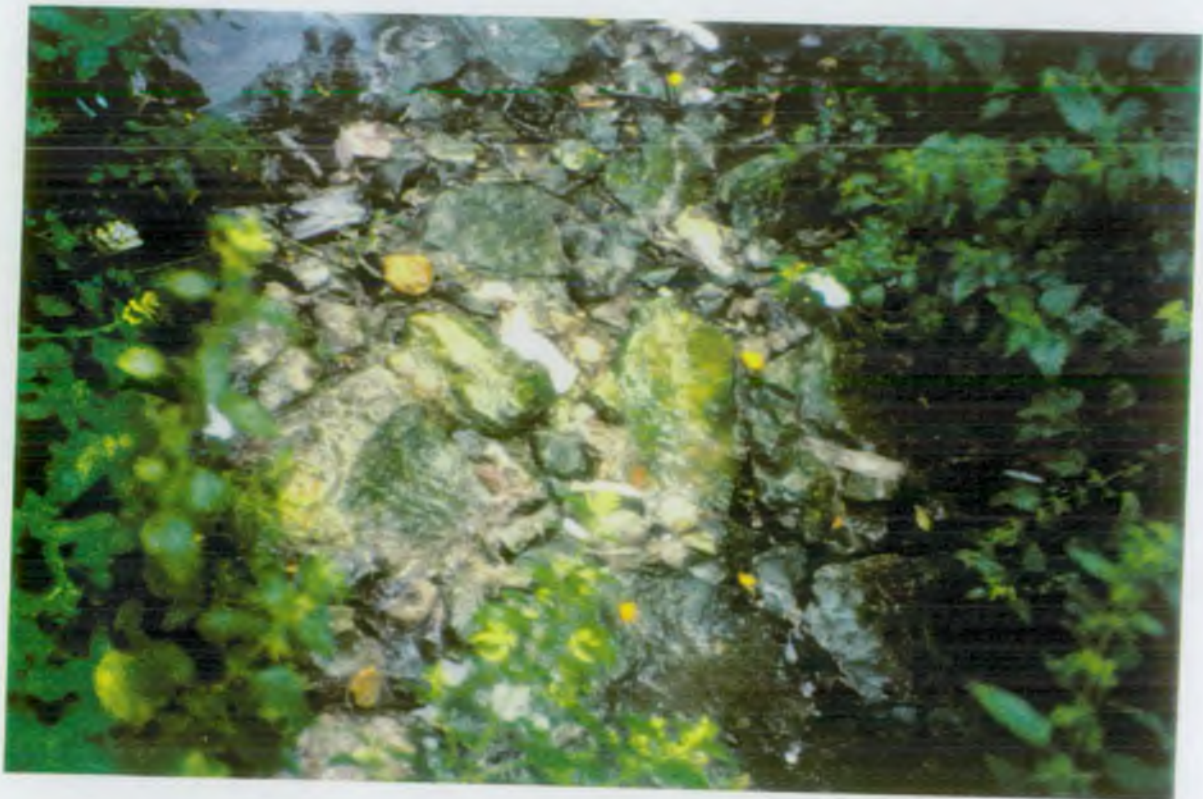
London Road West, Lambridge
Debris caught in screen. ↑

London Road West, Lambridge
Sewage debris caught in spillway. ↓

During July the screen remained clear of debris. In August there was considerable rainfall and the screen trapped a substantial amount of debris. Towards the end of September there was again considerable rainfall and the river level rose to partially submerge the screen. When river levels returned to normal the screen had been blinded with a mash of bio-degradable material both sewage and natural based. Sanitary towels were stranded in the spillway and on the bank around the CSO.
