**HOPE COVE: NON-COMPLIANCE
IN 1998 WITH THE EUROPEAN
COMMUNITY BATHING WATER
DIRECTIVE (76/160/EEC)**

**February 2001
DEV/EP/01/01
(CATCHMENT 08A)**

**Author: R. PEARSON.
ENVIRONMENT PROTECTION
INVESTIGATIONS OFFICER**

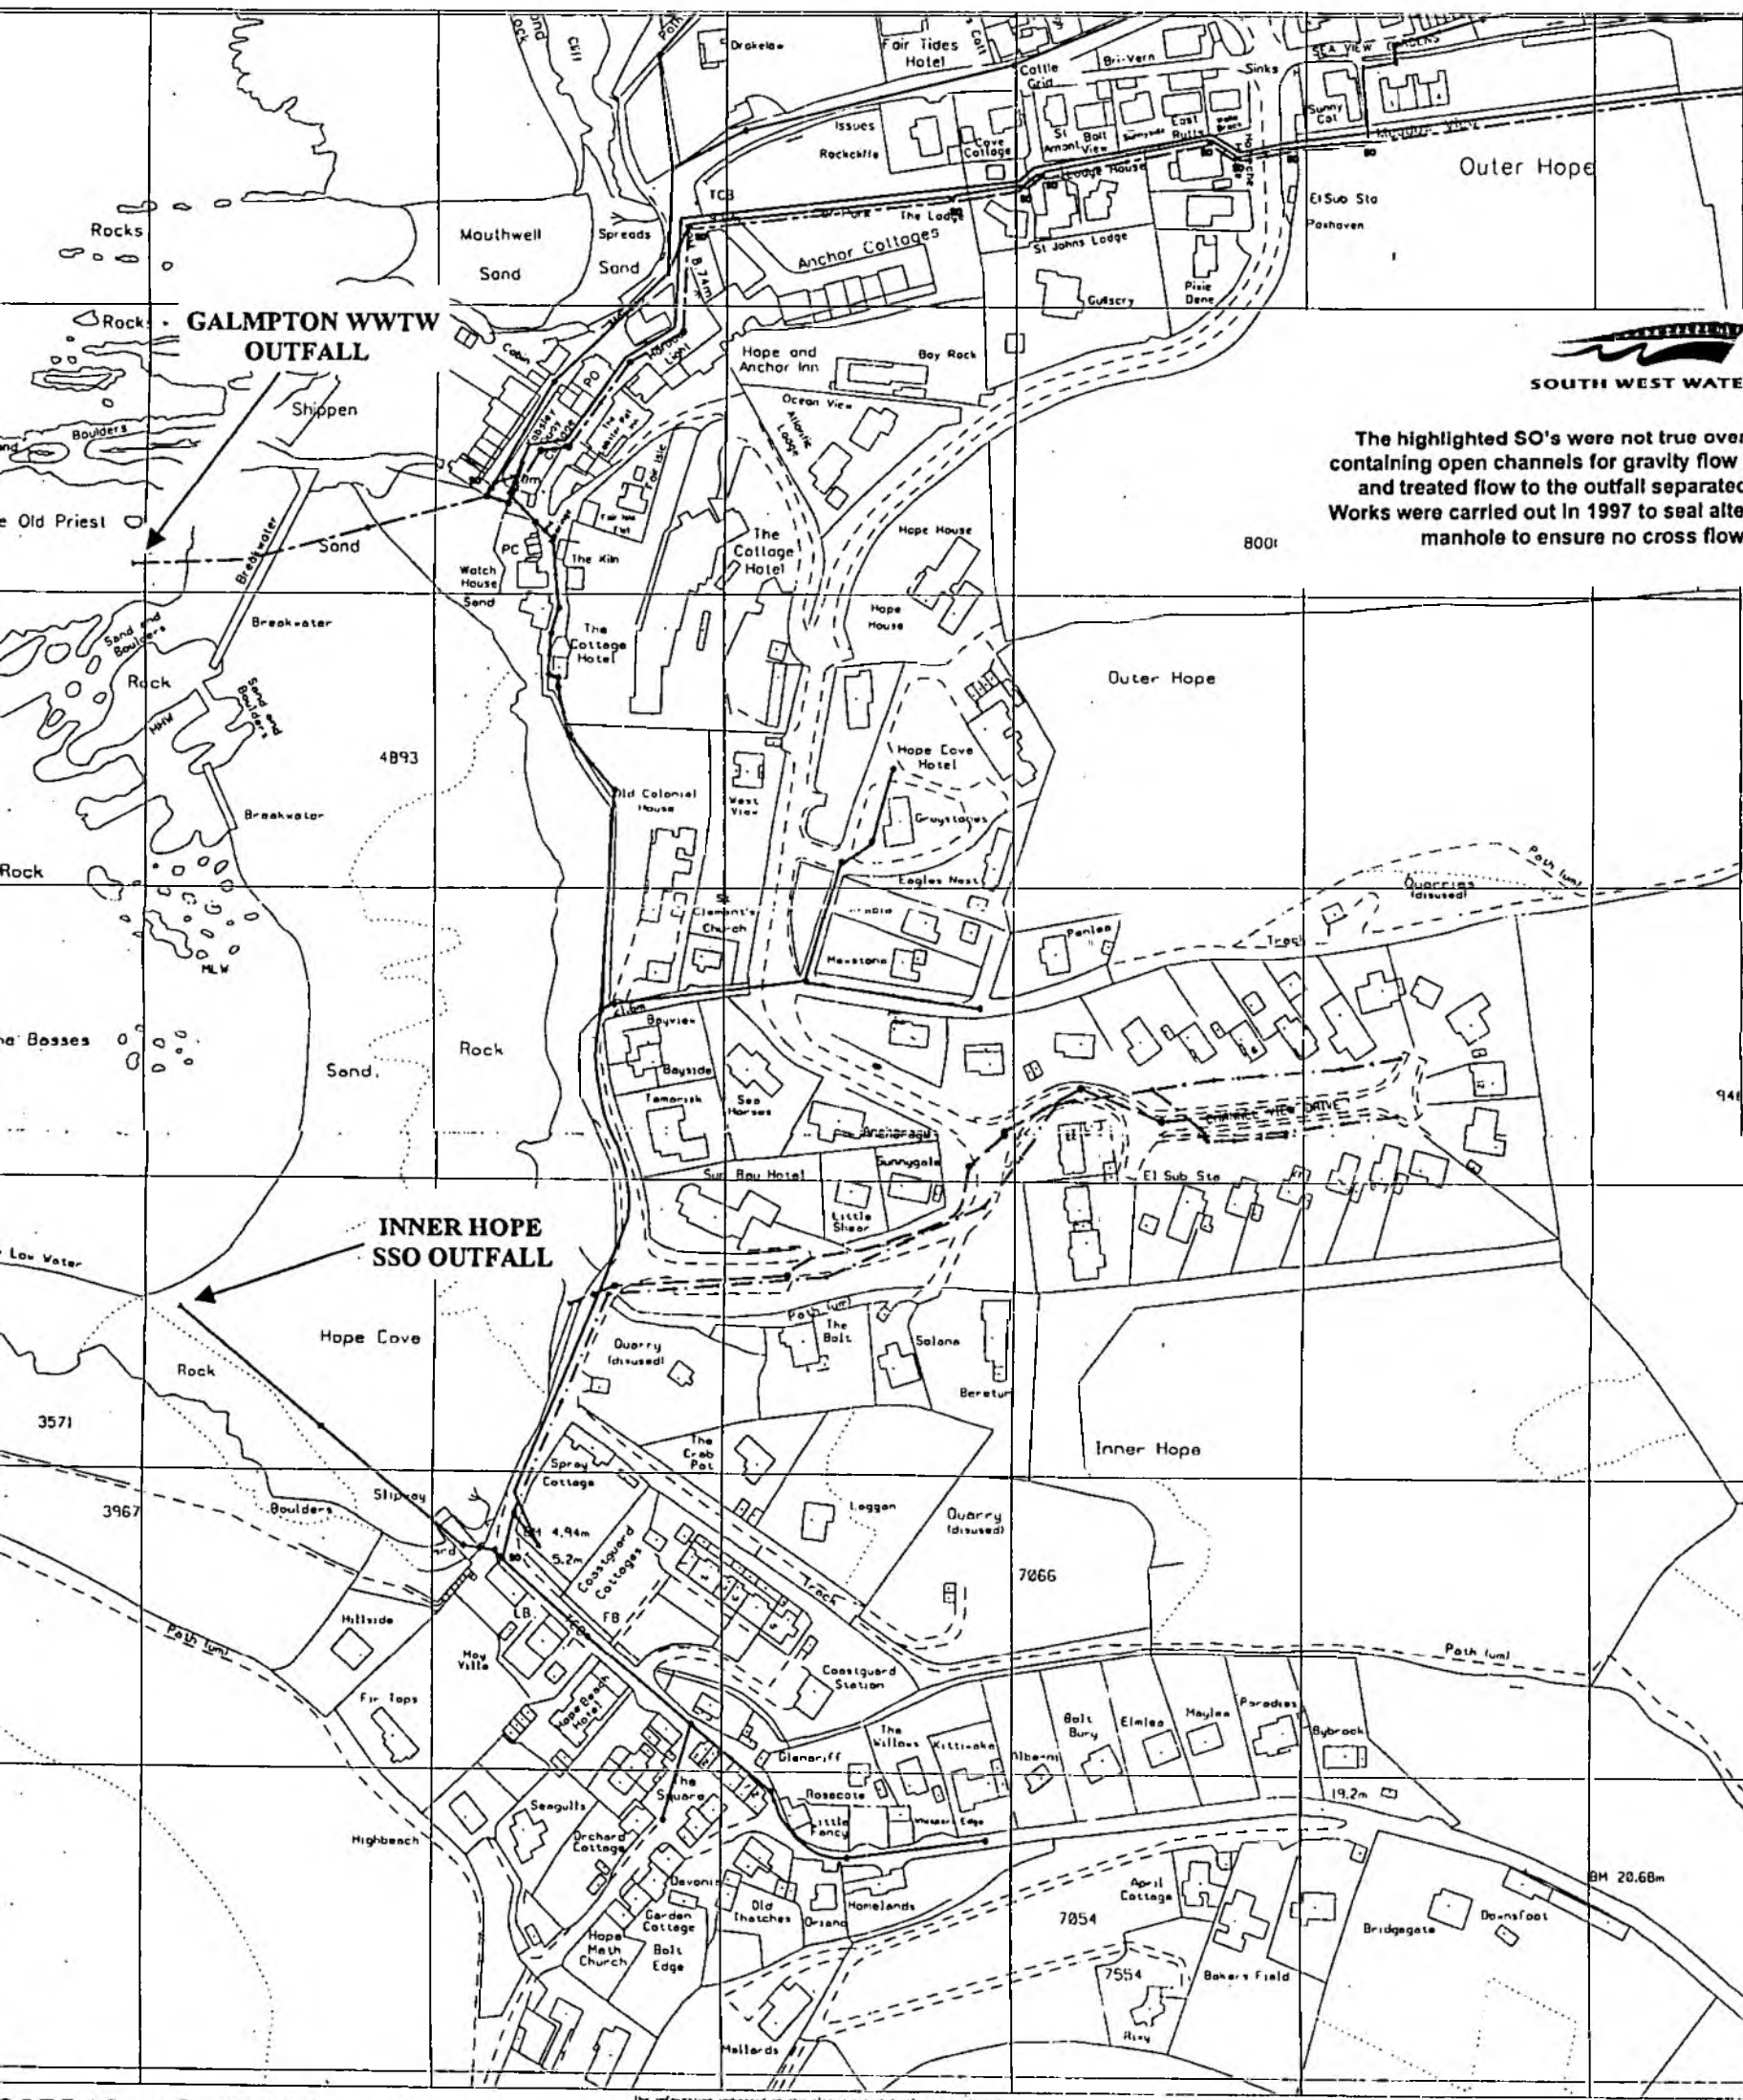
MAP 2. SWWL PLANS OF SEWERAGE FOR THE HOPE COVE AREA.

The highlighted SO's were not true overflows but chambers containing open channels for gravity flow to the pumping station and treated flow to the outfall separated by the rising main. Works were carried out in 1997 to seal alternate channels in each manhole to ensure no cross flow could occur.

Map 2. is a reproduction of South West Water Limited (SWWL) plans showing sewerage detail for the area.

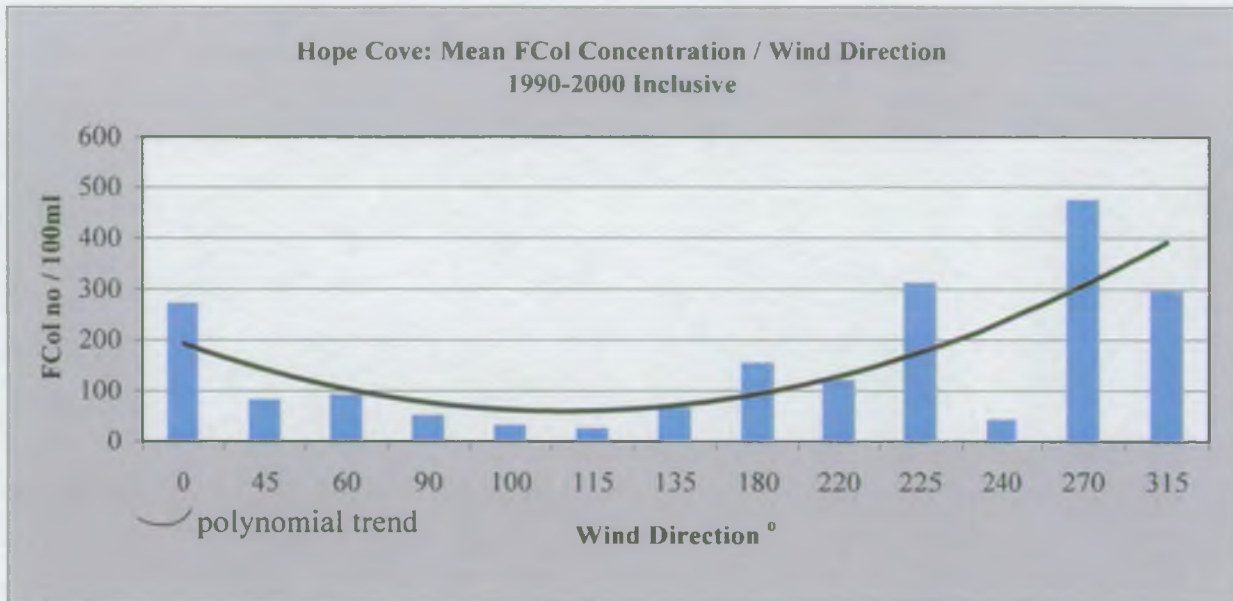
CHART 1. Faecal coliform concentrations at Hope Cove ECBW and wind direction

Plots were made for all samples from 1990 for faecal coliform concentrations and the times that samples were taken against the times of high water. No trends were evident. The same data were tested against wind direction; an enhancement in bacteria concentrations when the wind was between south-west and north was evident (this will include on-shore winds) with lowest concentrations when the wind was between north-east and south east (**Chart 1**).

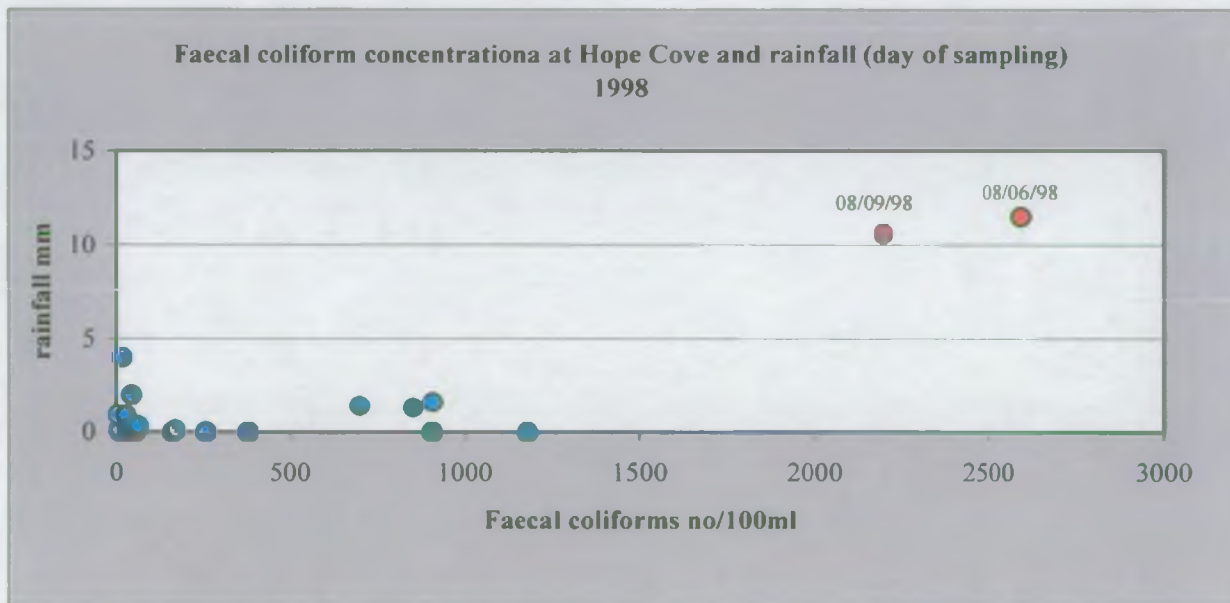
CHART 2. Faecal coliform concentrations at Hope Cove relative to same day rainfall 1998

Data for 1998 were compared with rainfall (Scobbiscombe rain gauge at NGR SX 631 470). This showed that the two poor samples taken in 1998 coincided with the highest rainfall on any day for which samples were taken that year (**Chart 2.**). Both poor samples would appear to be rain related, therefore. The relationship between the sample taken on 14/08/99 and wet weather is less clear (rainfall was 0.3mm on 14/08/99 and 4.7mm on 13/08/99).

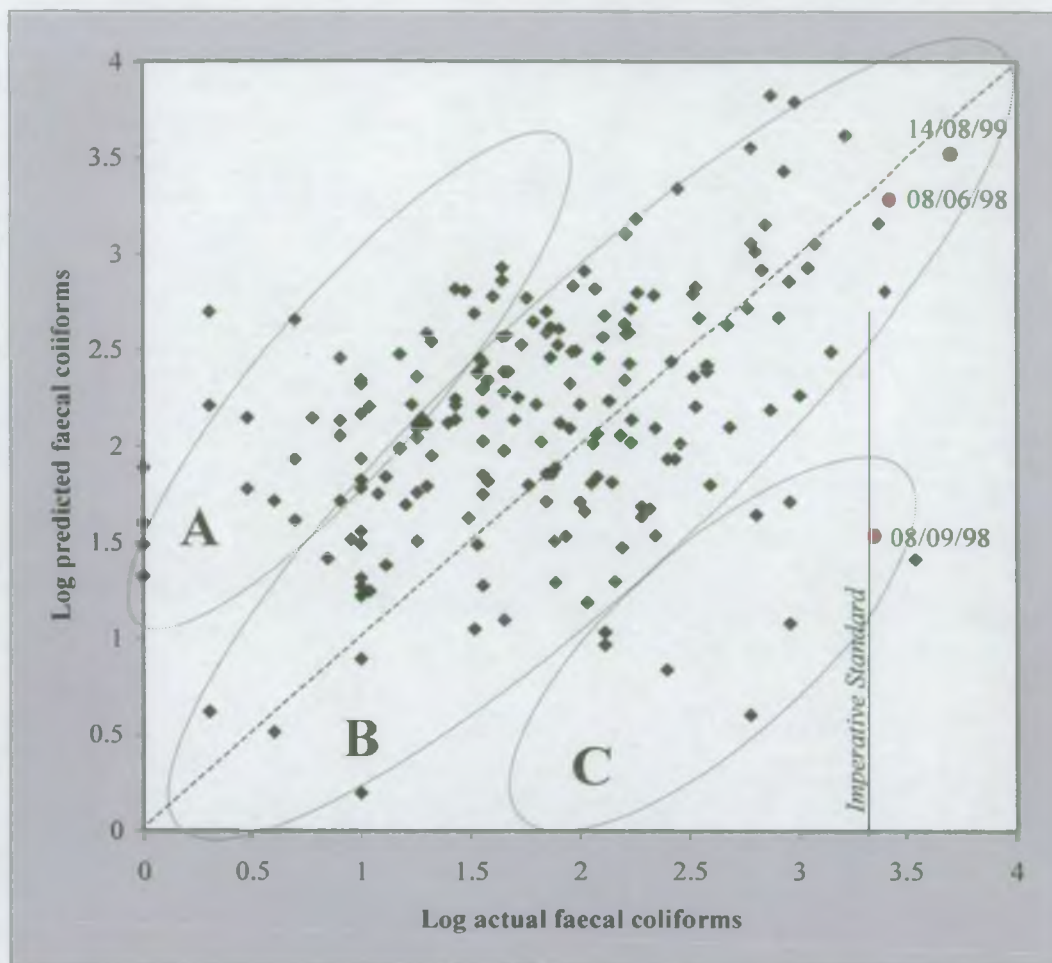
CHART 3. Predicted against actual faecal coliform concentrations at the ECBW site Hope Cove (1991-2000) based on faecal coliform concentrations in the Bolberry Stream.

Area A represents samples whose faecal coliform concentrations were substantially lower than we would have predicted and indicate that the Bolberry Stream is having little impact at the ECBW site.

The plot uses relative salinities to obtain predicted concentrations and assumes the Bolberry Stream to be the only source of faecal coliforms.

All data for the period 1991-2000² were tested against a standard mathematical model that uses comparative salinities to determine the influence of freshwater inputs on bathing beach samples (**Chart 3.**). The model showed that the Bolberry Stream, which historically has high coliform counts, was the most frequent influence on faecal coliform concentrations at the ECBW site but that other sources of contamination were present.

More specifically the model indicated that the samples taken on 08/06/98 and 14/08/99 were influenced by faecal coliform concentrations in the Bolberry Stream, whilst the sample taken on 08/09/98 was contaminated by bacteria from another source. A note was made by the Agency Officer at the time of sampling on 08/09/98 that the Bolberry Stream was entering the sea at the sample point (similar notes were made for samples taken on 07/05/98 and 05/09/98). Although the cause of the poor sample on this date is not believed to be the Bolberry Stream, the proximity of the stream to the sample point is an important consideration.

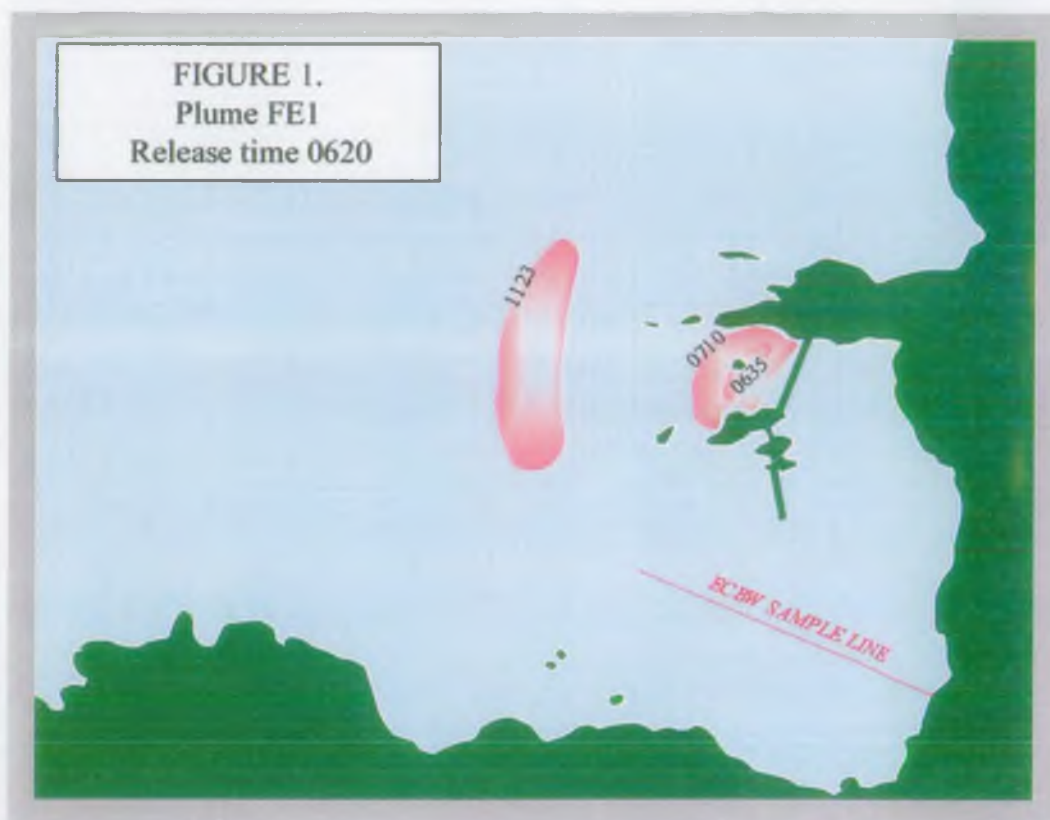
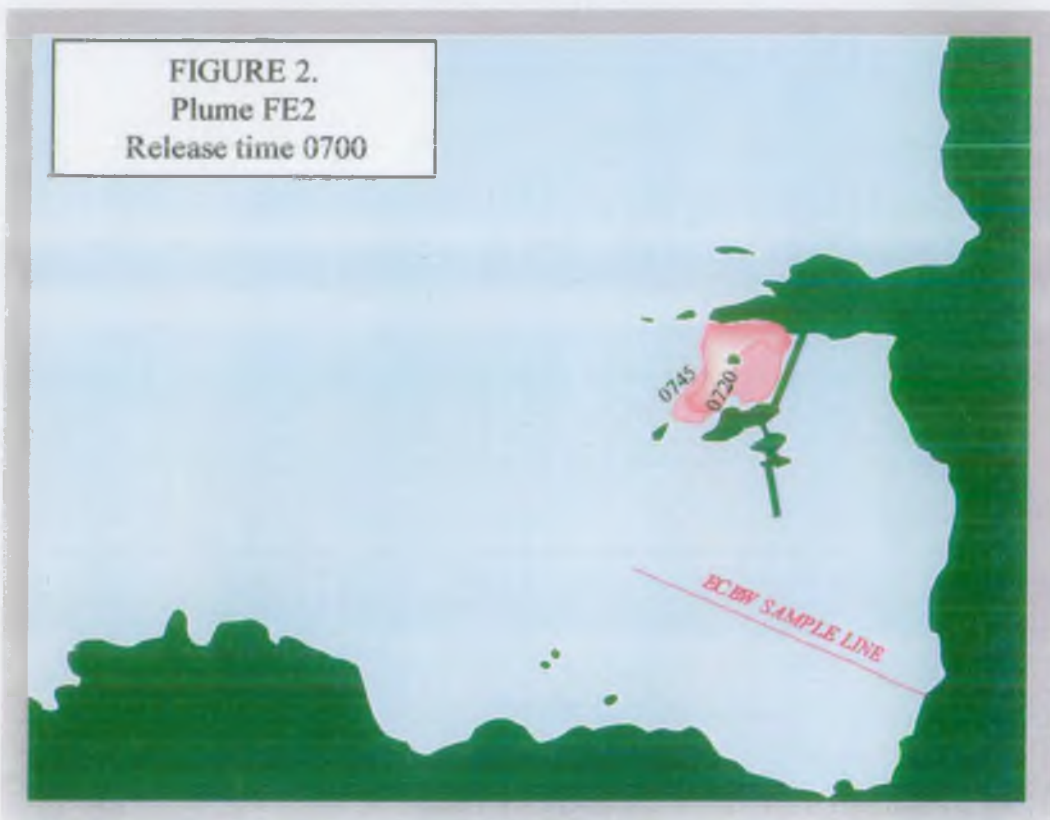
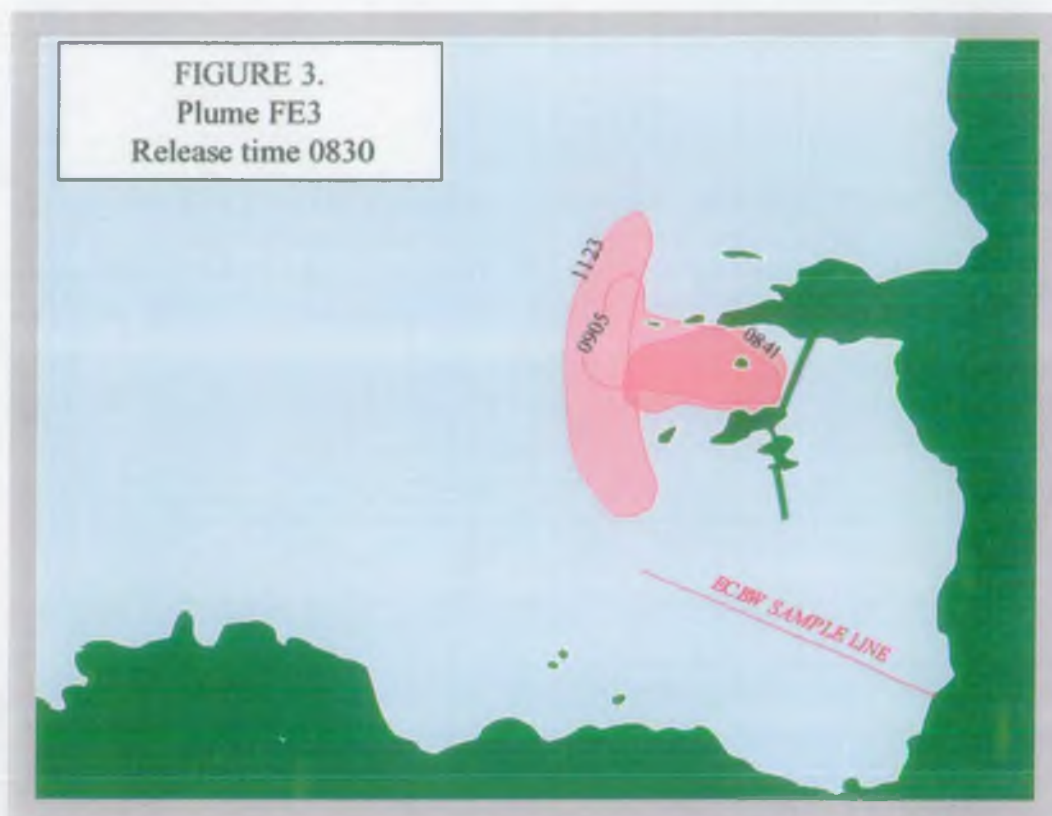
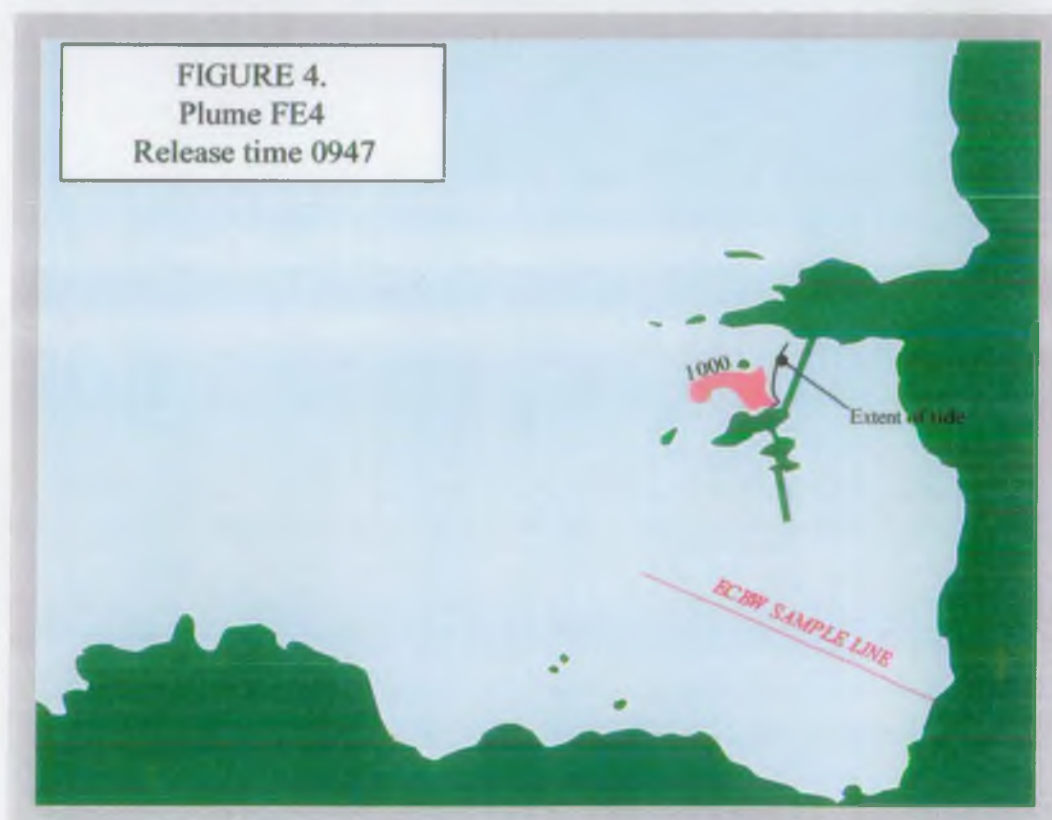
**GALMPTON WWTW DYE STUDIES FINAL EFFLUENT 9/9/99
SPRING TIDES**

**GALMPTON WWTW FINAL EFFLUENT DYE STUDIES 9/9/99
SPRING TIDES**

On 09/09/99 a dye survey was undertaken to establish the behaviour of the effluent plume from Galmpton WWTW. The survey was carried out over a full spring tide cycle and under conditions believed to provide maximum impact at the ECBW site (north or north-west winds). Predicted high water at Salcombe was 0634 BST.

Neither of these surveys indicated that effluent was carried around the breakwater to the beach when wind conditions were expected to produce maximum impact. The wind direction on 08/06/98, 08/09/98 and 14/08/99 when poor samples were obtained was, respectively, south-west, south-west and west. In order to emulate these conditions a further dye survey was undertaken in south-west winds on 14/06/00. Predicted high water at Salcombe was 0457 BST. South-west winds tend to swing in around Bolt Tail to produce an on-shore wind at Inner Hope and it was felt that this might more effectively transport effluent to the ECBW site. Such behaviour was not observed, however, and the plume tended to travel more towards the beach at Mouthwell Sands (**Photograph 1**). Five dye drops were made between 0745 and 1832 BST. Dye transport was apparent following the first two dye drops and the results are shown in **Figures 14-15**. Dye patches from subsequent drops remained in the vicinity of the outfall. During this survey waves were again seen breaching the breakwater (**Photograph 2**).

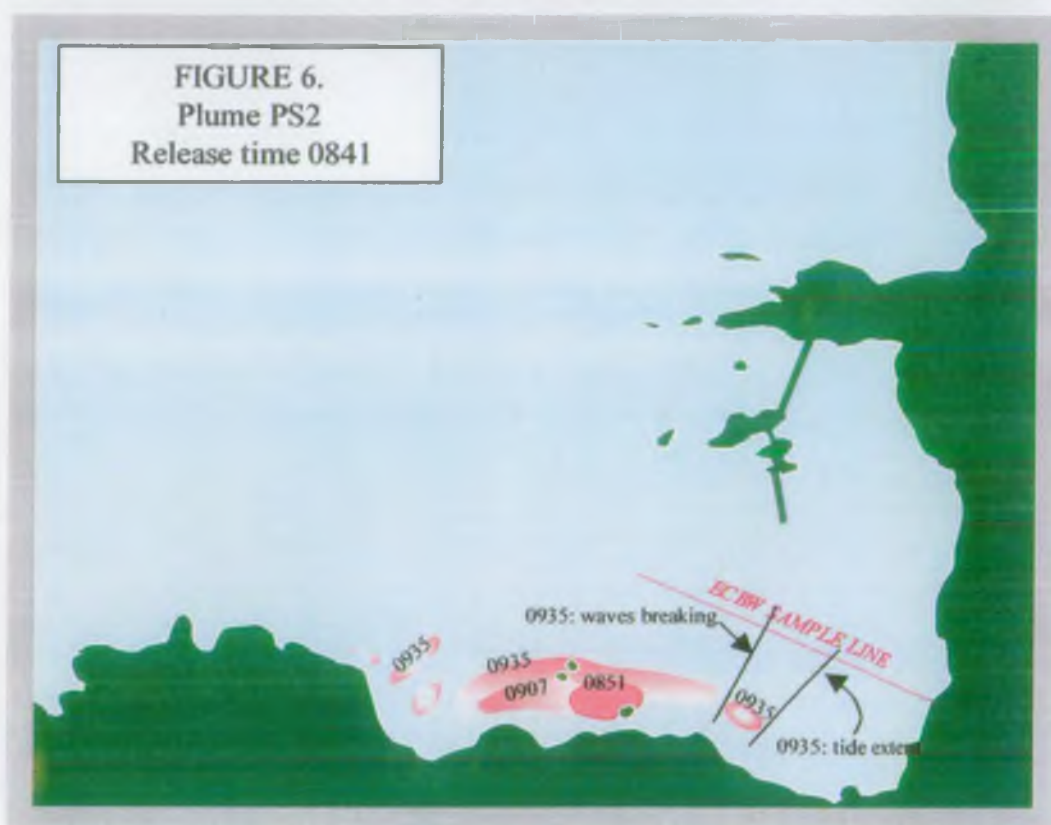
**INNER HOPE PUMPING STATION OVERFLOW
DYE STUDIES 9/9/99 SPRING TIDES**

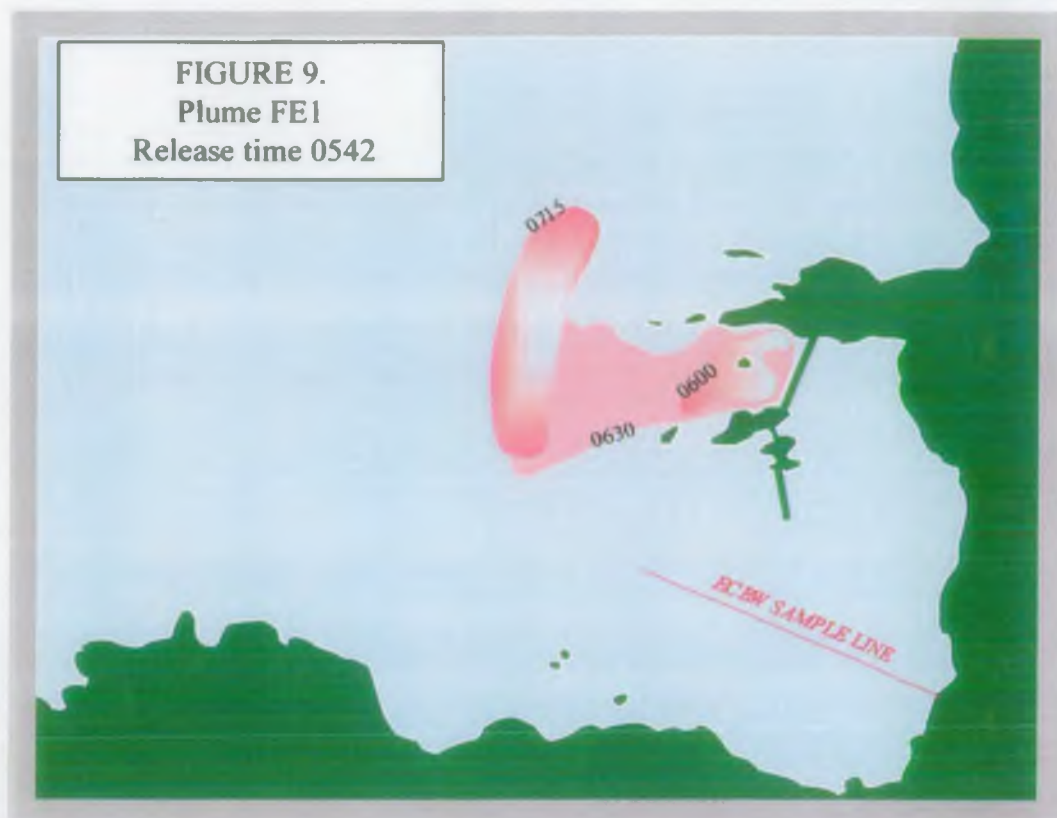
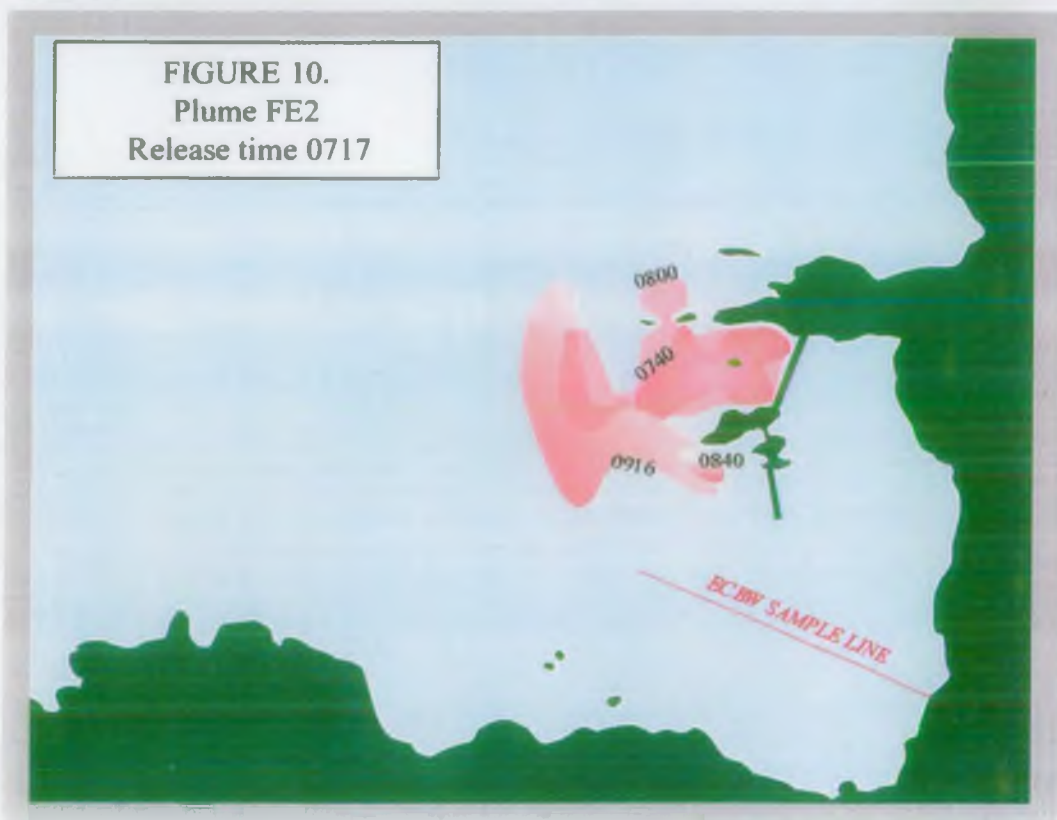
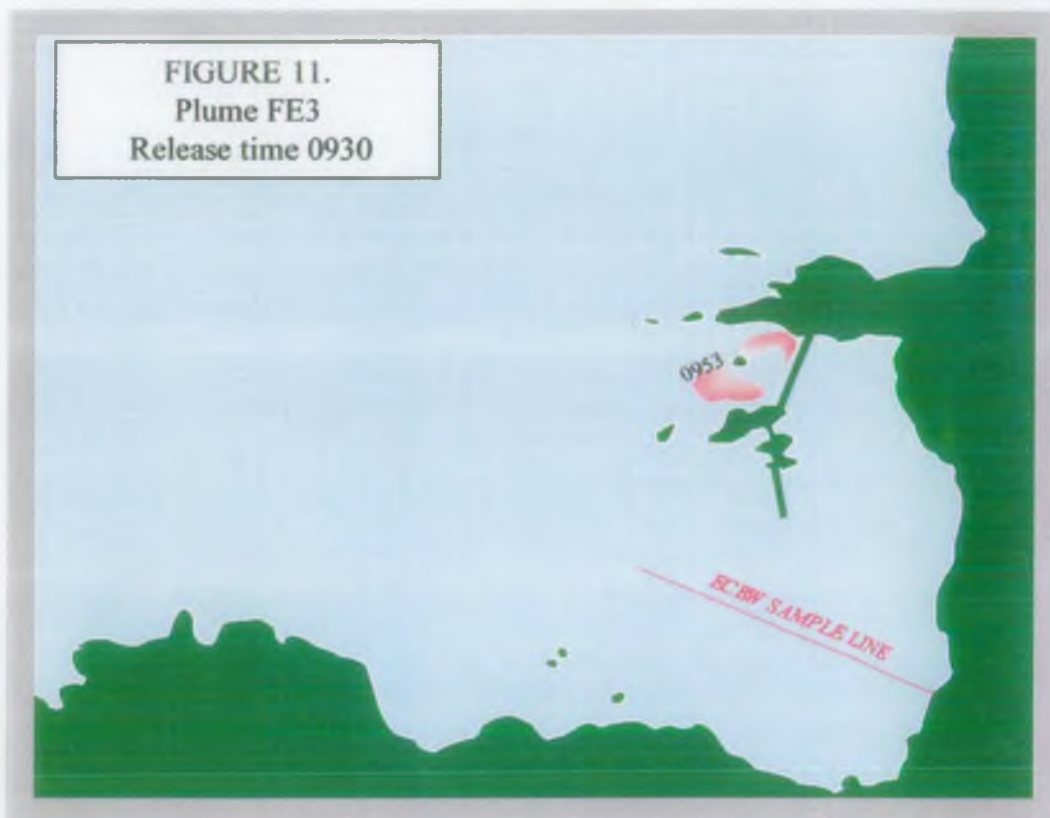
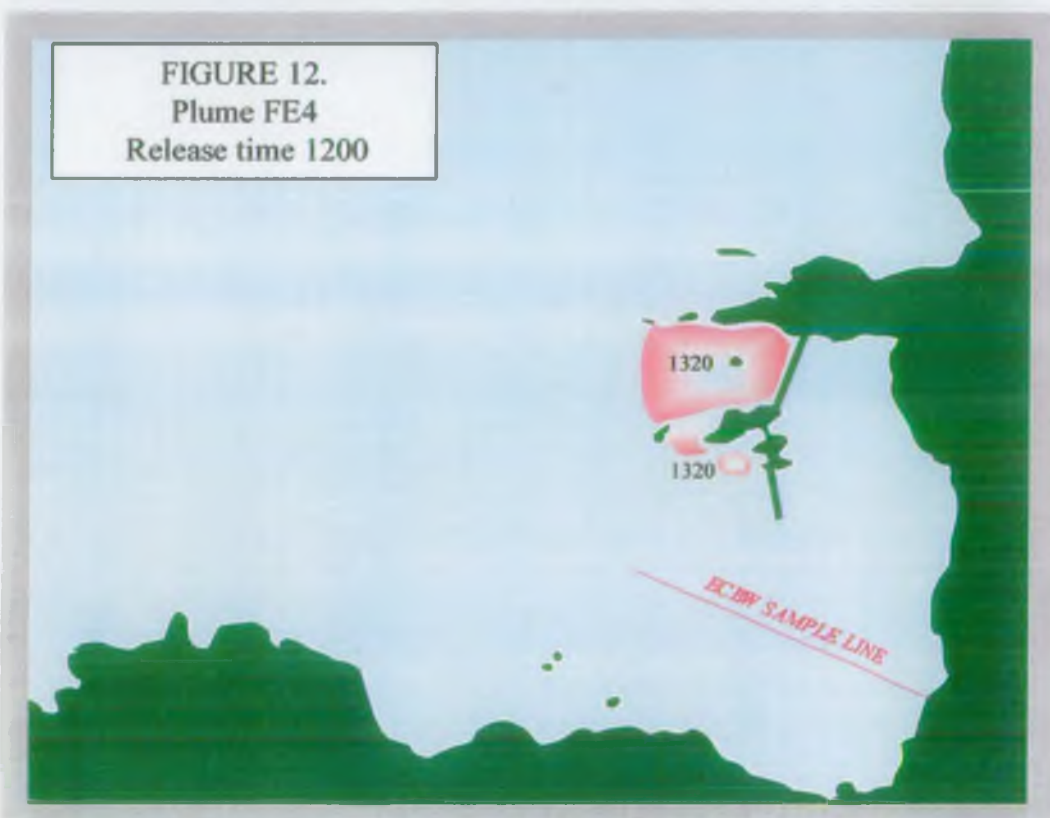
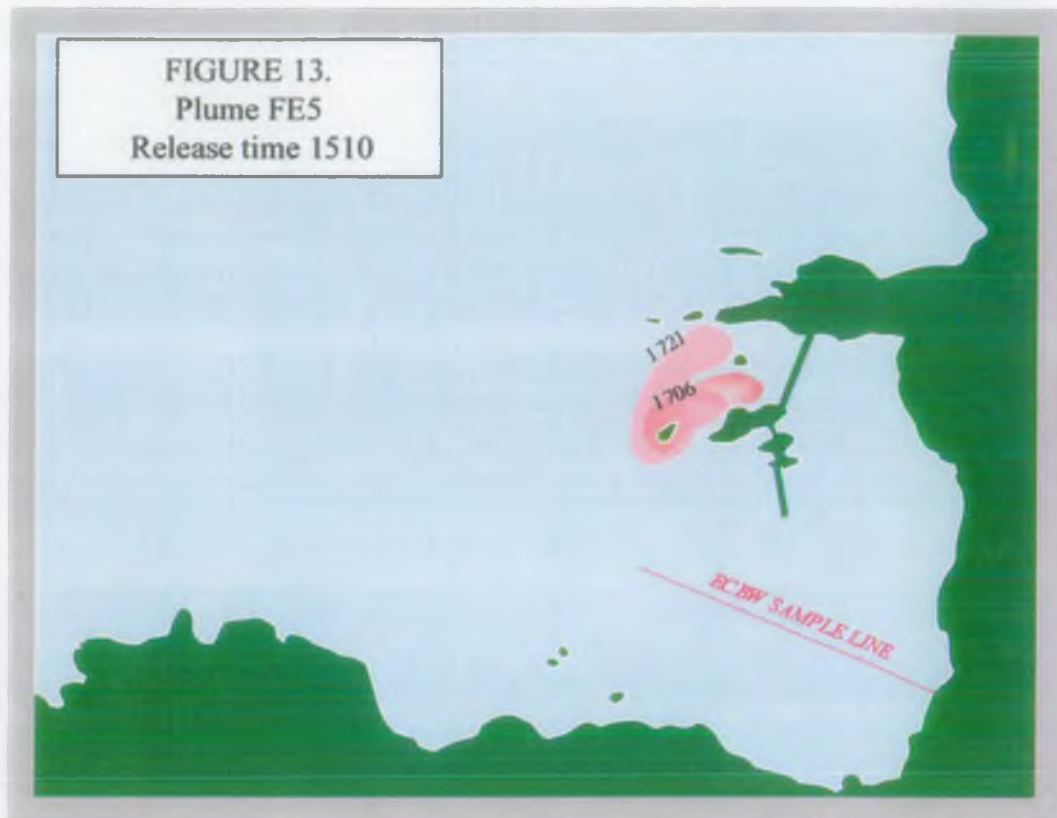
**GALMPTON WWTW FINAL EFFLUENT DYE STUDIES 20/9/99
NEAP TIDES**

**GALMPTON STW FINAL EFFLUENT DYE STUDIES 20/9/99
NEAP TIDES**

At high water on 20/09/99 waves were observed breaching the breakwater. A sample was taken from inside the breakwater at NGR 6746 4003 to assess the potential effect of this process on water quality at the ECBW site. Results are shown in **Table 8**. Both total and faecal coliform concentrations exceeded the Imperative standard. Breaching of the breakwater may well be contributing to reduced water quality in those samples from the ECBW site that were collected at or just prior to high water, or during the period following high tide when water is ebbing from this part of the beach (see also Section 3.4.3).

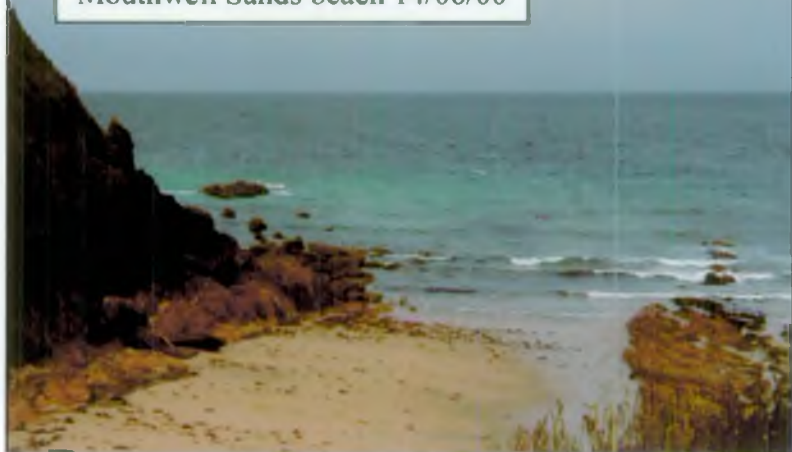
Photograph 1.

Potential impact of Galmpton
WWTW effluent dye plume at
Mouthwell Sands beach 14/06/00

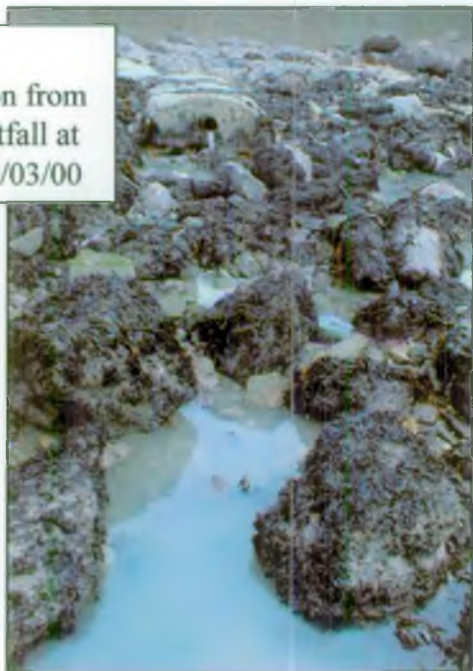
Photograph 3.

Poor effluent dispersion from
Galmpton WWTW outfall at
Low Water Springs 09/03/00

The outfall is sited above low water springs so that at low water on a spring tide there is little effluent dispersion. An examination of the outfall was made on 09/03/00 under these conditions when pools of contaminated water were observed (**Photograph 3**).

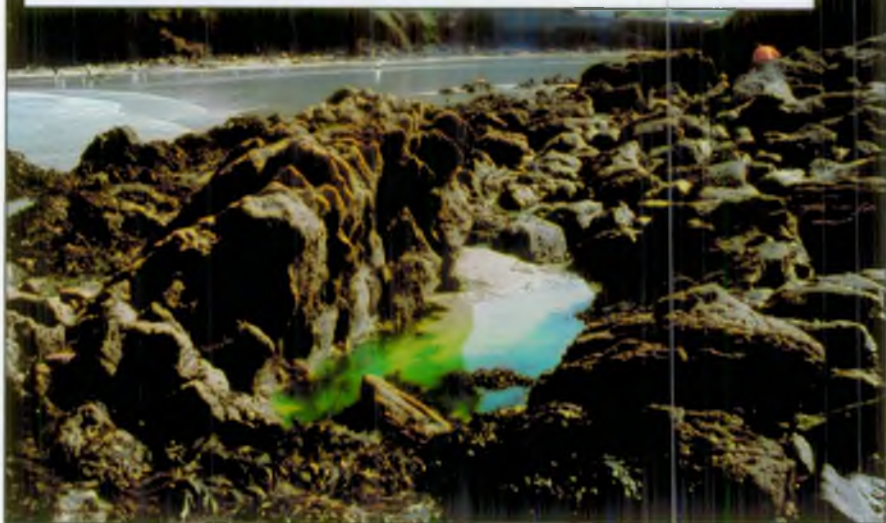
Photograph 5.

Residual dye in rock pools close to Inner Hope emergency outfall discharge point 09/09/09. ECBW in background.

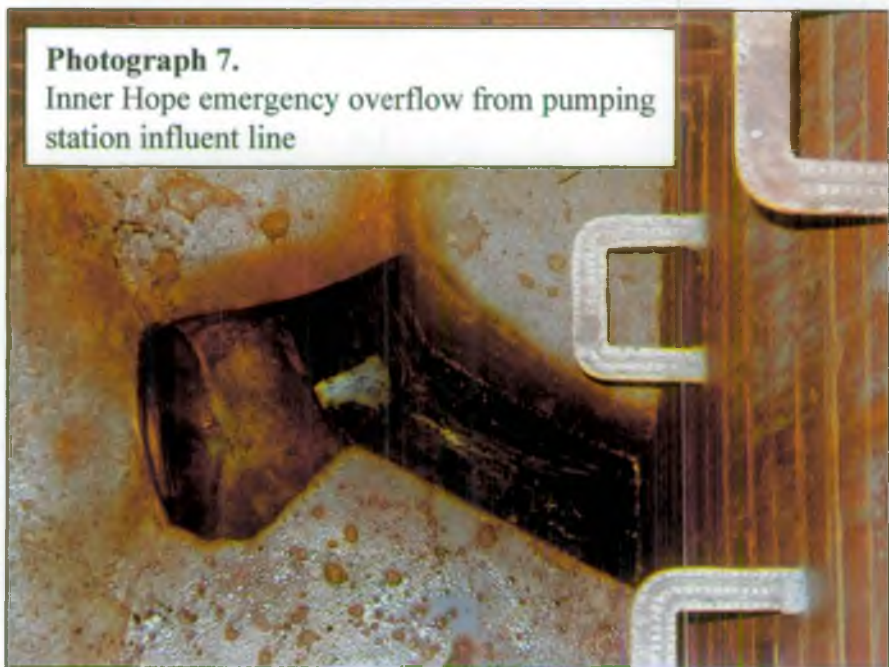
Photograph 7.

Inner Hope emergency overflow from pumping station influent line

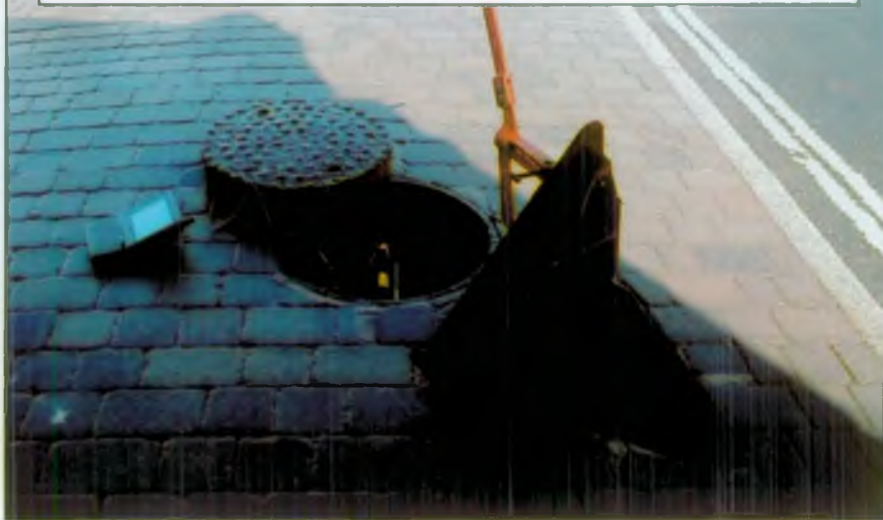
Photograph 6.

Inner Hope emergency overflow: triangular cover to influent line, circular cover to discharge chamber.

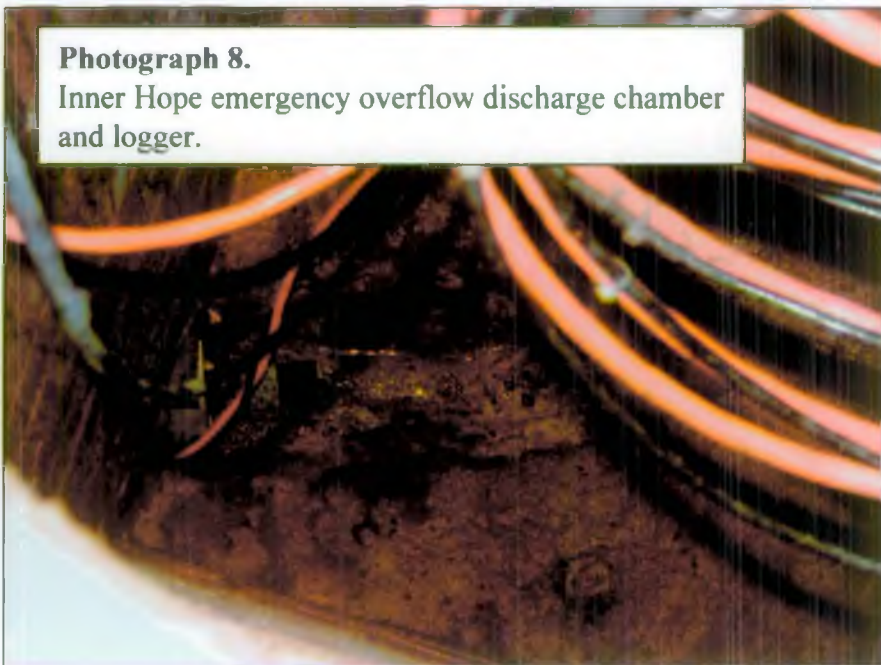
Photograph 8.

Inner Hope emergency overflow discharge chamber and logger.

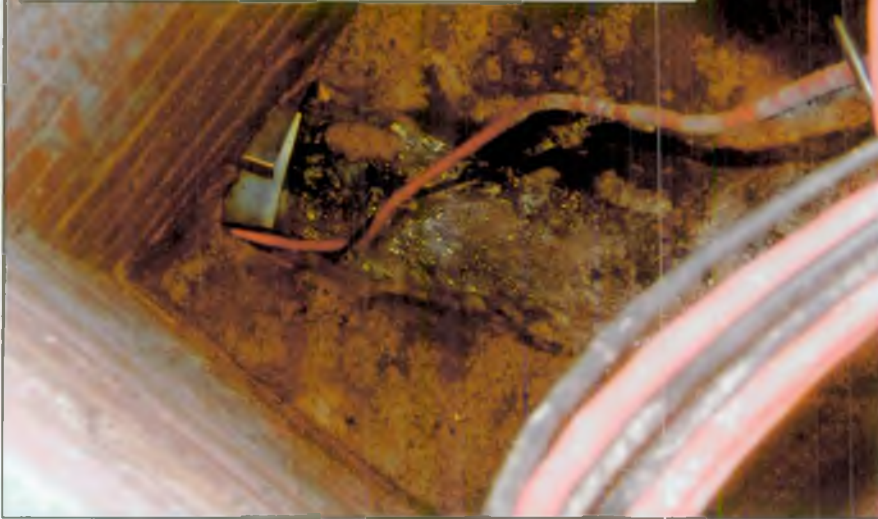
Photograph 9.

Discharge from Inner Hope emergency overflow:
crude debris visible

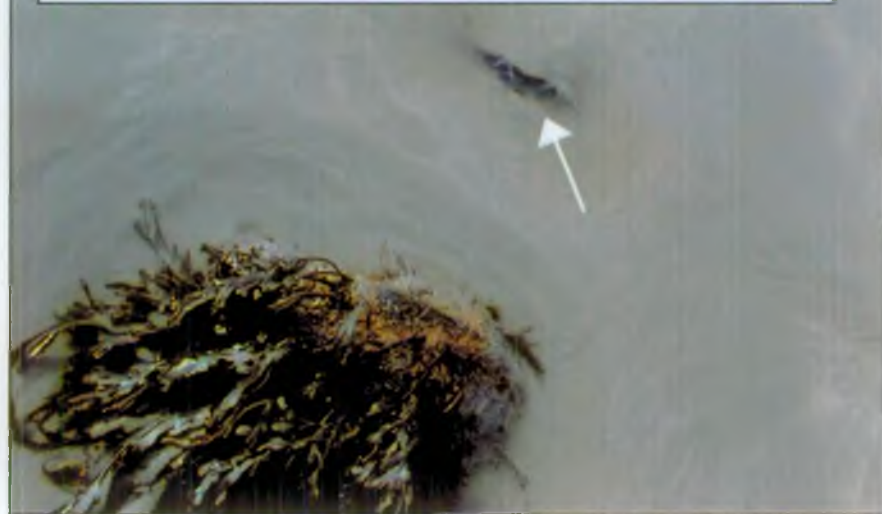
Photograph 10.

Examination of the outfall pipe at low water on 09/03/00 revealed a fracture some 20m short of the designed discharge position. The emergency overflow was operating on this date and crude sewage was observed issuing from the fracture (**Photographs 10 and 11**). Faecal debris was noted in nearby rock pools.

A fracture in the Inner Hope emergency outfall pipe is compromising effective dispersal of discharges.

Inner Hope emergency overflow: discharge of untreated
sewage from fracture in discharge pipe (arrowed) 09/03/00

The fracture in the Inner Hope emergency outfall pipe is repaired.

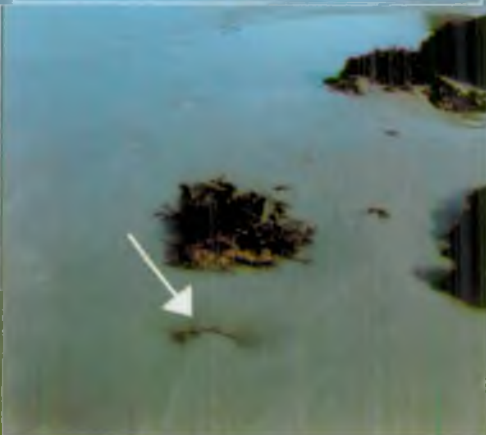
Photograph 11.

Inner Hope emergency overflow:
discharge of untreated sewage
from fracture in discharge pipe
(arrowed) 09/03/00

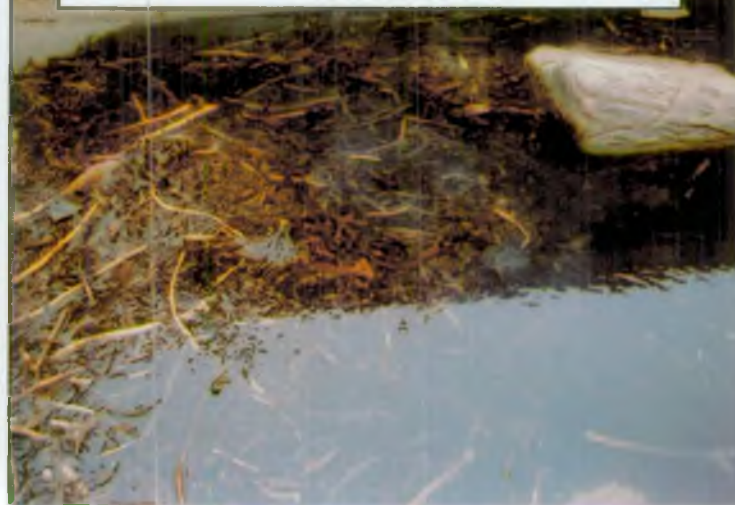
Photograph 12.

Deposits of decaying algae on landward side
of breakwater

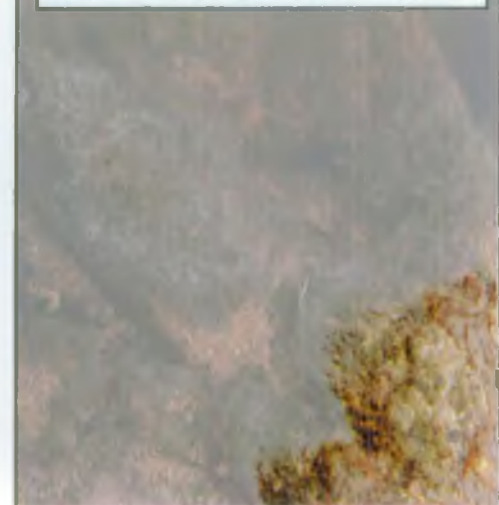
Photograph 13.

Grey coloured growths have been observed on the substrate of residual pools inside the breakwater (**Photograph 13**). Photographs of these growths were inspected by Agency biologists who concluded that they depicted sewage fungus. The growths were absent on some occasions and so it seems less likely that they are associated with the decomposition of seaweed – which is invariably present – than contamination from effluent carried over the breakwater or poor water quality in Stream A.

Sewage fungus in rock pools on
landward side of breakwater
