National Rivers Authority

IMPACT ASSESSMENT OF MELDON QUARRY ON WATER QUALITY IN THE WEST OKEMENT RIVER

FWI/91/002

Author: Dr R.P. Smlth

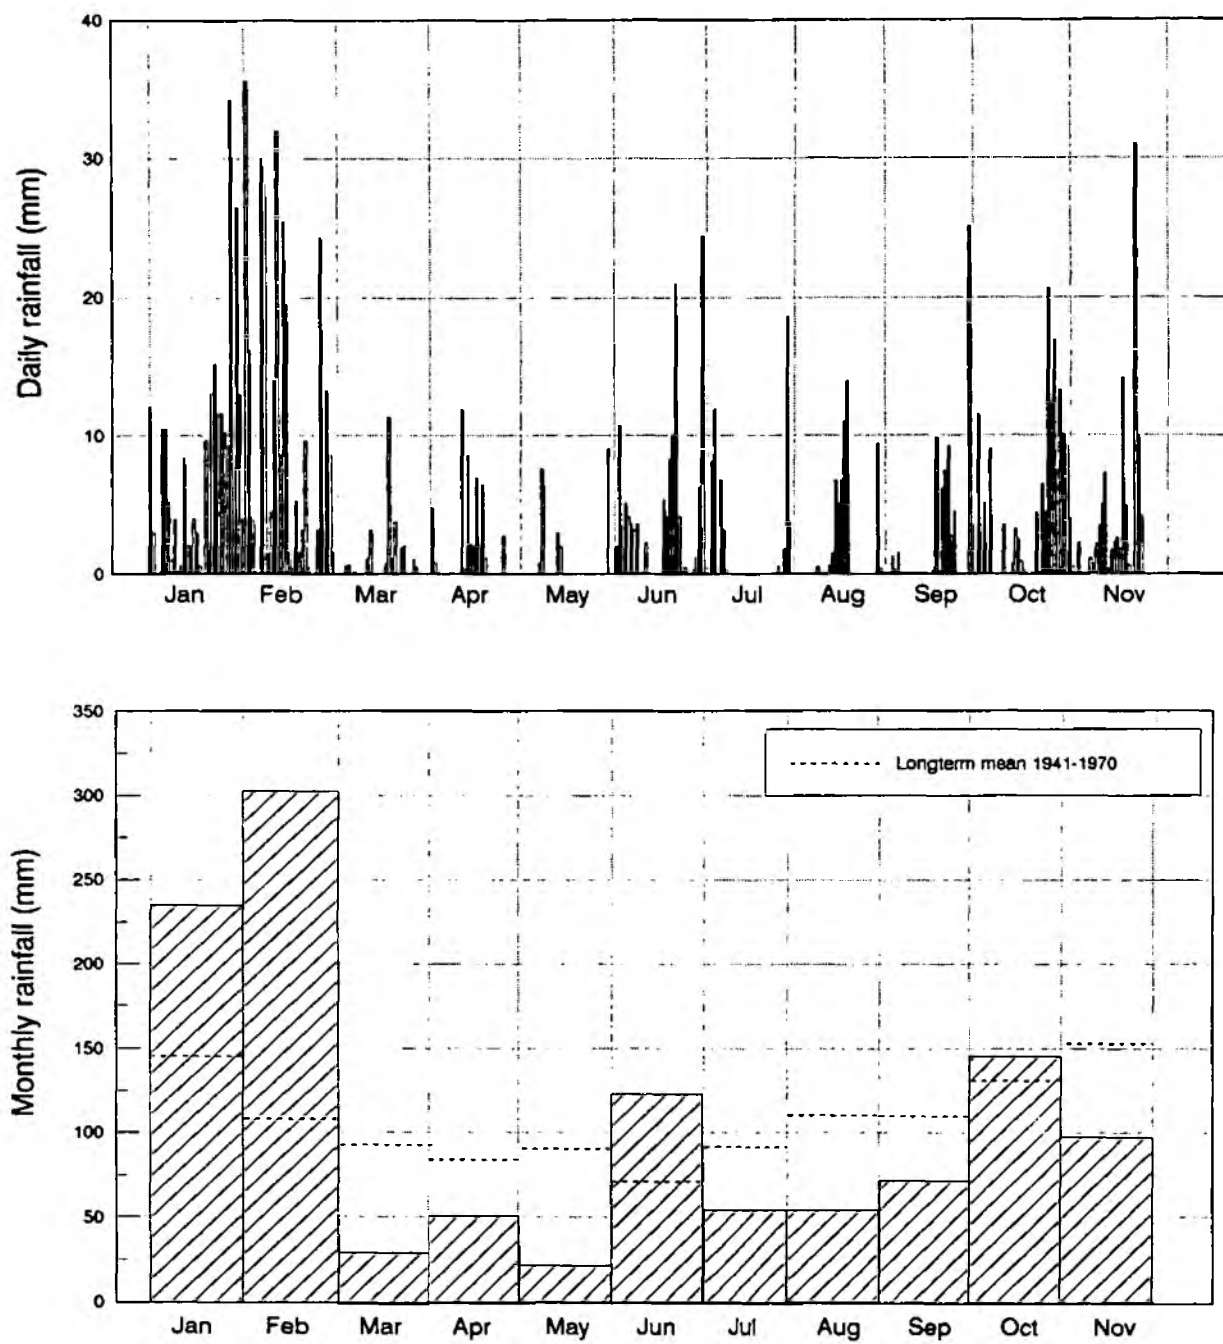
Fig. 2. Daily & monthly rainfall at Okehampton Pleasure Gardens during 1990

Rainfall recorded at Okehampton Pleasure Gardens during the first survey ranged from 8.1mm on 3 July 1990 to 11.9mm on 4 July 1990 (see Fig. 2). Although this rainfall event was not particularly notable during the summer of 1990, it produced a surge of drainage water from Meldon Quarry.

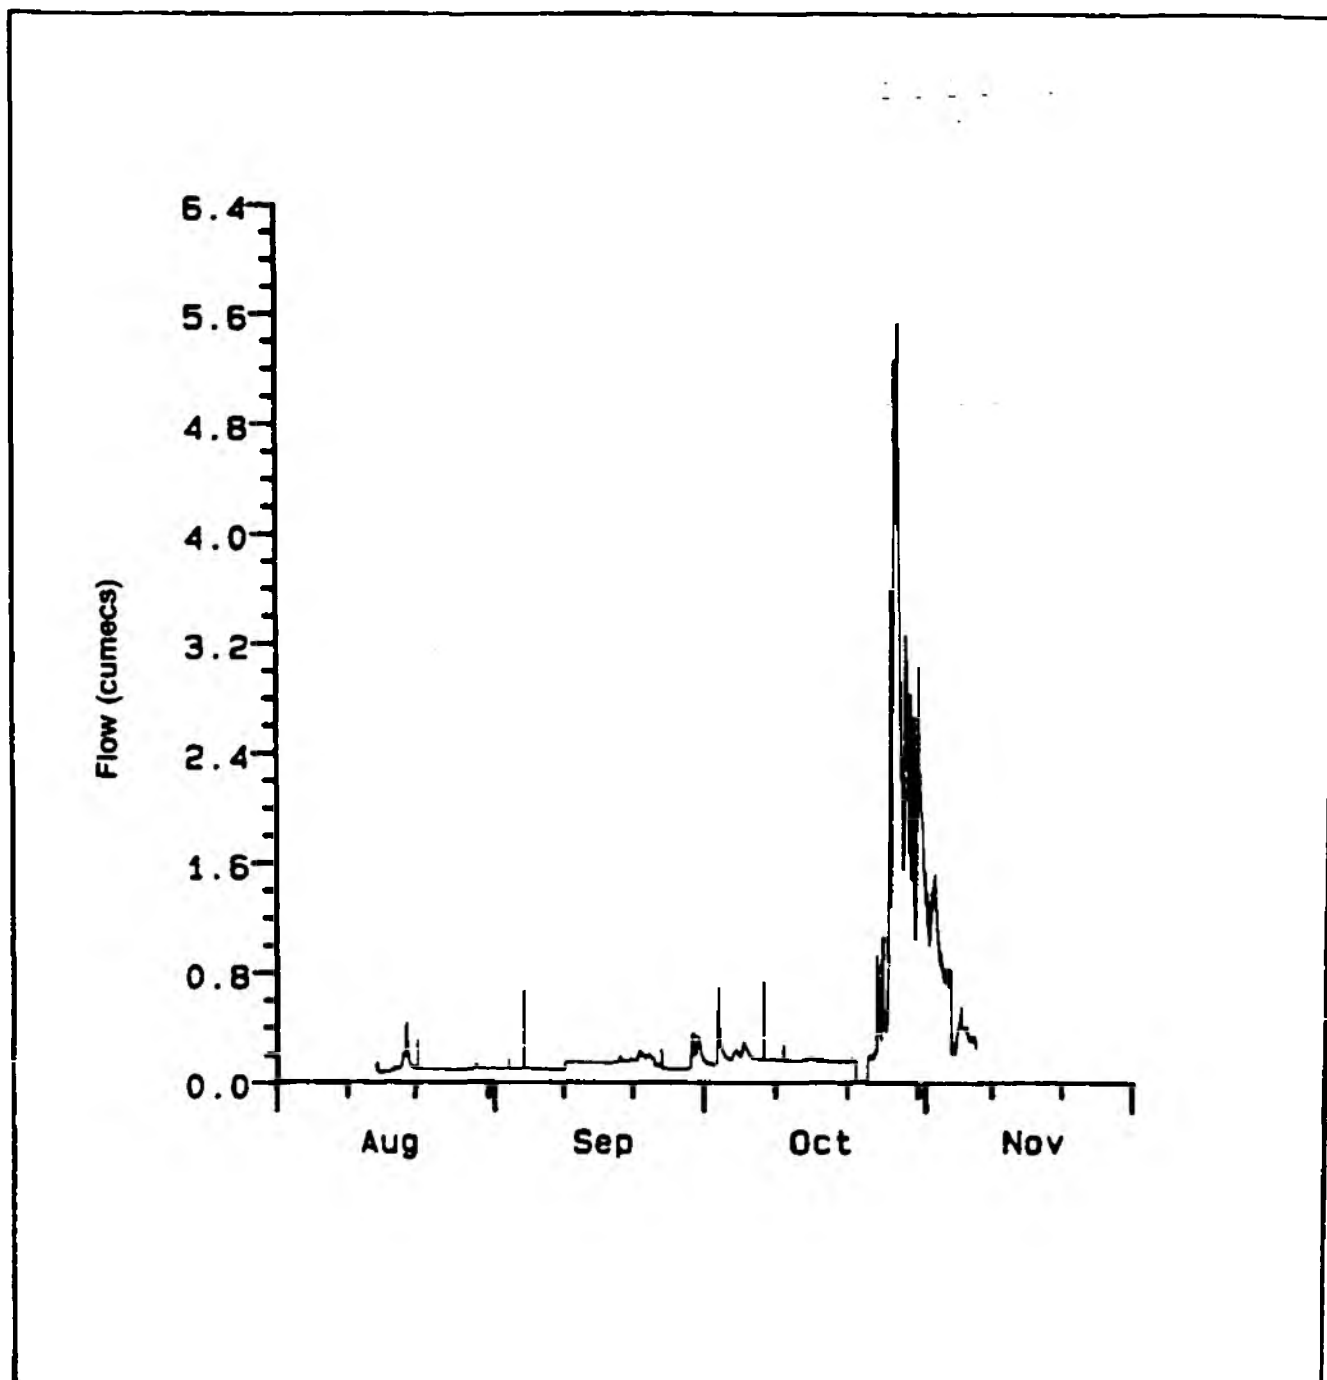
Fig. 3. Flow In the West Okement River upstream of Meldon Quarry
During August to November 1990.

During the end of October 1990 rainfall was more continuous reaching a maximum of 20.5mm on 25 October 1990. Flow in the West Okement River on 28 October peaked at 5.6 cumecs (see Fig. 3).

Flow from Meldon Reservoir largely controls the amount of dilution available. Flow in the West Okement River during the survey on 28-29 October 1990 was much greater than the July survey mainly because the flow from Meldon Reservoir after the drought was not restricted to the compensation flow (see Fig. 3).

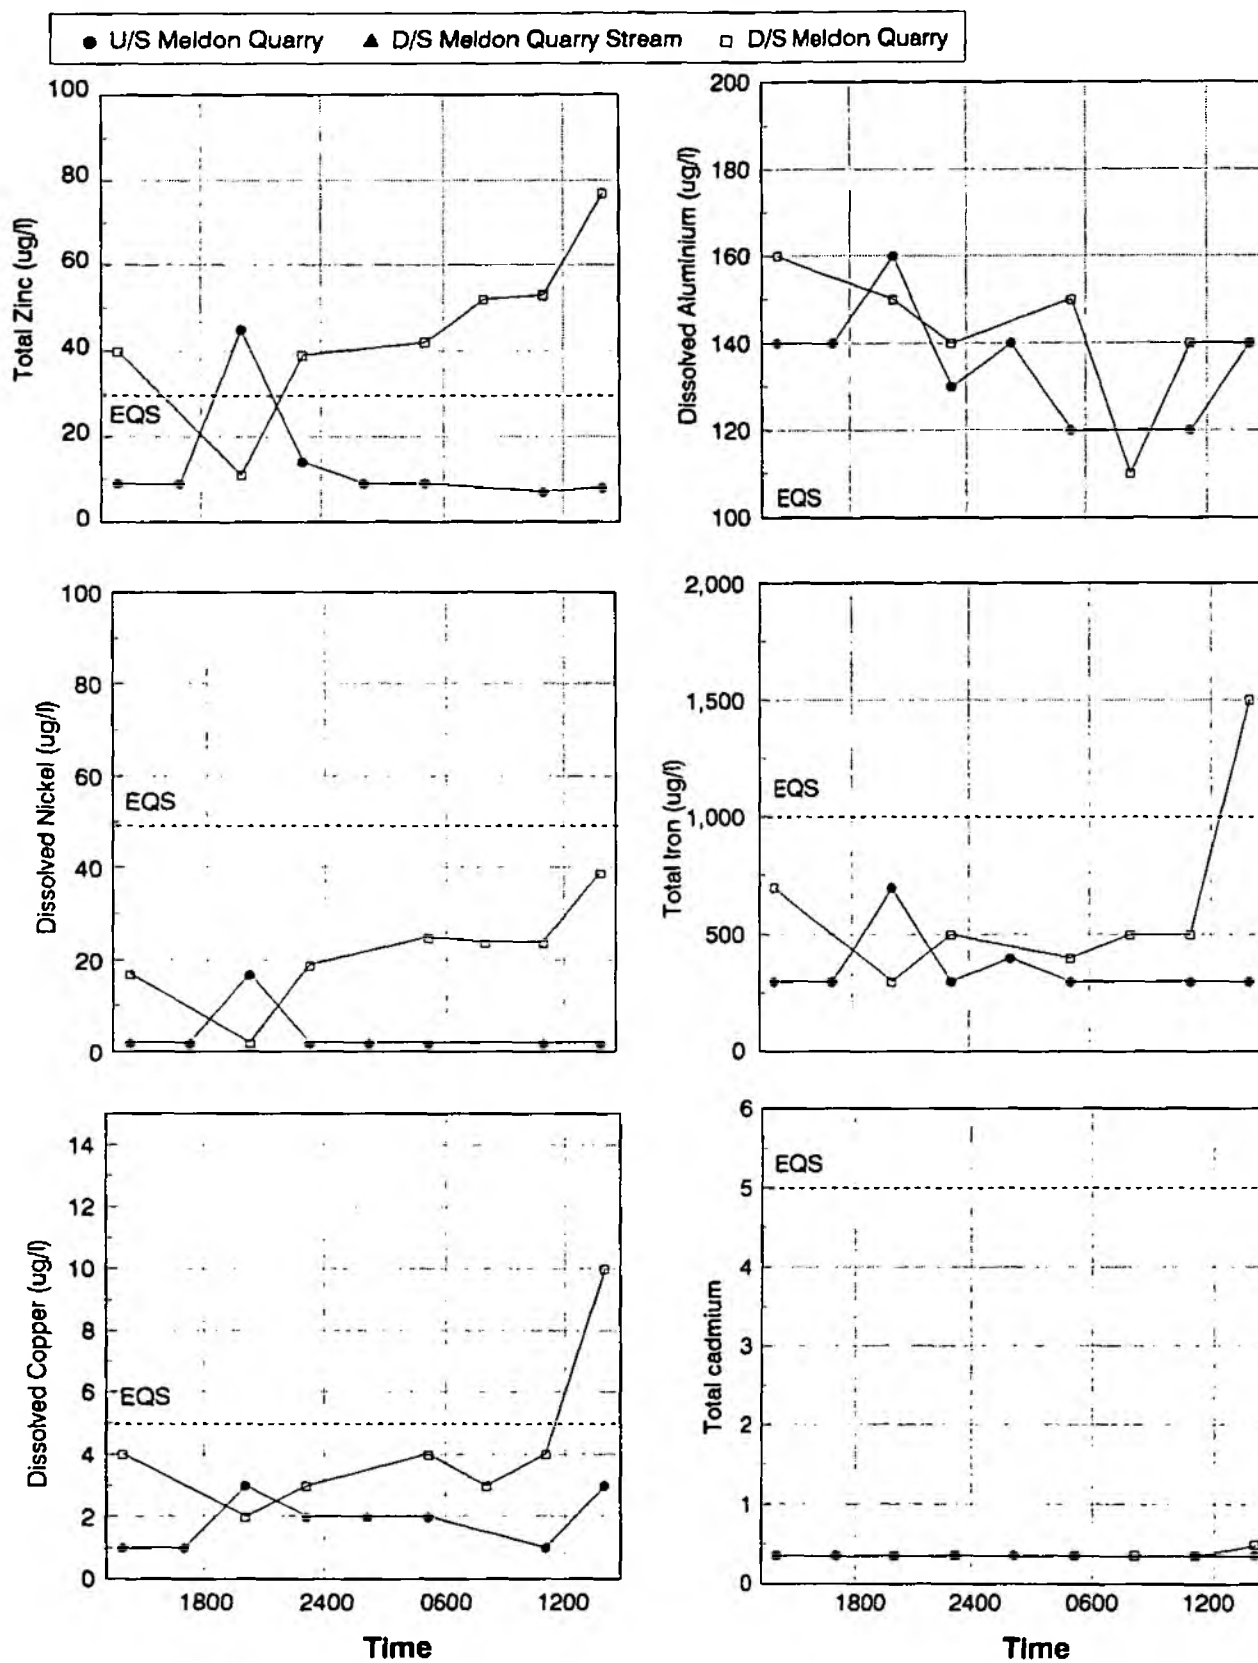
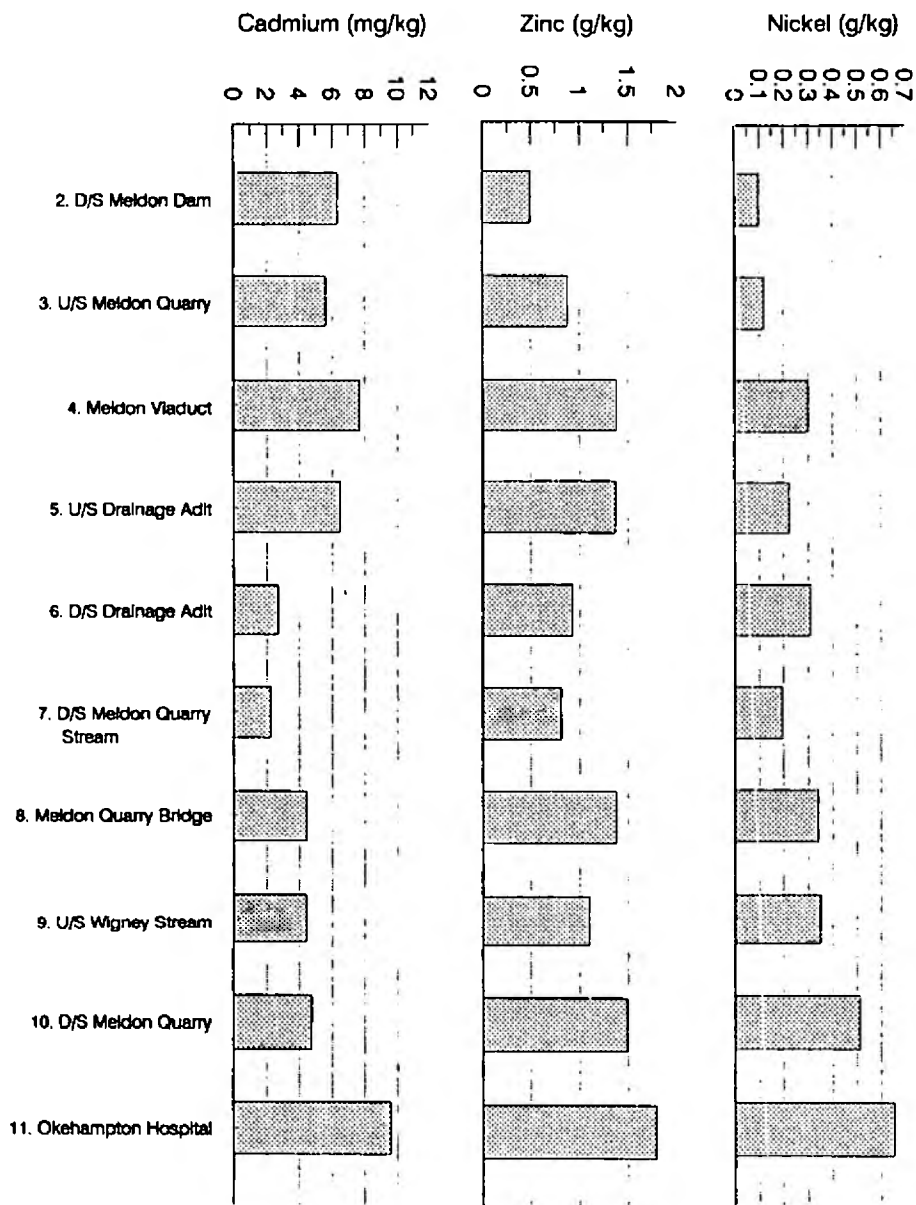
Fig. 8. Water quality in the West Okement River on 28-29 October 1990

Metal concentrations in the West Okement River were much lower downstream of discharges from Meldon Quarry during the survey on 28-29 October 1990 compared to the survey on 4-5 July 1990 (see Fig. 8 compared to Fig. 5).
