**AN INVESTIGATION INTO THE
WATER QUALITY OF THE RIVER
WALDON DURING WET WEATHER**

**JUNE 1996
DEV/E/17/96**

AN INVESTIGATION INTO THE WATER QUALITY OF THE RIVER WALDON DURING WET WEATHER 25 MARCH 1996.

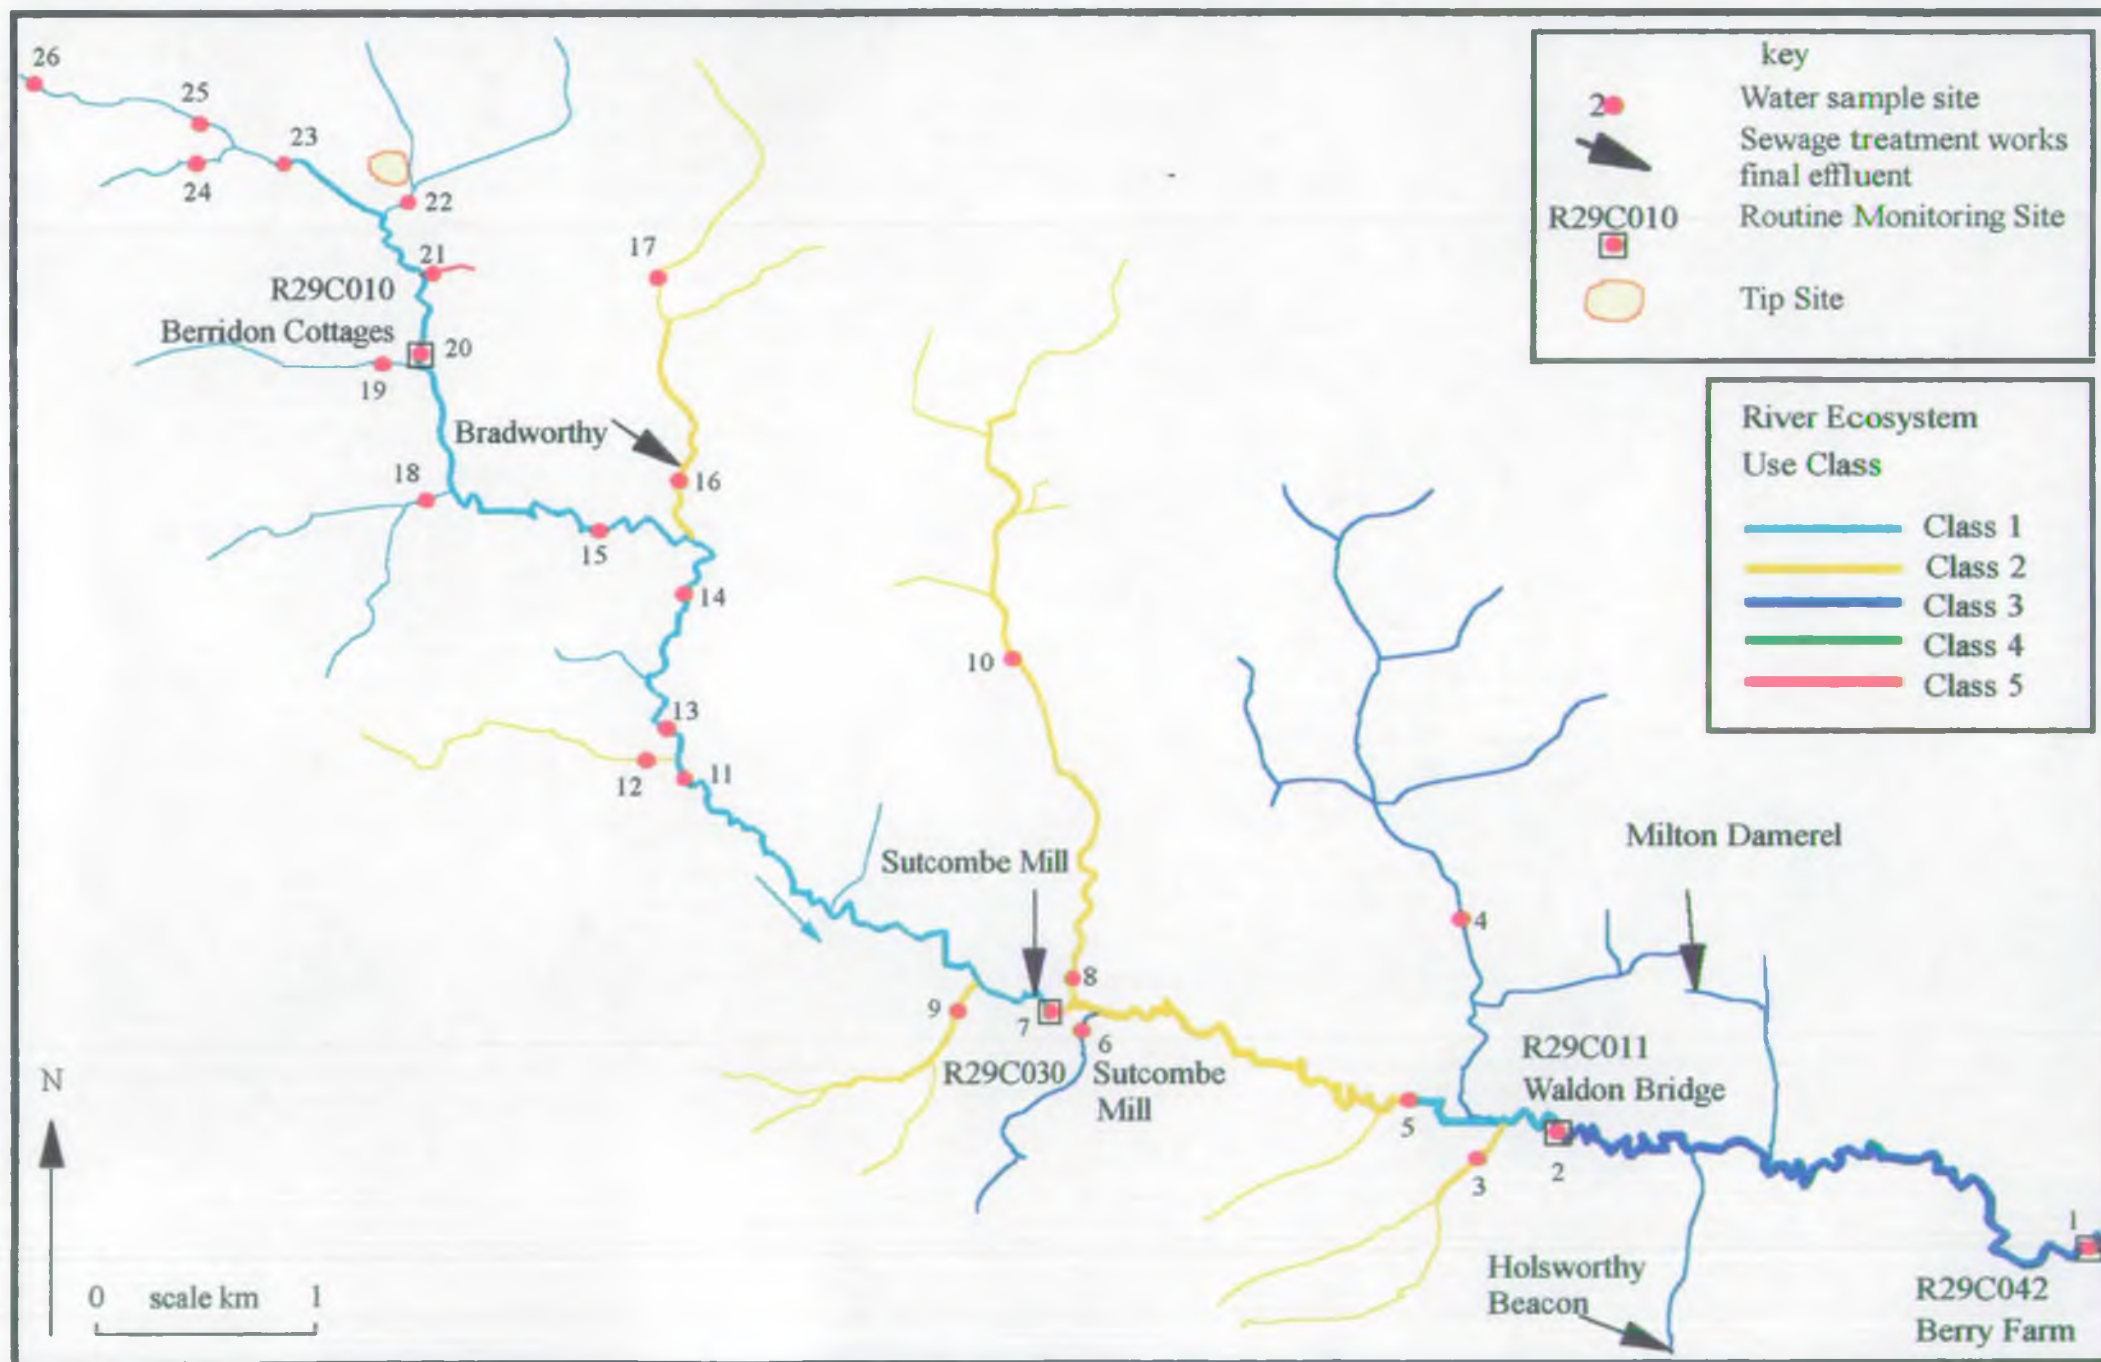
Figure 1. Map showing the River Waldon wet weather sample sites used 25 March 1996.

An un-licensed tip area was located abounding a tributary north west of Bradworthy (see Figure 1). Although no chemical impact was detected during the survey (see Table 1, site 22) it is feasible that waste matter / leachate could in time enter the watercourse in the future. Because of the nature of the site (owners own 'agricultural waste', see proforma), action by the Waste Regulation section was not found to be possible at this stage due to current legislation. However, action to remedy the situation under Water Resources law may be possible and is to be progressed by Water Quality.
