**ENVIRONMENT  
AGENCY**

**Investigation into the 1999 Failure  
of the European Community  
Bathing Waters Directive at  
Teignmouth Town Beach**

**January 2001  
DEV/EP/03/01  
(CATCHMENT 06A)**

**Author: S. HUNTER  
ENVIRONMENT PROTECTION  
INVESTIGATIONS OFFICER**

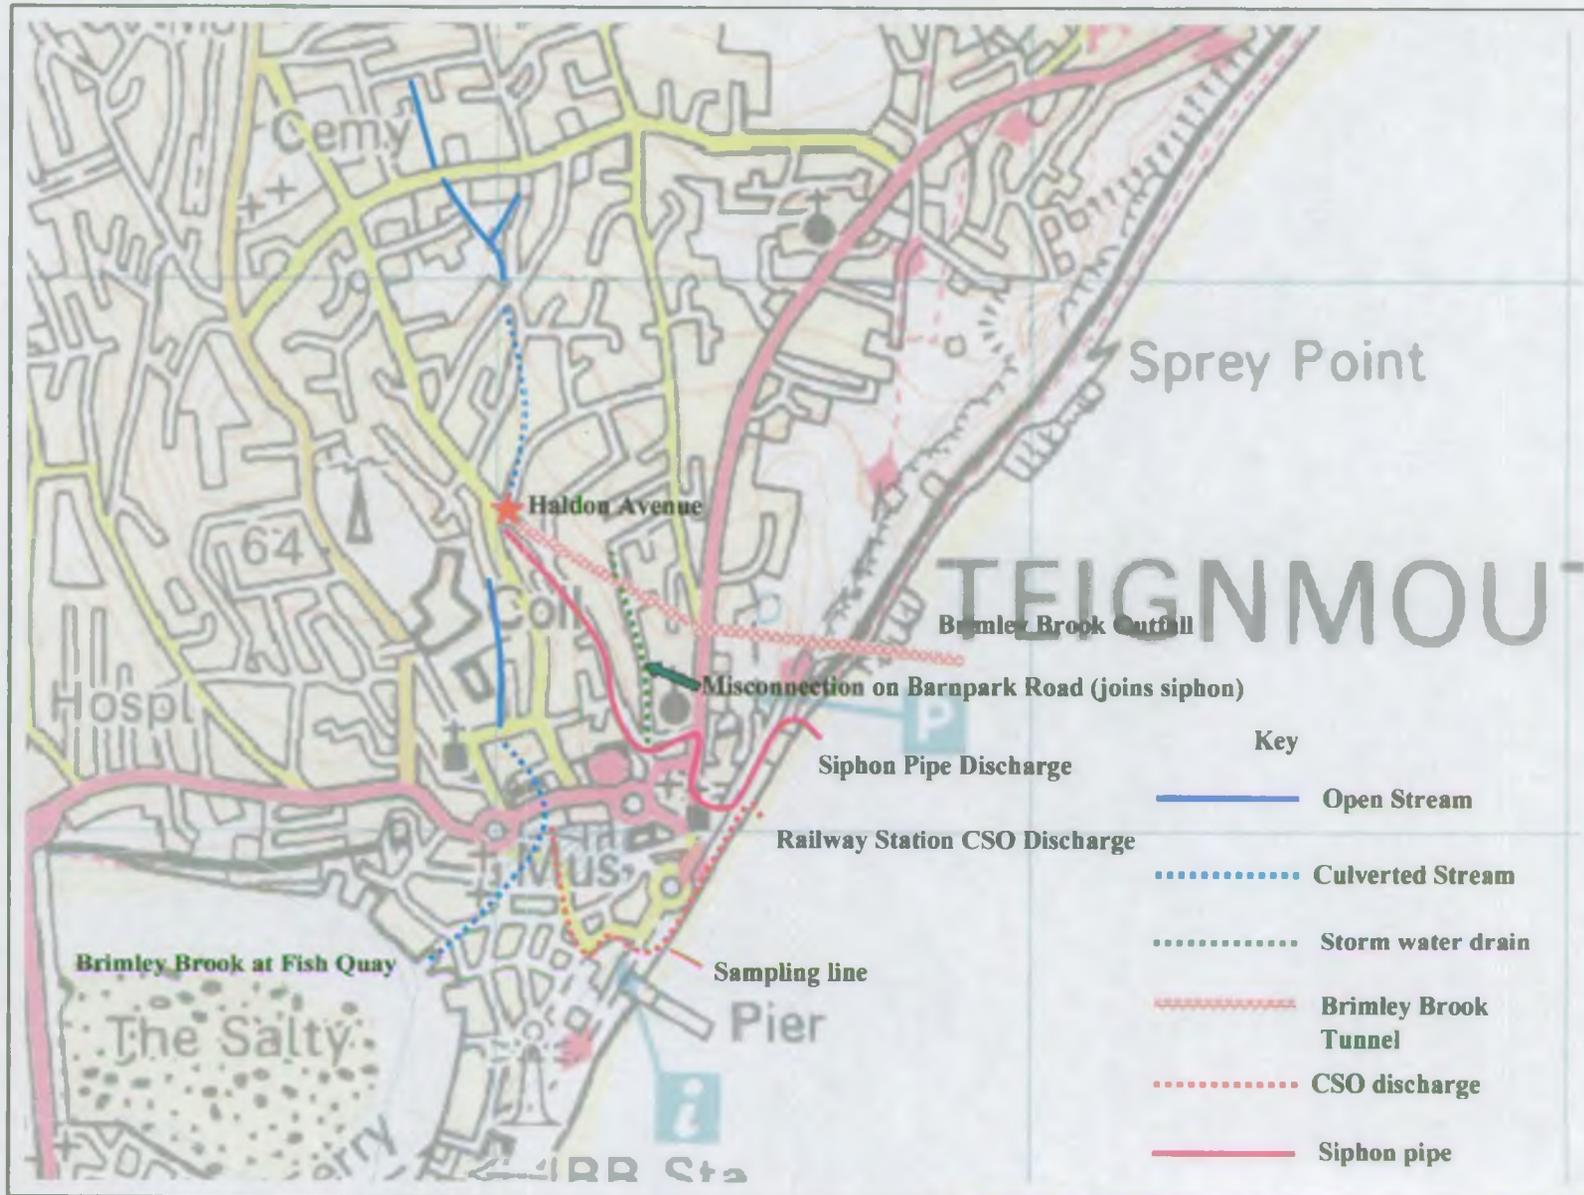
Figure 3

Two storm overflow discharge pipes are located approximately 325 metres east of the sampling point, see figure 2; plates 3 & 4 for photos showing location, the photographs were taken shortly after a storm event. These two discharges result from storm flows in the siphon pipe and a Combined Sewer Overflow (CSO) situated in the Railway Station carpark, see figure 3.

Map of Teignmouth

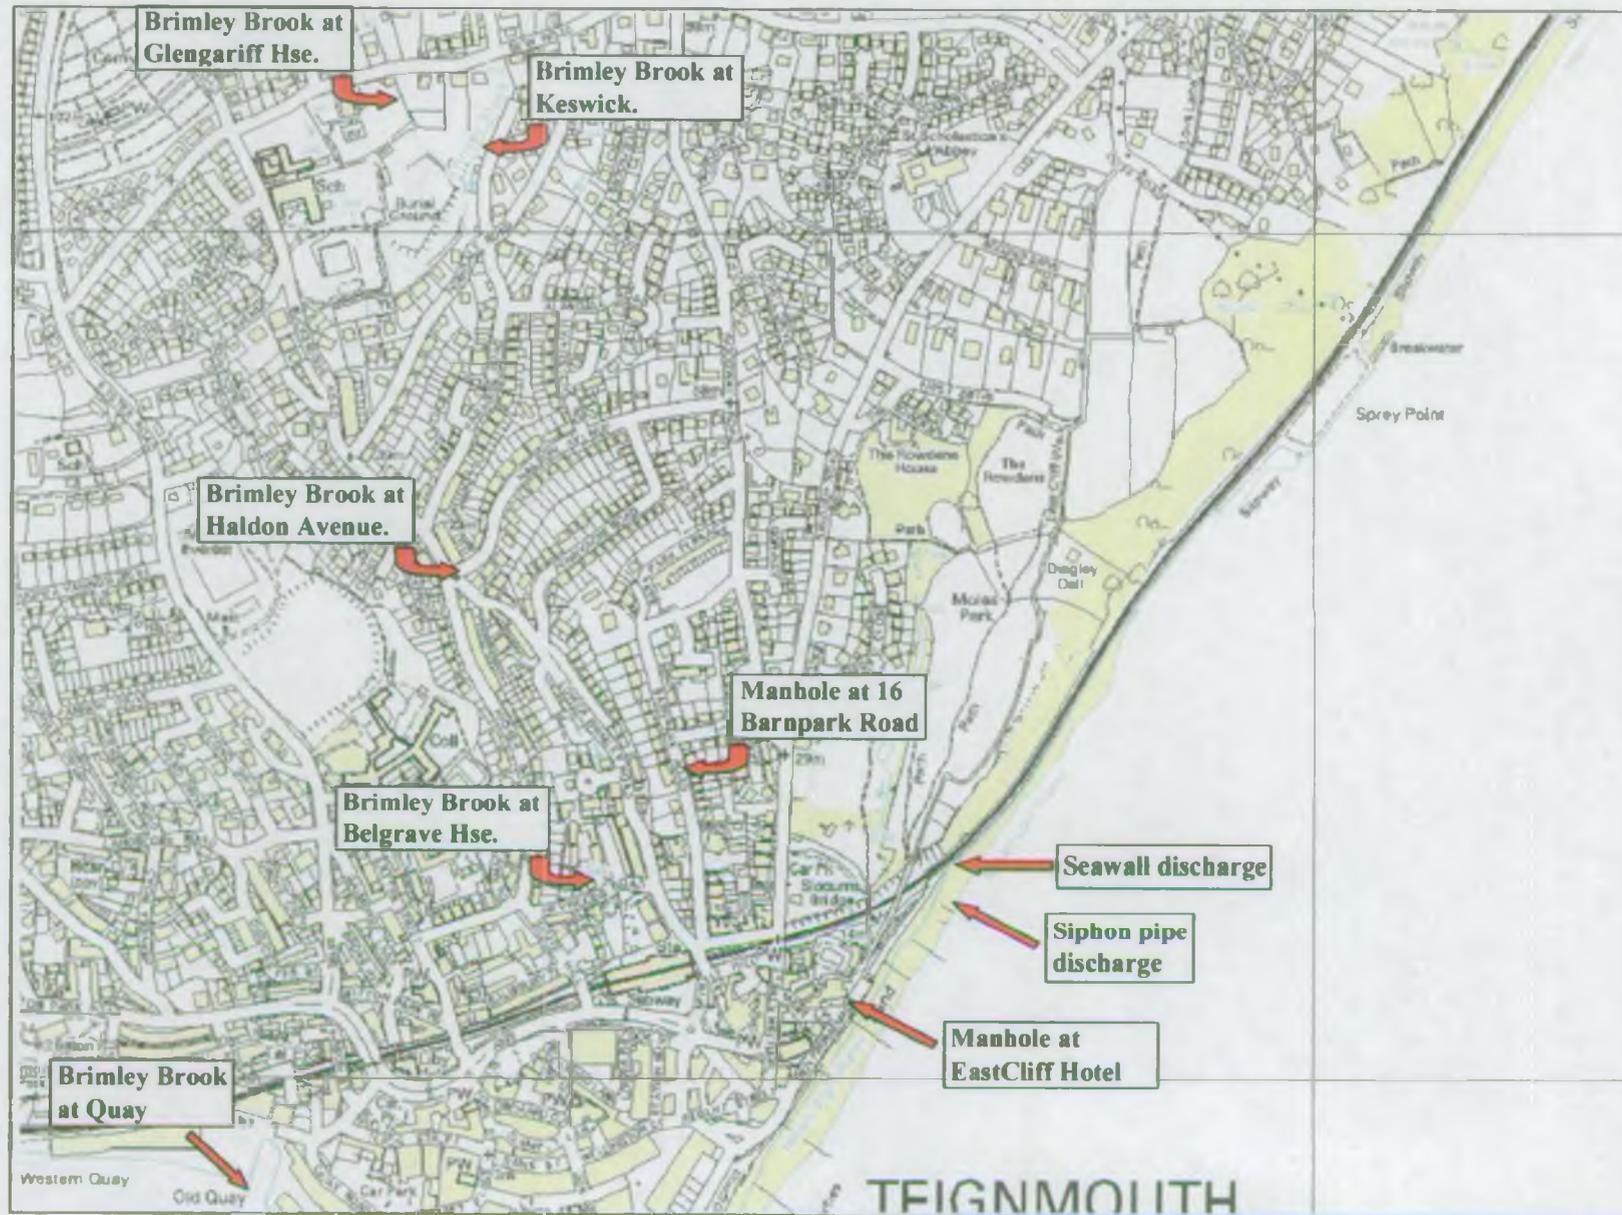
Figure 5

Map showing Sample Point Locations Teignmouth Bathing Beach Failure Investigation.
