**FINE SEDIMENT DEPOSITION
IN THE RIVER KEER**

GEOMORPHOLOGICAL ASSESSMENT

Report code T86/12/1

June 1997

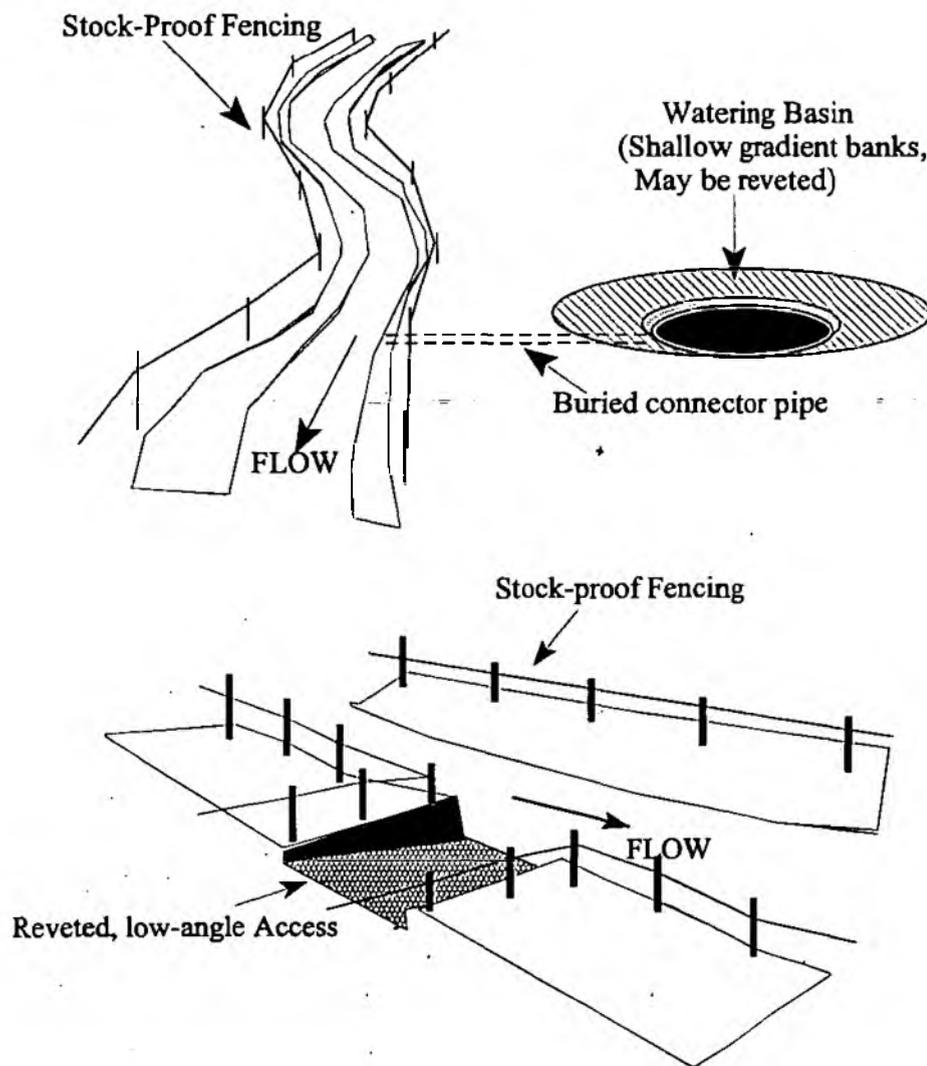
Figure 5: Example of an On-line Watering Structure.

N.B. A. Off-line watering structures are preferable to on-line watering structures, as they remove all stock pressure from the banks, whereas on-line structures merely concentrate it onto revetted sections, and stock may still gain limited access to the banks from the channel side of the fencing.
