**FINAL DRAFT REPORT**

**MILLENDREATH STREAM  
EC BATHING WATERS  
BACTERIAL CONTAMINATION  
INVESTIGATION 1995**

**March 1996**

**COR/96/001**

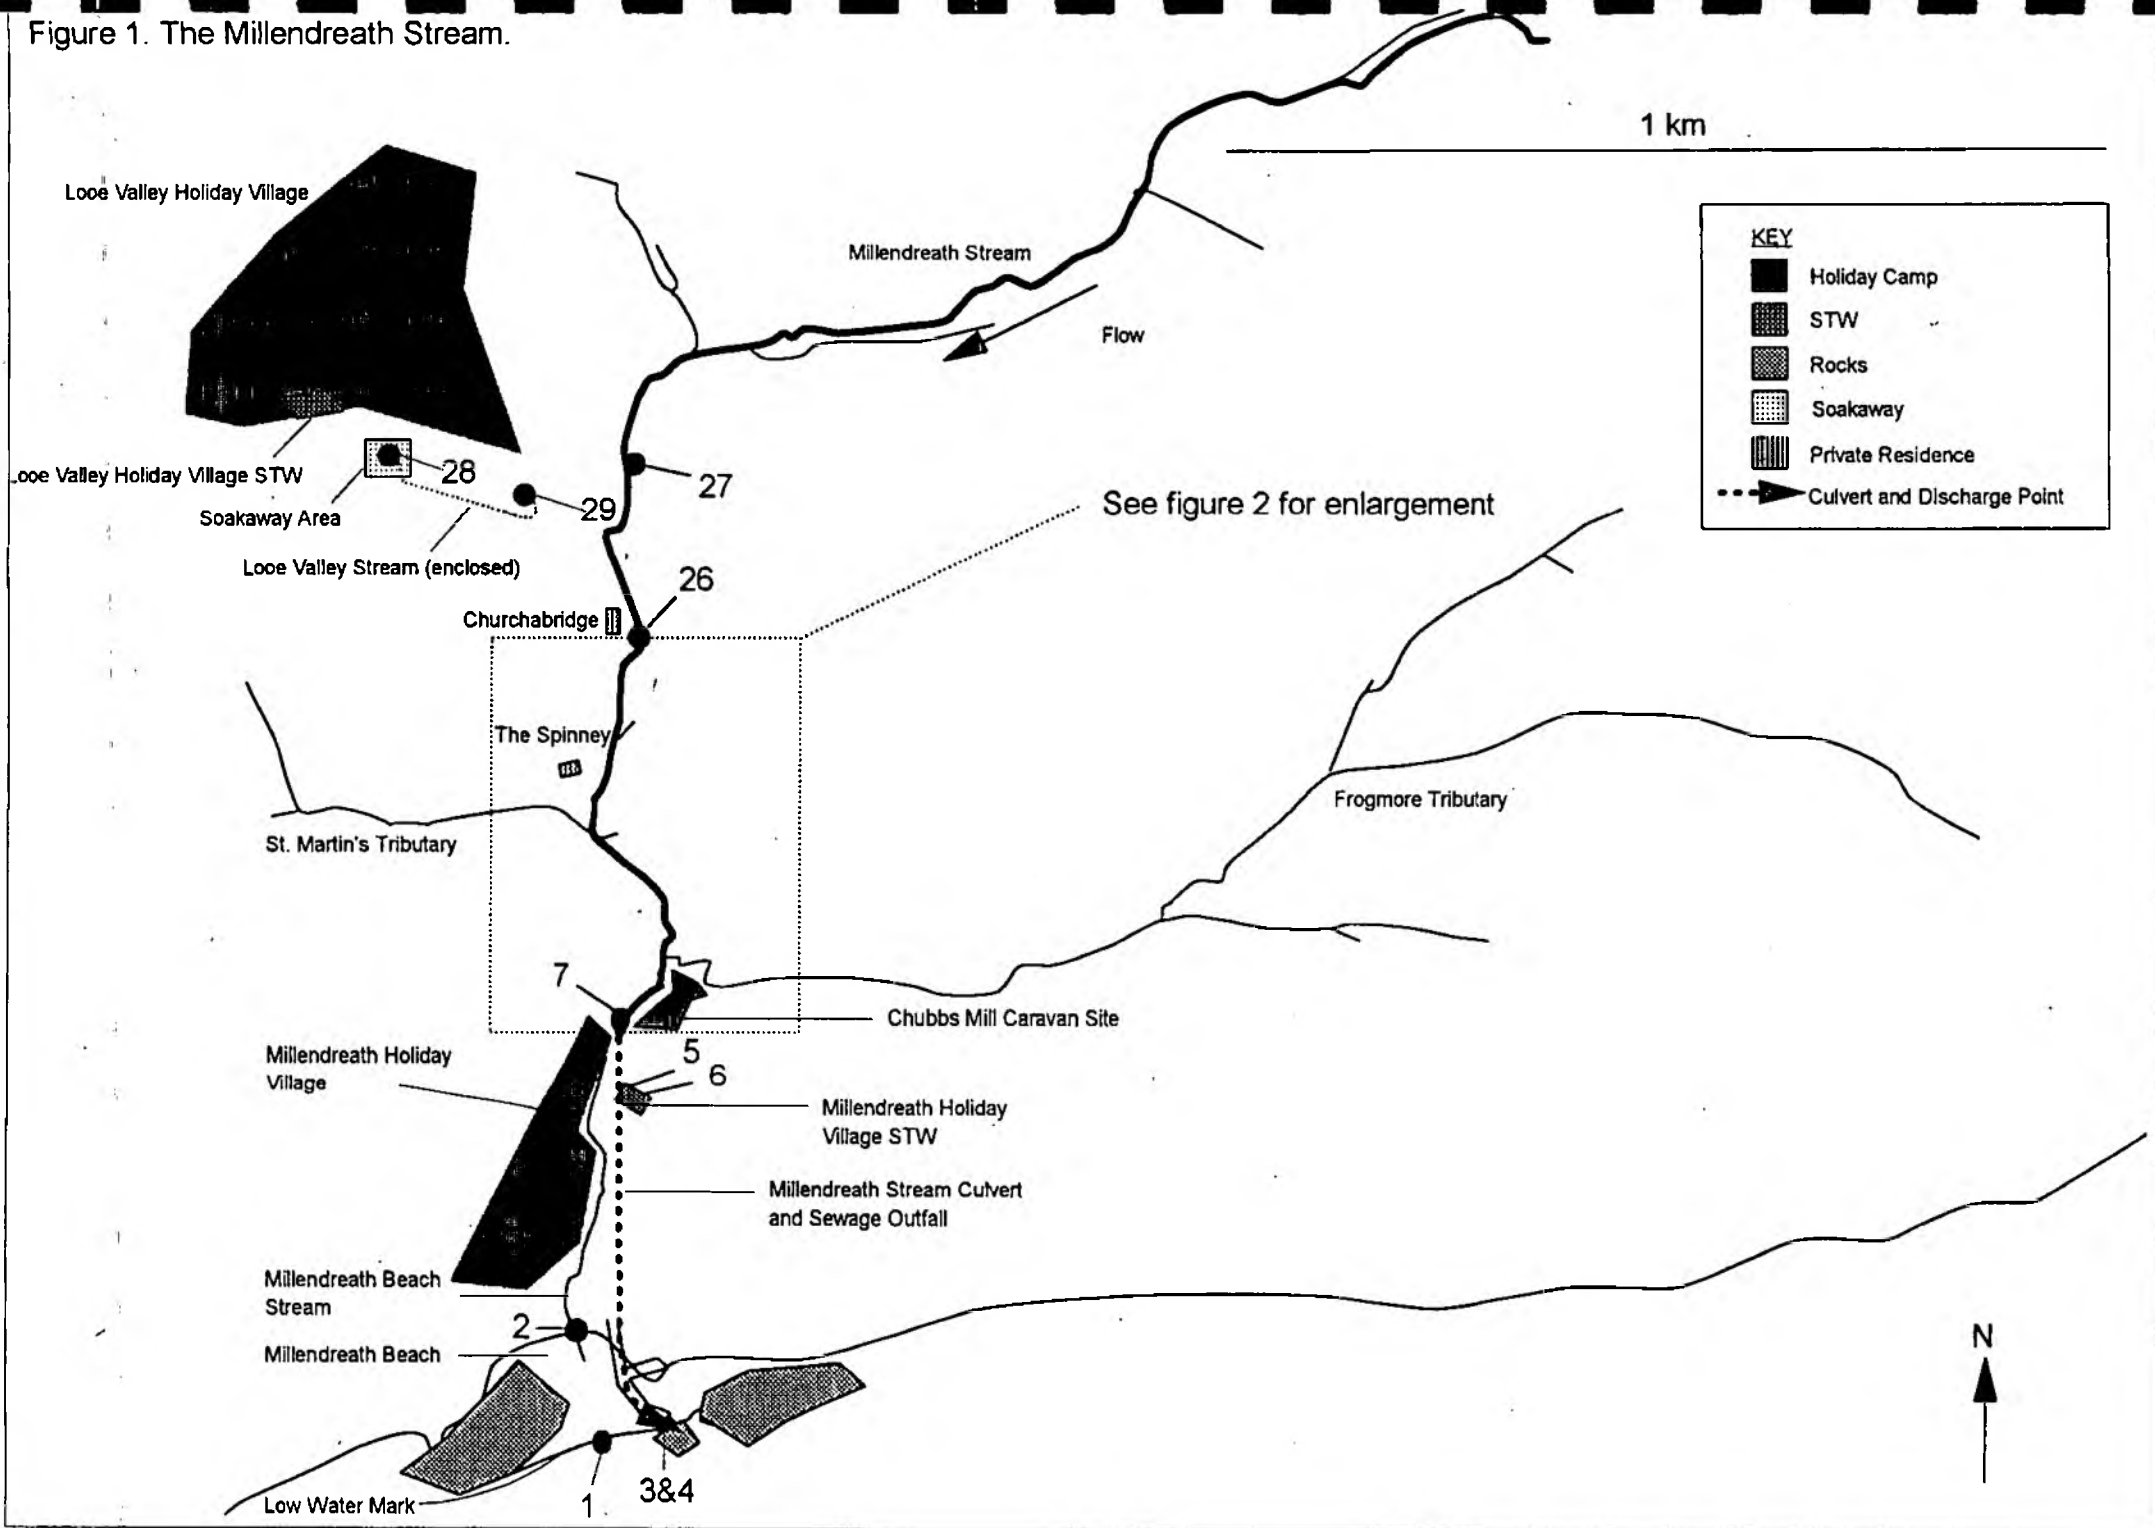
Figure 1. The Millendreath Stream.

In the course of the investigation it became apparent that the Millendreath Stream is culverted in its lower reach, commencing at site 7, upstream of Millendreath Holiday Village STW. The culvert discharges to the sea just above the low water mark on Millendreath Beach, alongside effluent from the Millendreath Holiday Village STW (Plate 1). As a consequence the beach stream is little more than residual land drainage and is not continuous with the Millendreath Stream (see Figure 1).

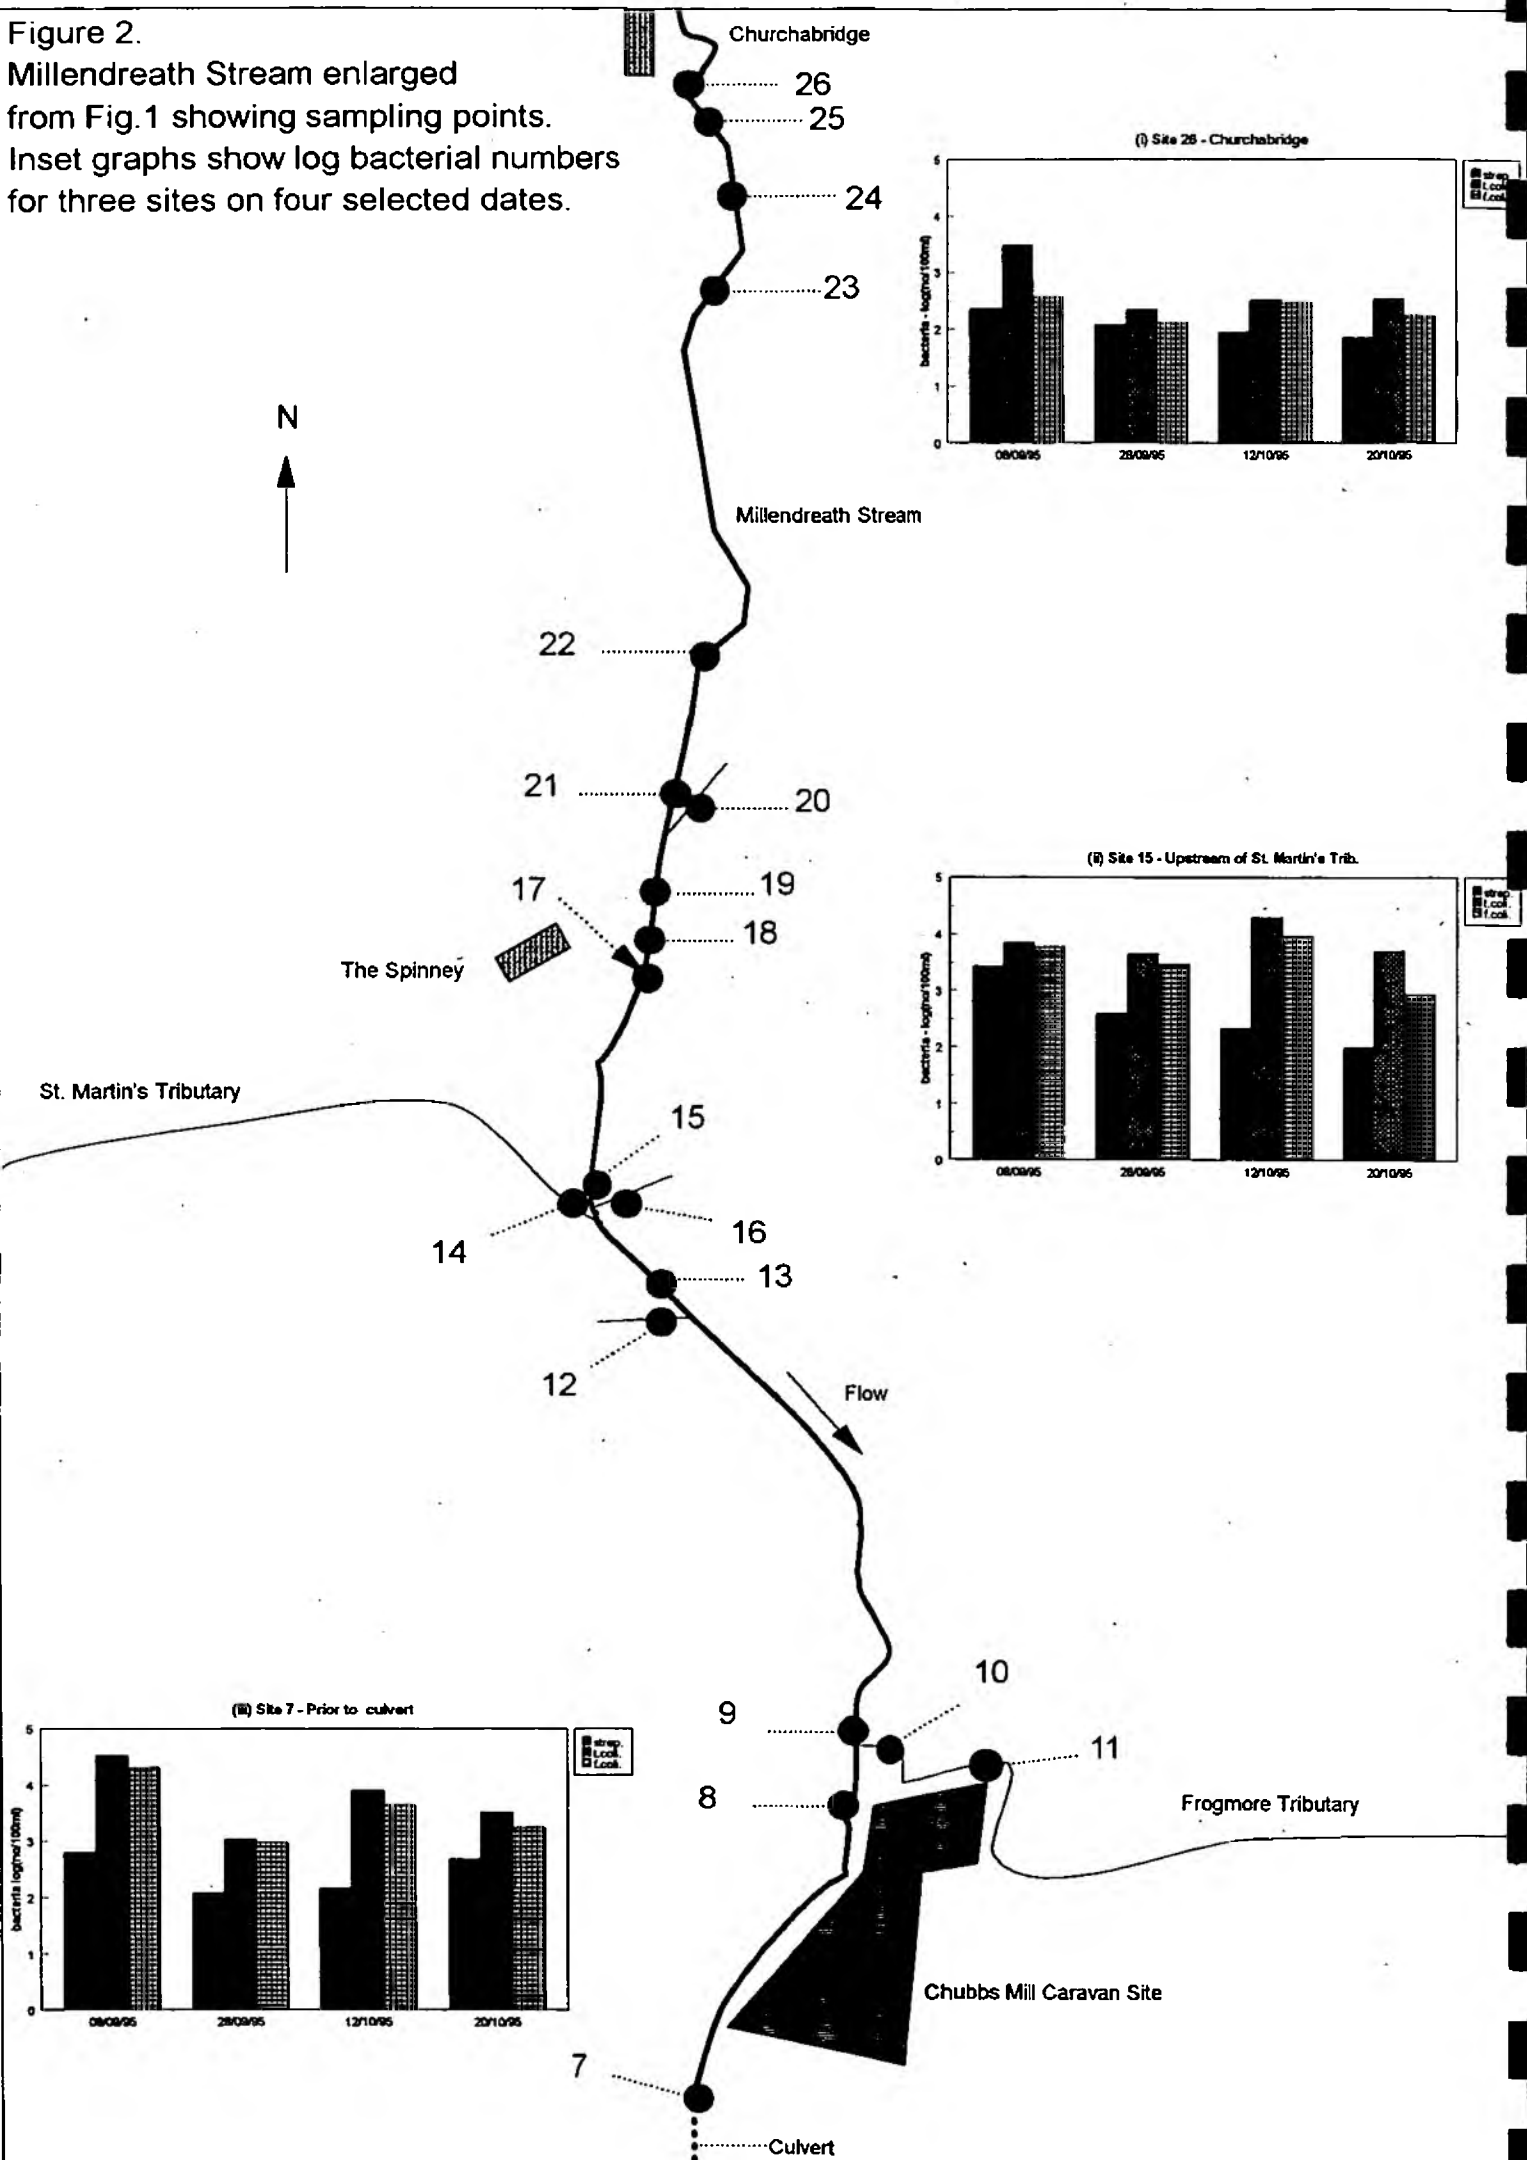
Figure 2.

As the culvert discharge is only accessible for sampling on low water springs, the downstream sampling point on most occasions was at site 7 prior to the culvert. After preliminary surveys site 26, downstream of the road at Churchbridge, was identified as a 'clean' upstream control. Subsequent surveys attempted to identify possible sources of contamination between these points. (See Figure 2).

Millendreath Stream enlarged from Fig.1 showing sampling points. Inset graphs show log bacterial numbers for three sites on four selected dates.
