**DEVON AREA  
INTERNAL REPORT**

**AN INVESTIGATION INTO  
THE SEWAGE SYSTEM AND  
STORM OVERFLOW AT  
BEER**

**MAY 1997  
DEV/WQ/9/97**

**Author: W. LOXTON.  
INVESTIGATIONS TECHNICIAN**

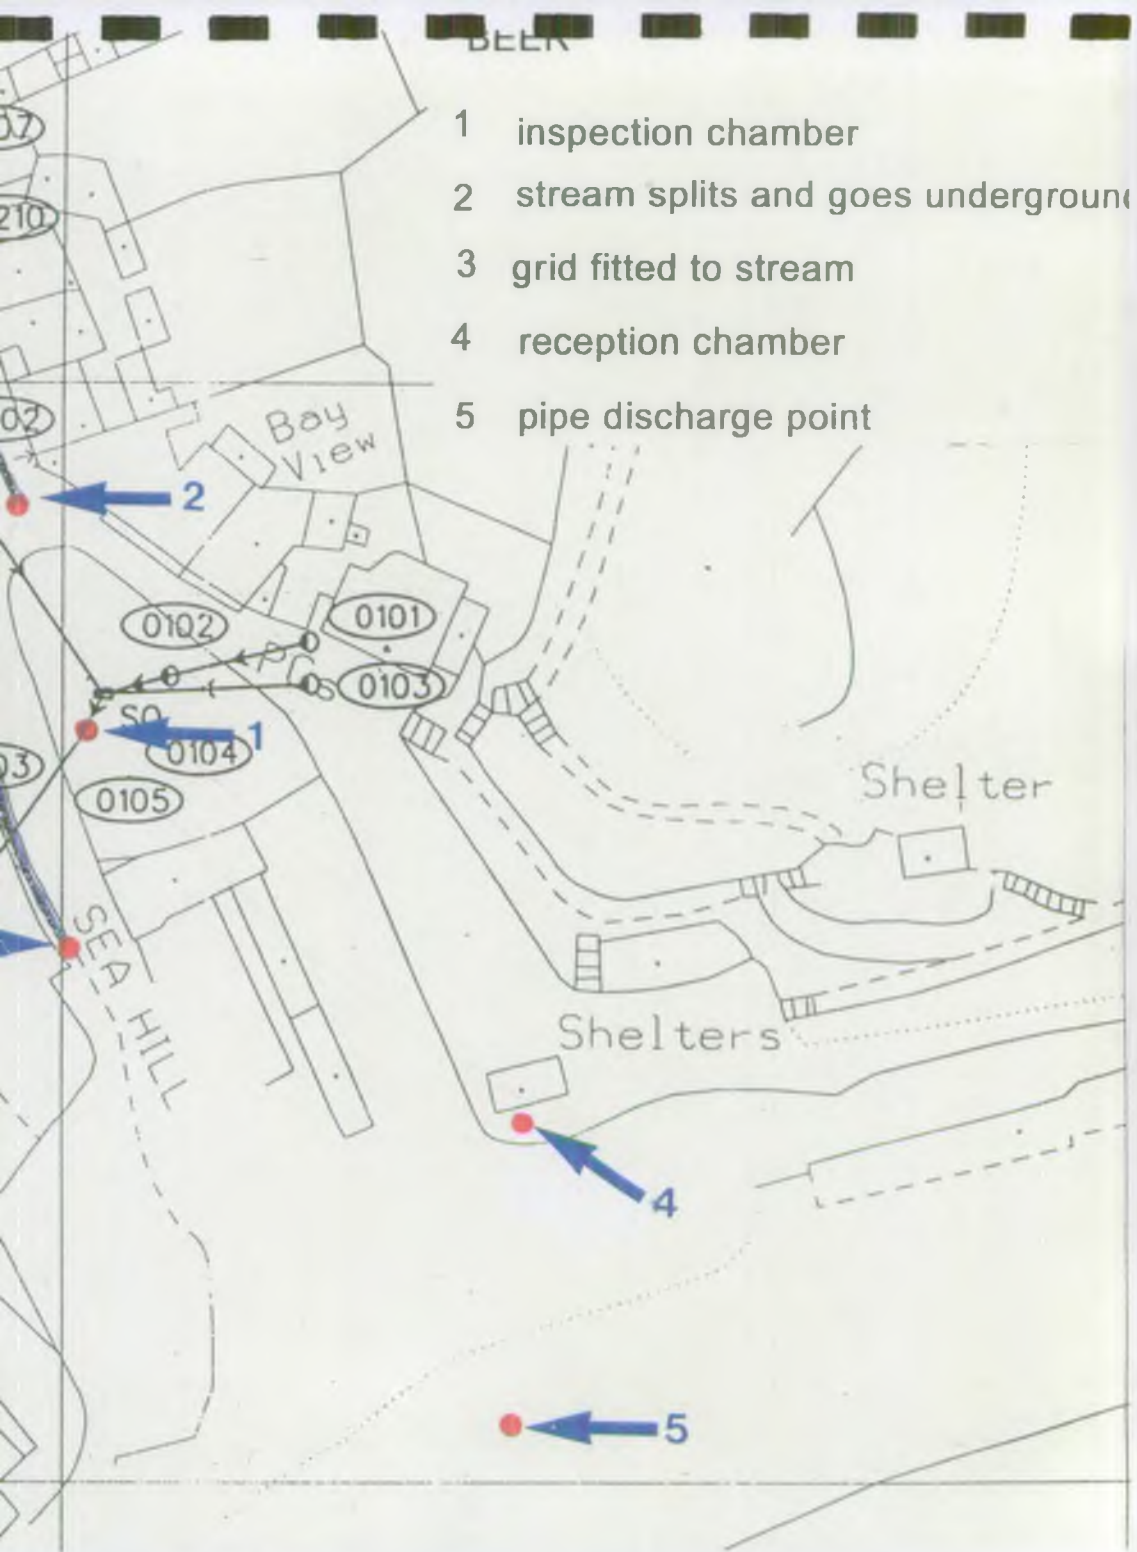
**APPENDIX 3**

- 1 inspection chamber
- 2 stream splits and goes underground
- 3 grid fitted to stream
- 4 reception chamber
- 5 pipe discharge point
