DEVON AREA INTERNAL REPORT

INVESTIGATIONS OF DISCHARGES INTO THE RIVER LEMON AT NEWTON ABBOT

DEV/E/02/96
JANUARY 1996
Author: T CRONIN
INVESTIGATIONS OFFICER

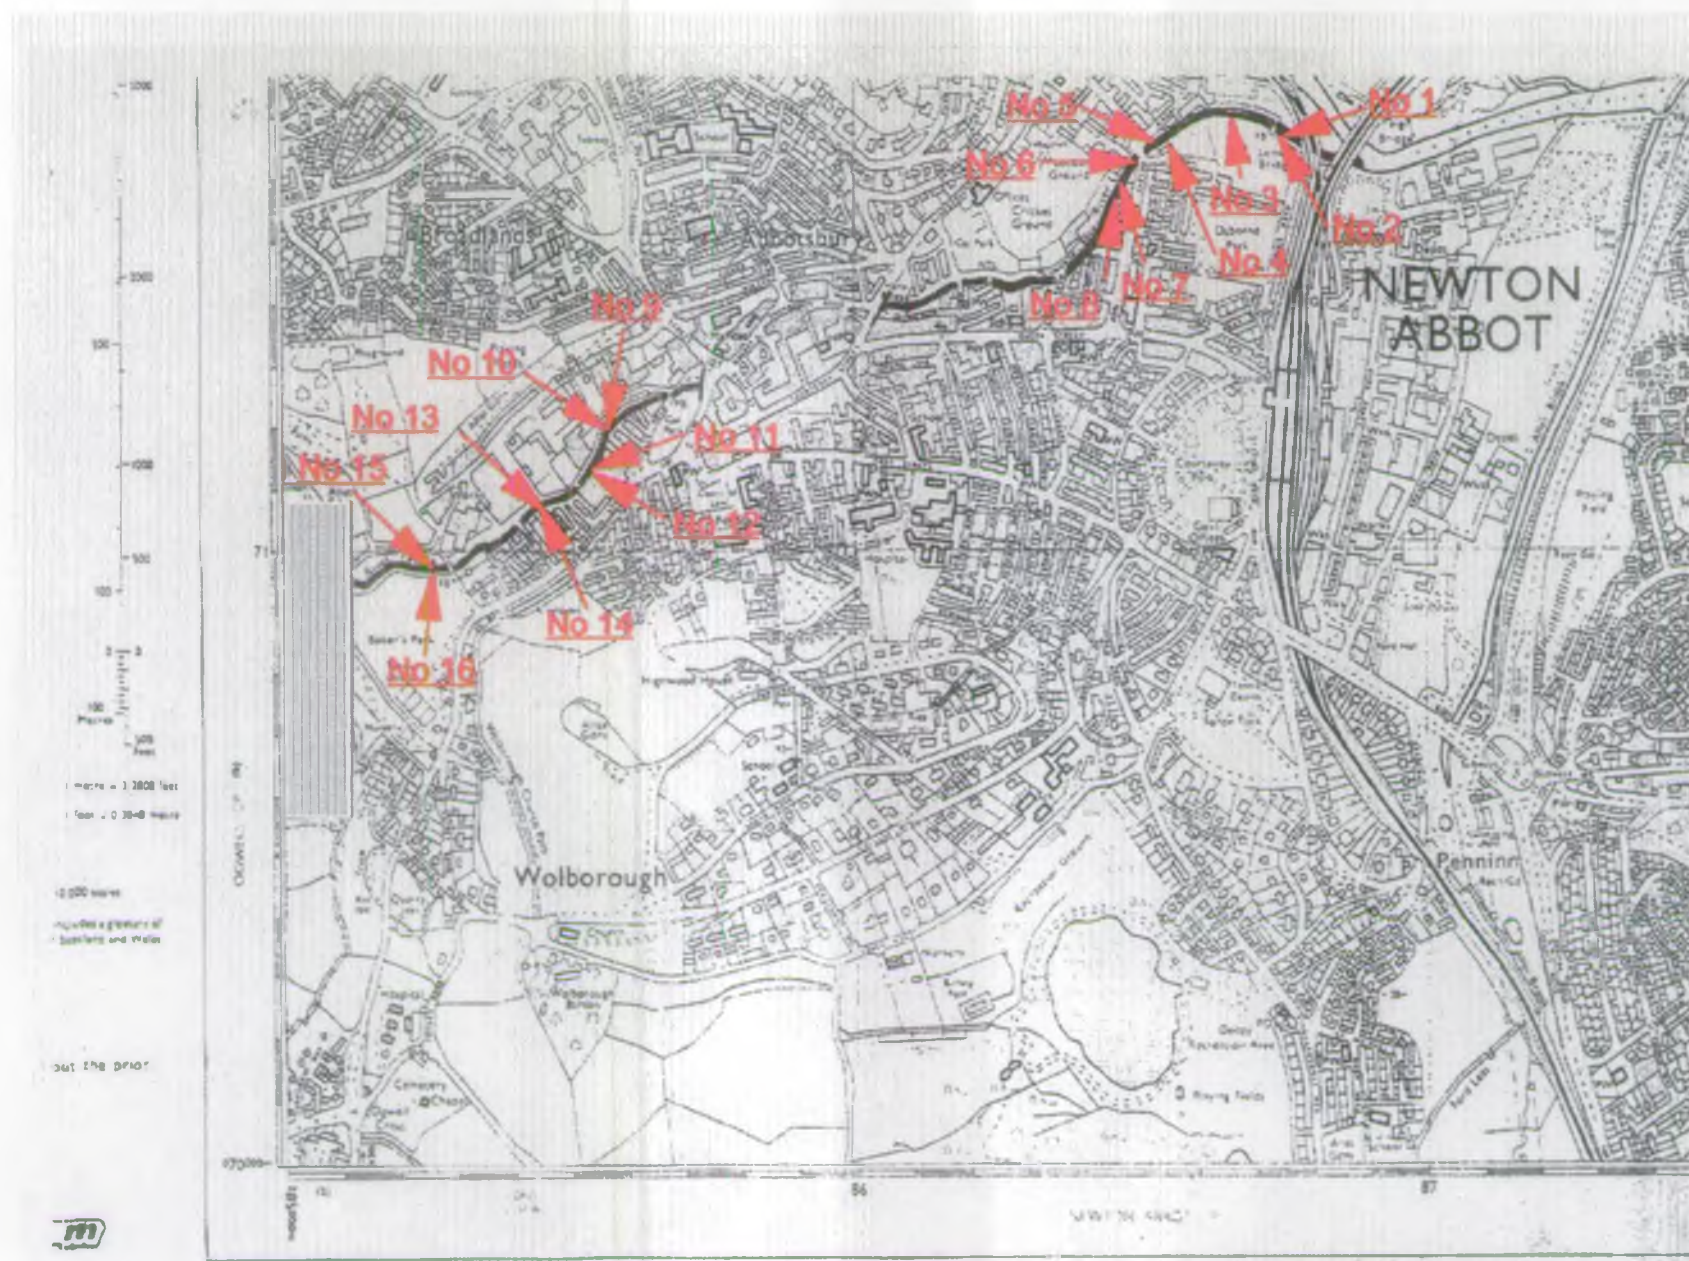
Map showing positions of photographs.

Numerous pipes that appear to be storm drains were observed in this section, ranging from 6 inches to 3 feet in diameter, the position of these pipes are indicated in Figure 2, and photographs in Appendix A.

A map showing the location of the pipes photographed is shown in Figure 2.

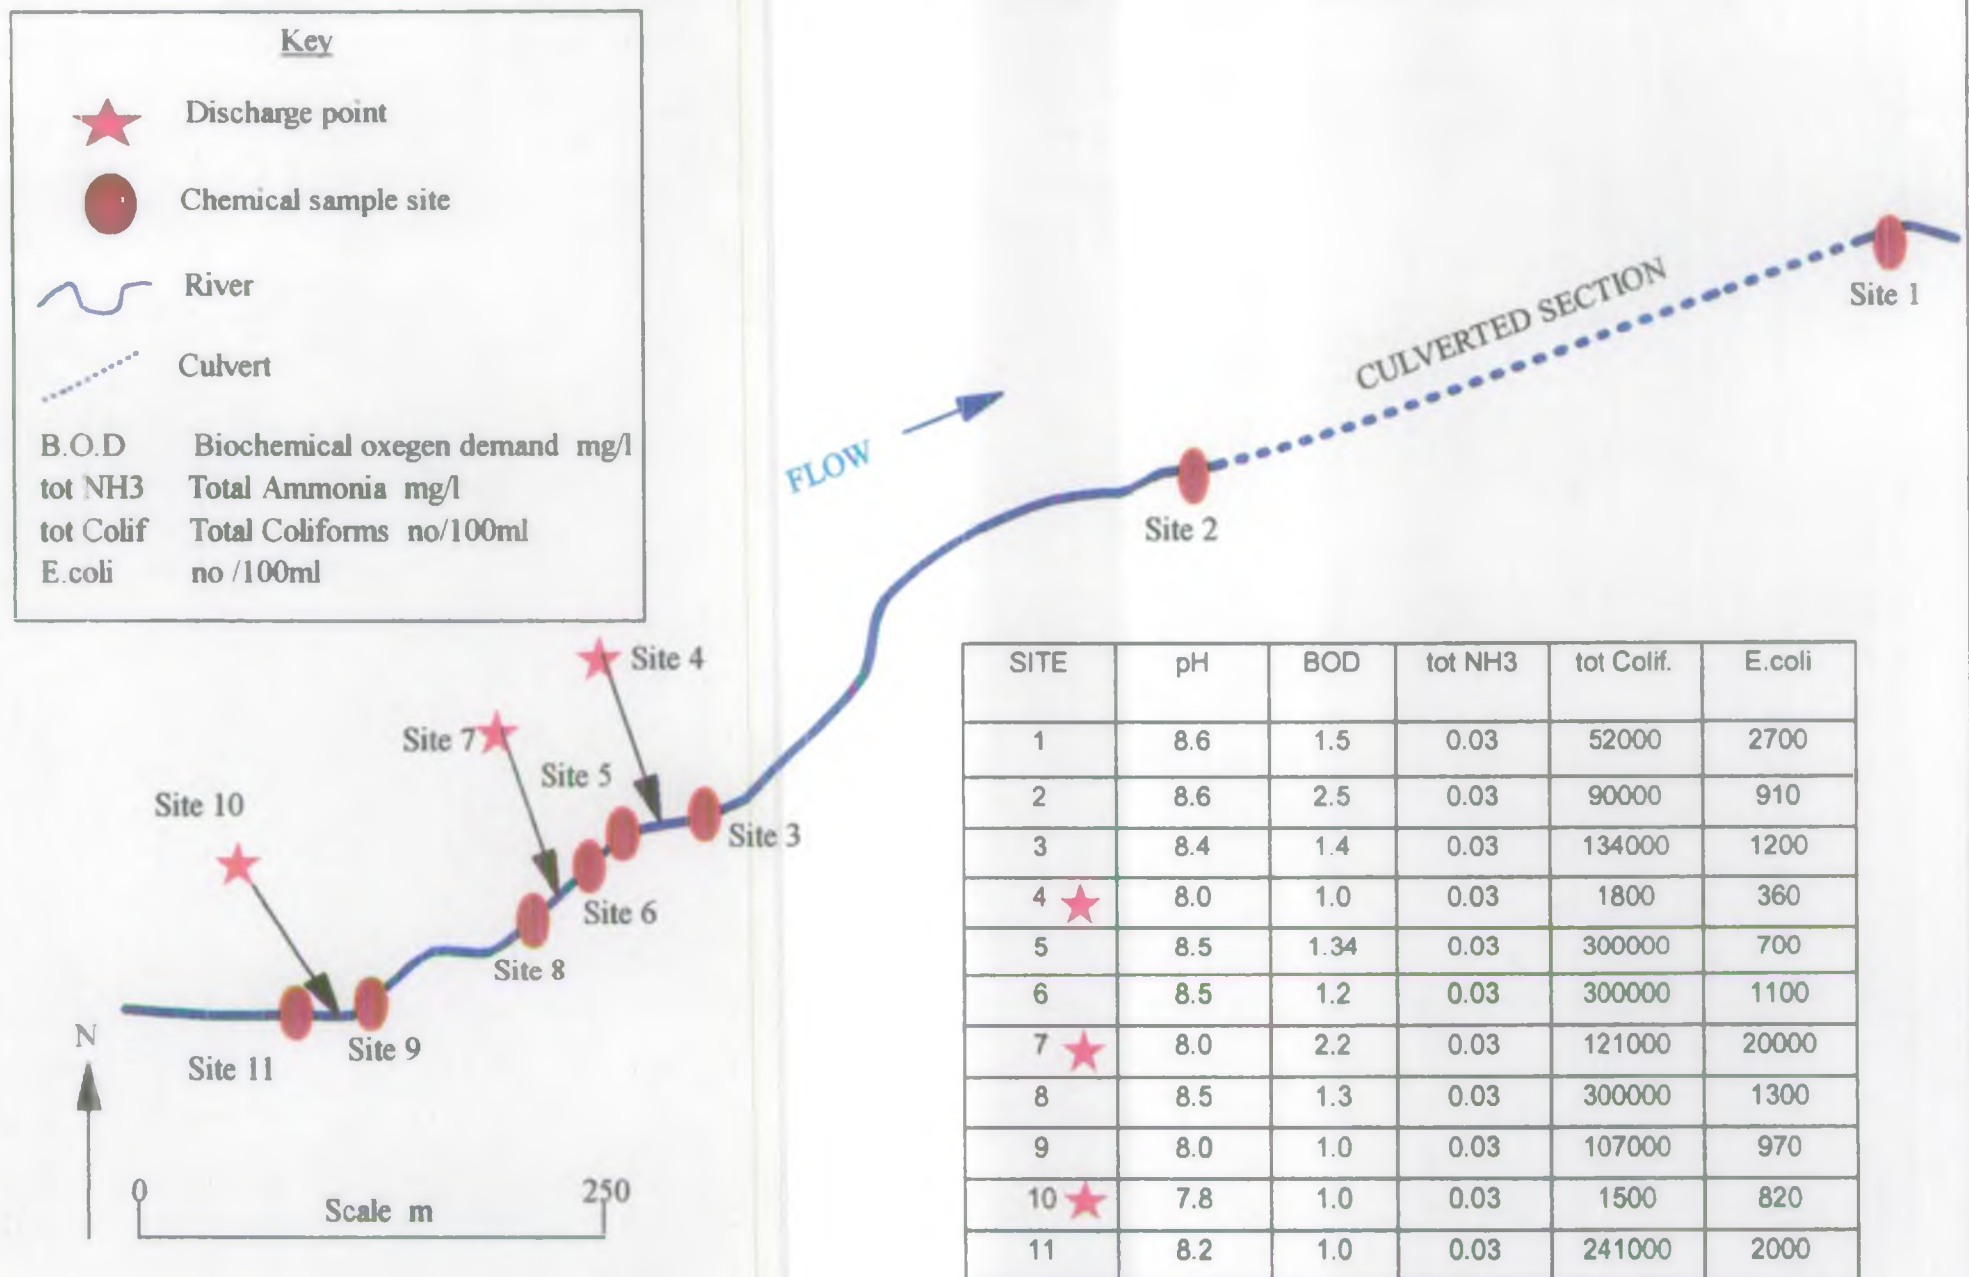
Figure No 3

On one of these occasions (August 11 1995) three pipes at different sites were found to be discharging. Samples of these discharges were taken, the full results of which are shown in Table 1. as sites 4,7,10 and their location are shown in Figure 3, again as sites 4,7,10. The pipes are depicted in Appendix A plates 9,12,14.

Eleven samples were collected on August 11 1995 the results are shown in Table 1. and their positions are shown in Figure 3.

It must be stressed that this can only be used as a very crude guideline, however it is interesting to note that apart from site 1 and site 7 (Table 1 and Figure 3) all ratios are below 3, this would tend to indicate that most bacteriological contamination of the sites sampled could be attributed to some form of agricultural or animal contamination.

The discharge from site 7 shows high levels of both total coliform and E.coli (121000 and 20000 respectively), and must be seen as a contributing factor to the high levels found at both sites 6 and 5.

The spring water discharging from pipes found during this survey would need to be traced.
