**A Litter Assessment of Two Major
Tributaries of the Taff, The Cynon
and the Rhondda
Surveyed March - April 1990
Report No. EAE/91/1**

**By: Gillian L. Davies & Dawn C. Boden
S.E. Environmental Appraisal Unit
Rivers House
St. Mellons Business Park
St. Mellons
Cardiff.**

May 1991

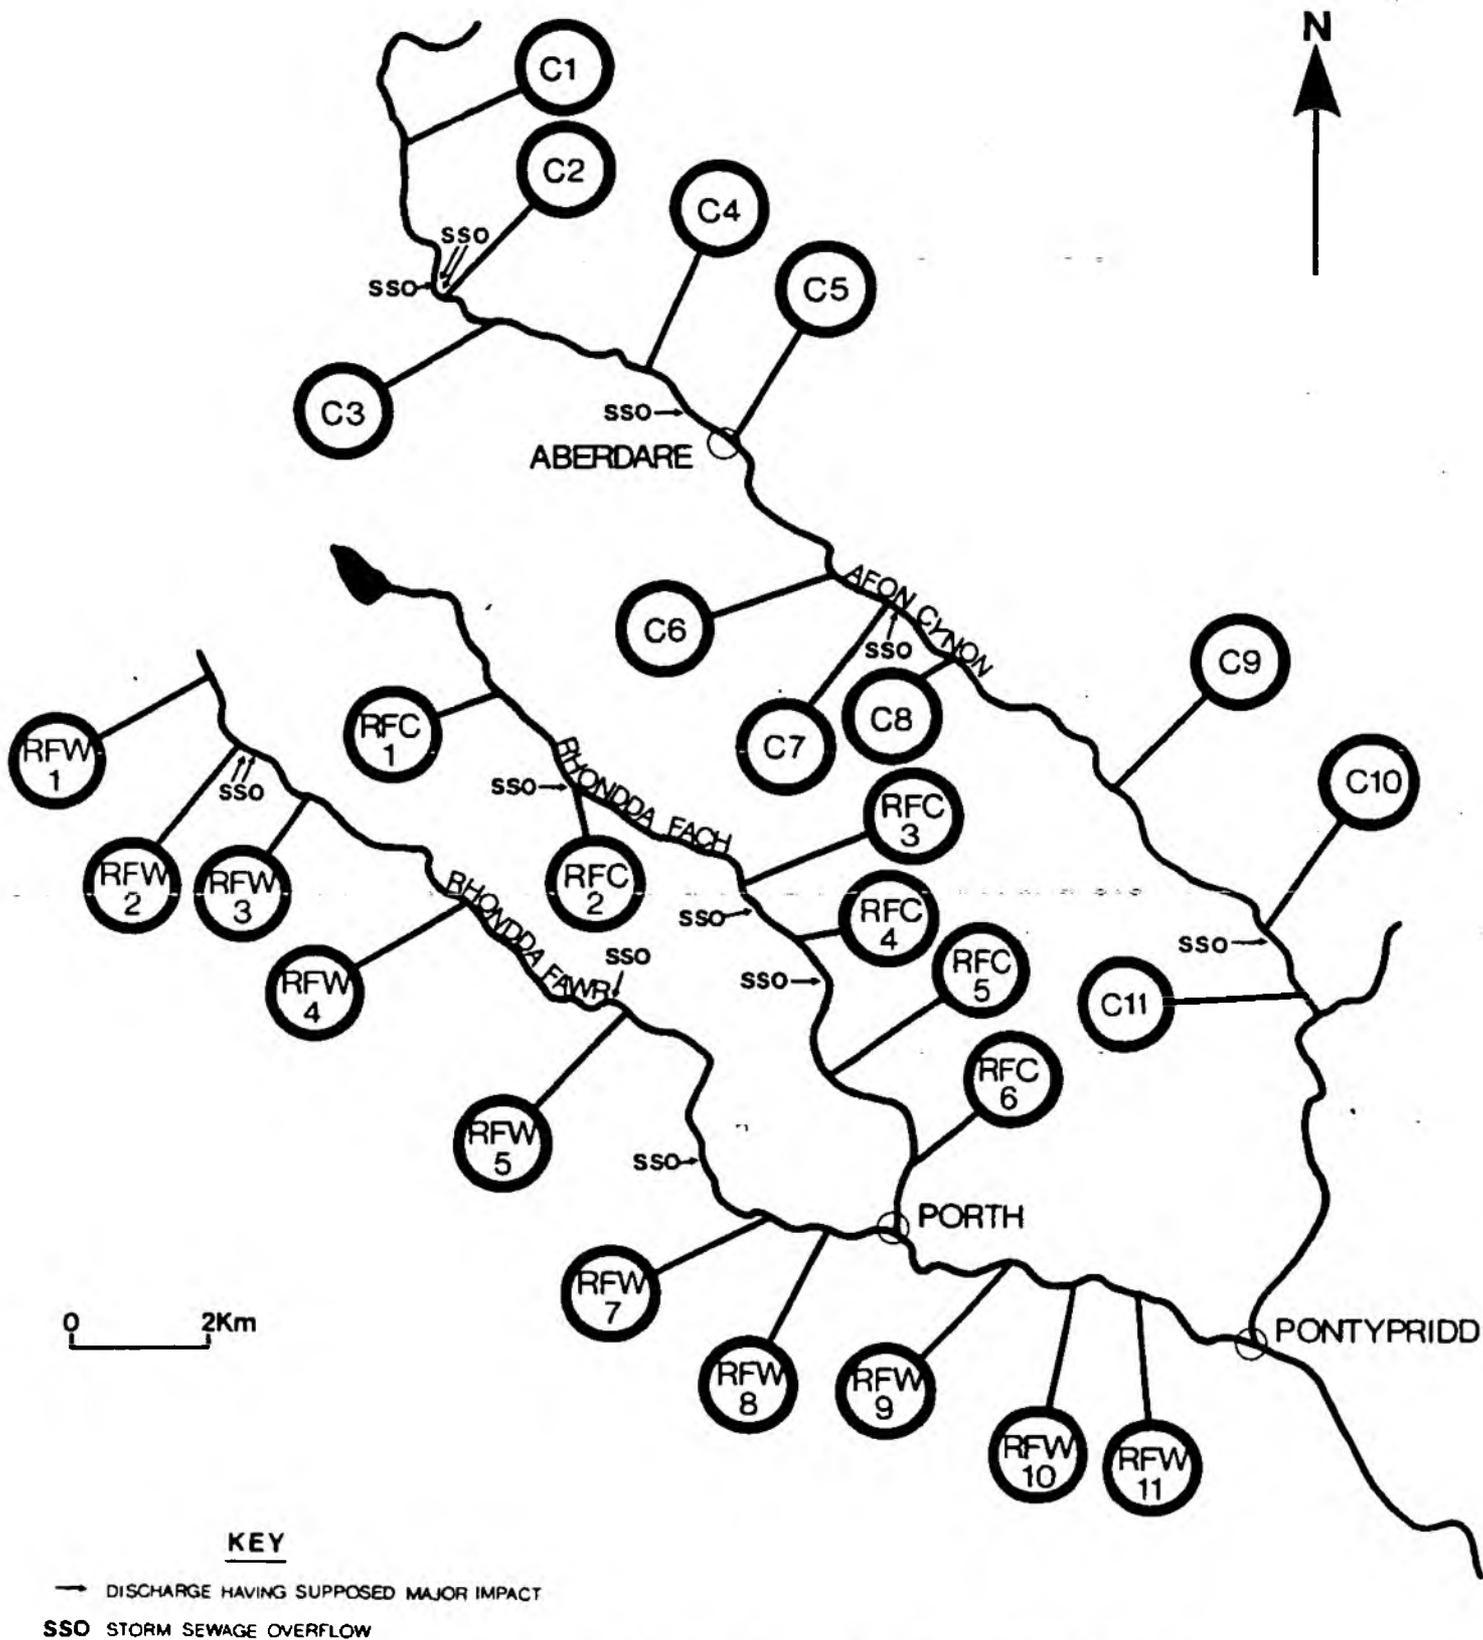
Fig. 1: Survey sites in the Cynon, Rhondda Fach and Rhondda Fawr

Fig. 1 shows the distribution of sampling sites and the location of a number of Storm Sewage Overflows (SSO's) within the Cynon and Rhondda catchments, which have been identified by the Pollution Control Section as being potential major inputs of the sewage derived litter (SDL) component.

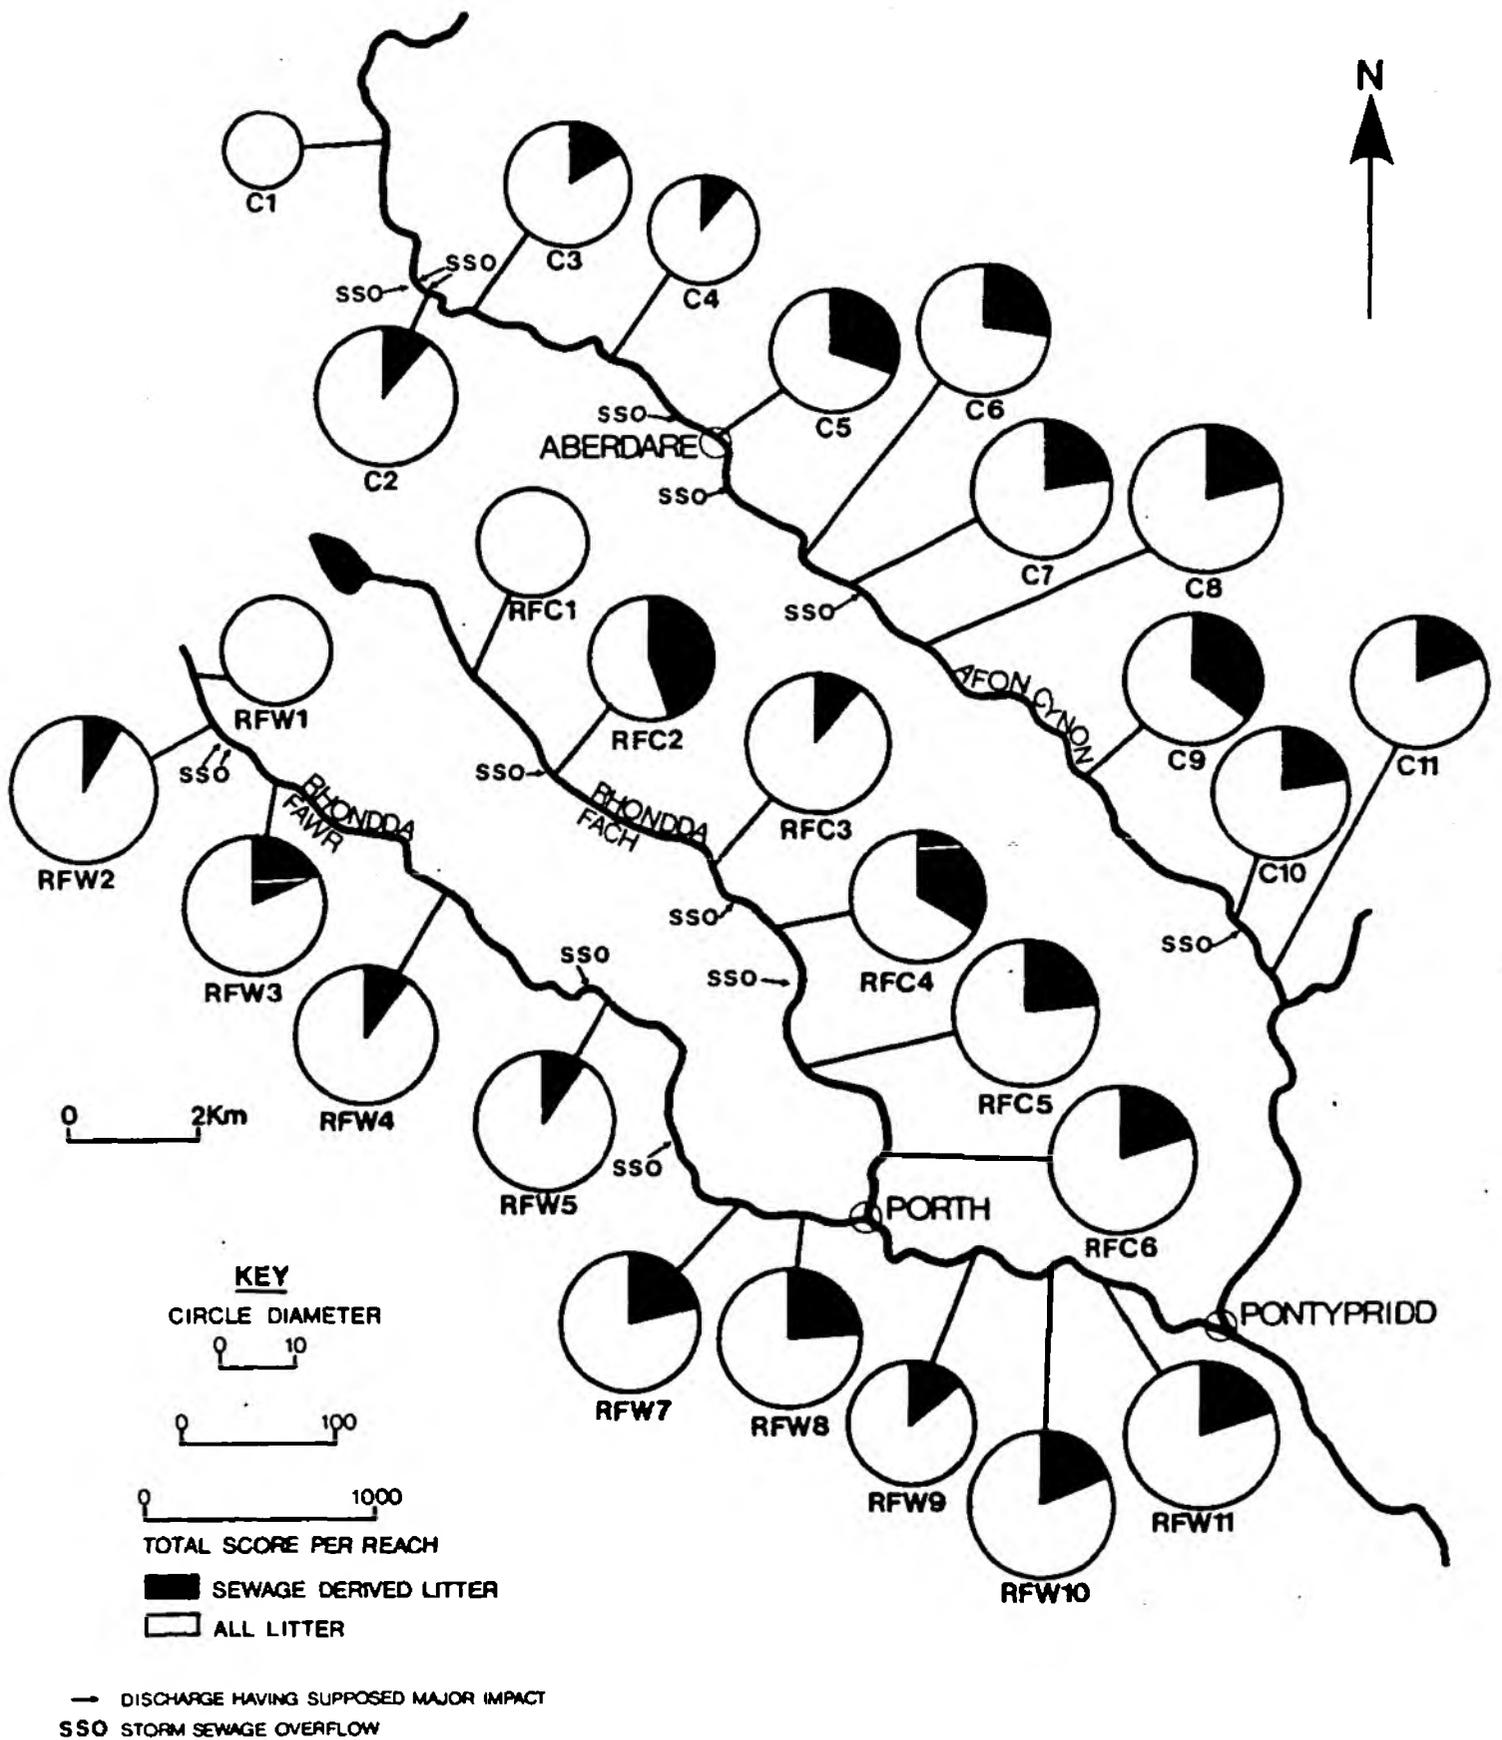
Fig. 2. Abundance of litter and the proportion which is sewage derived at each survey site of the Cynon, Rhondda Fach and Rhondda Fawr.

The proportions of sewage derived litter (SDL) to other types of litter is illustrated in Fig. 2 as pie diagrams, with the diameter of the circle representing the logarithm of the total score. Sewage derived litter was present at all sites in the Cynon downstream of C1, the headwaters site. It constituted greater than 25% of all litter at sites C5 (30%), C6 (27%) and C9 (35%). Sewage contamination, in the upper reaches, can be linked directly to storm sewage overflow

Sewage derived litter was present at all sites on the Rhondda Fach and Rhondda Fawr downstream of the headwater sites (RFC1 and RFW1) (Fig 2). Maximum quantities of SDL (greater than 25%) were recorded at sites RFC2 (45%) and RFC4 (33%) on the Rhondda Fach and site RFW8 (29%) on the Rhondda Fawr. The gross contamination by sewage litter at site RFC2 is directly attributable to the Maerdy SSO, and the increase at site RFC4 is related to the Tylorstown SSO. In contrast, the Rhondda Fawr had a background proportion of sewage litter of less than 25% and the maximum (29%) recorded at site RFW8 (Dinas) could not be related to any known problem inputs.

Plastic strips, dropped litter (ie sweet wrappers, crisp packets etc), metal objects and builders rubble occurred at all sites within the Rhondda catchment. Plastic strips (mainly shredded polythene) were a particularly heavy contaminant (Fig. 2) along with dropped litter.

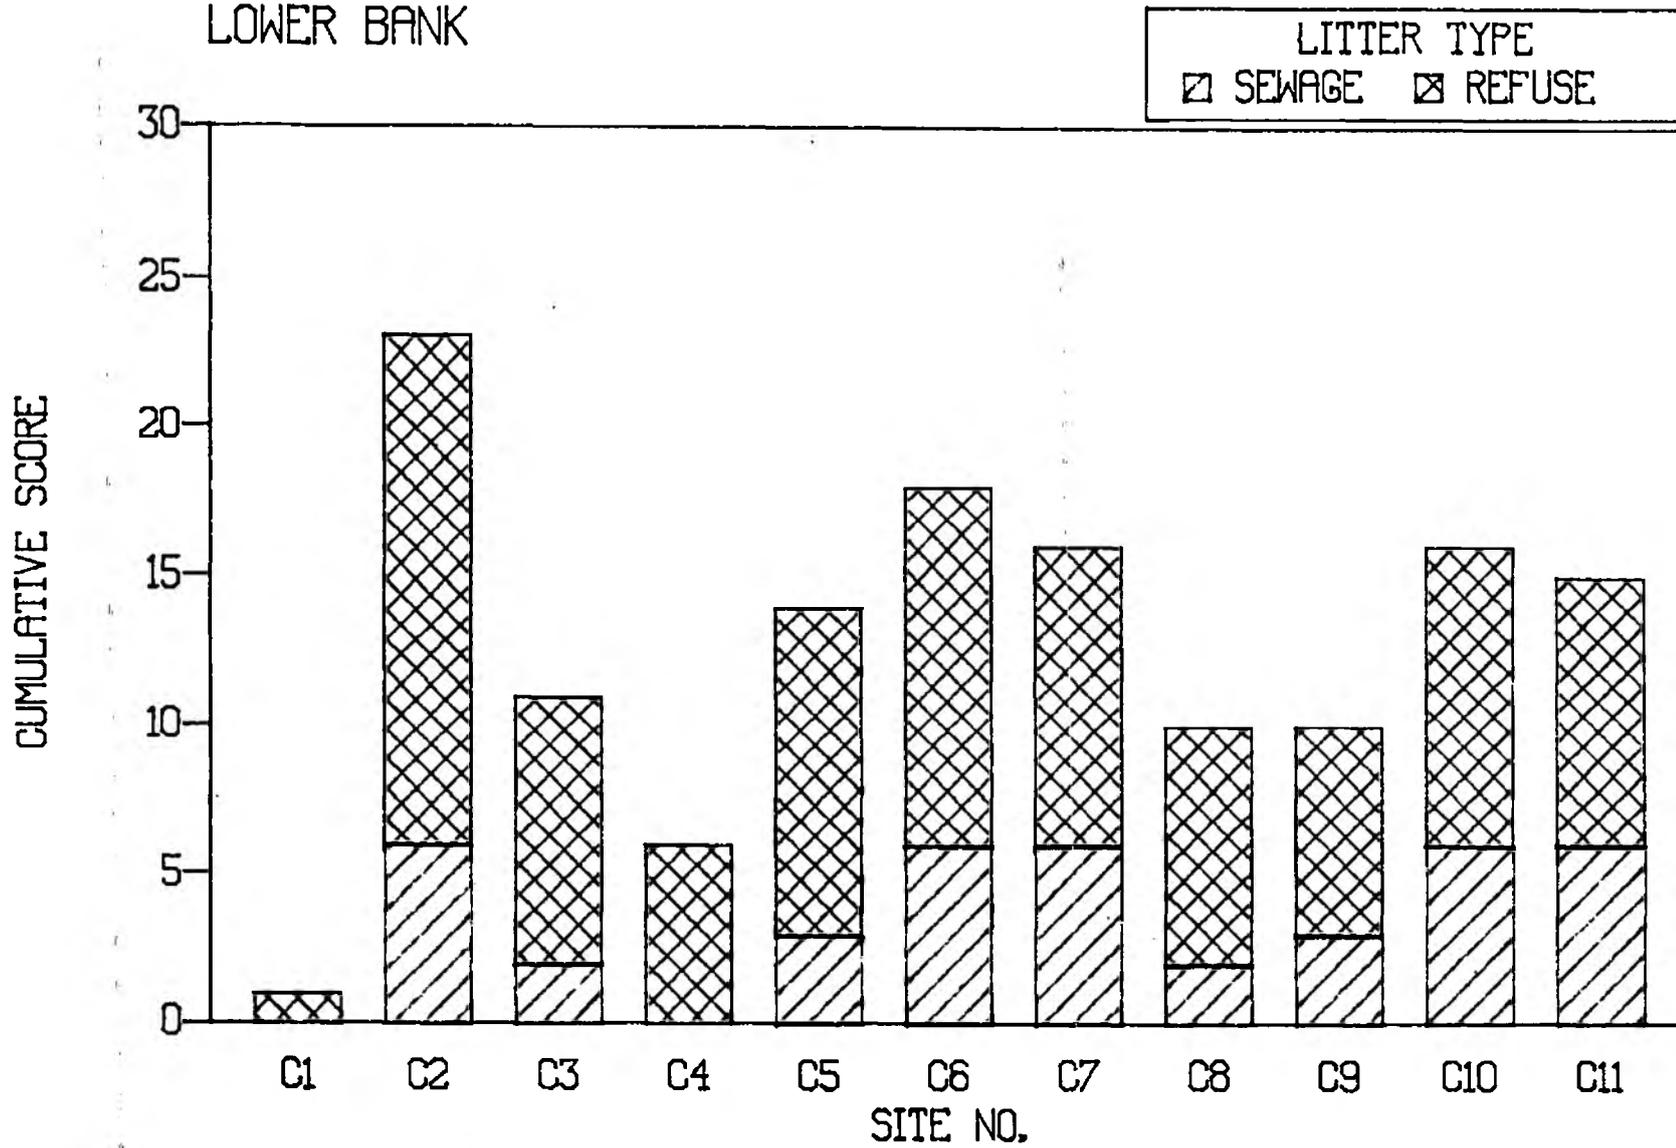
FIG. 4
CYNON LITTER:SEMI-QUANTITATIVE ASSESSMENT

Sewage derived litter was present at most sites on the lower bank (except sites C1 and C4) (Fig. 3), where it was mainly caught up on bankside vegetation, but penetrated to the middle bank between sites C7-C11 (Fig. 4) and to the upper bank between sites C7-C9 (Fig. 6). This depended to some extent on the profile of the river bank and the maximum level reached by the flood water. The most littered site from this assessment was C2 at Hirwaun (mainly refuse) (Fig. 7).
