Environmental Protection Report

RIVER TAW – HABITAT REHABILITATION 1992

March 1993
Fisheries Section

ENVIRONMENTAL IMPROVEMENT WORKS - RIVER TAW CATCHMENT - 1992

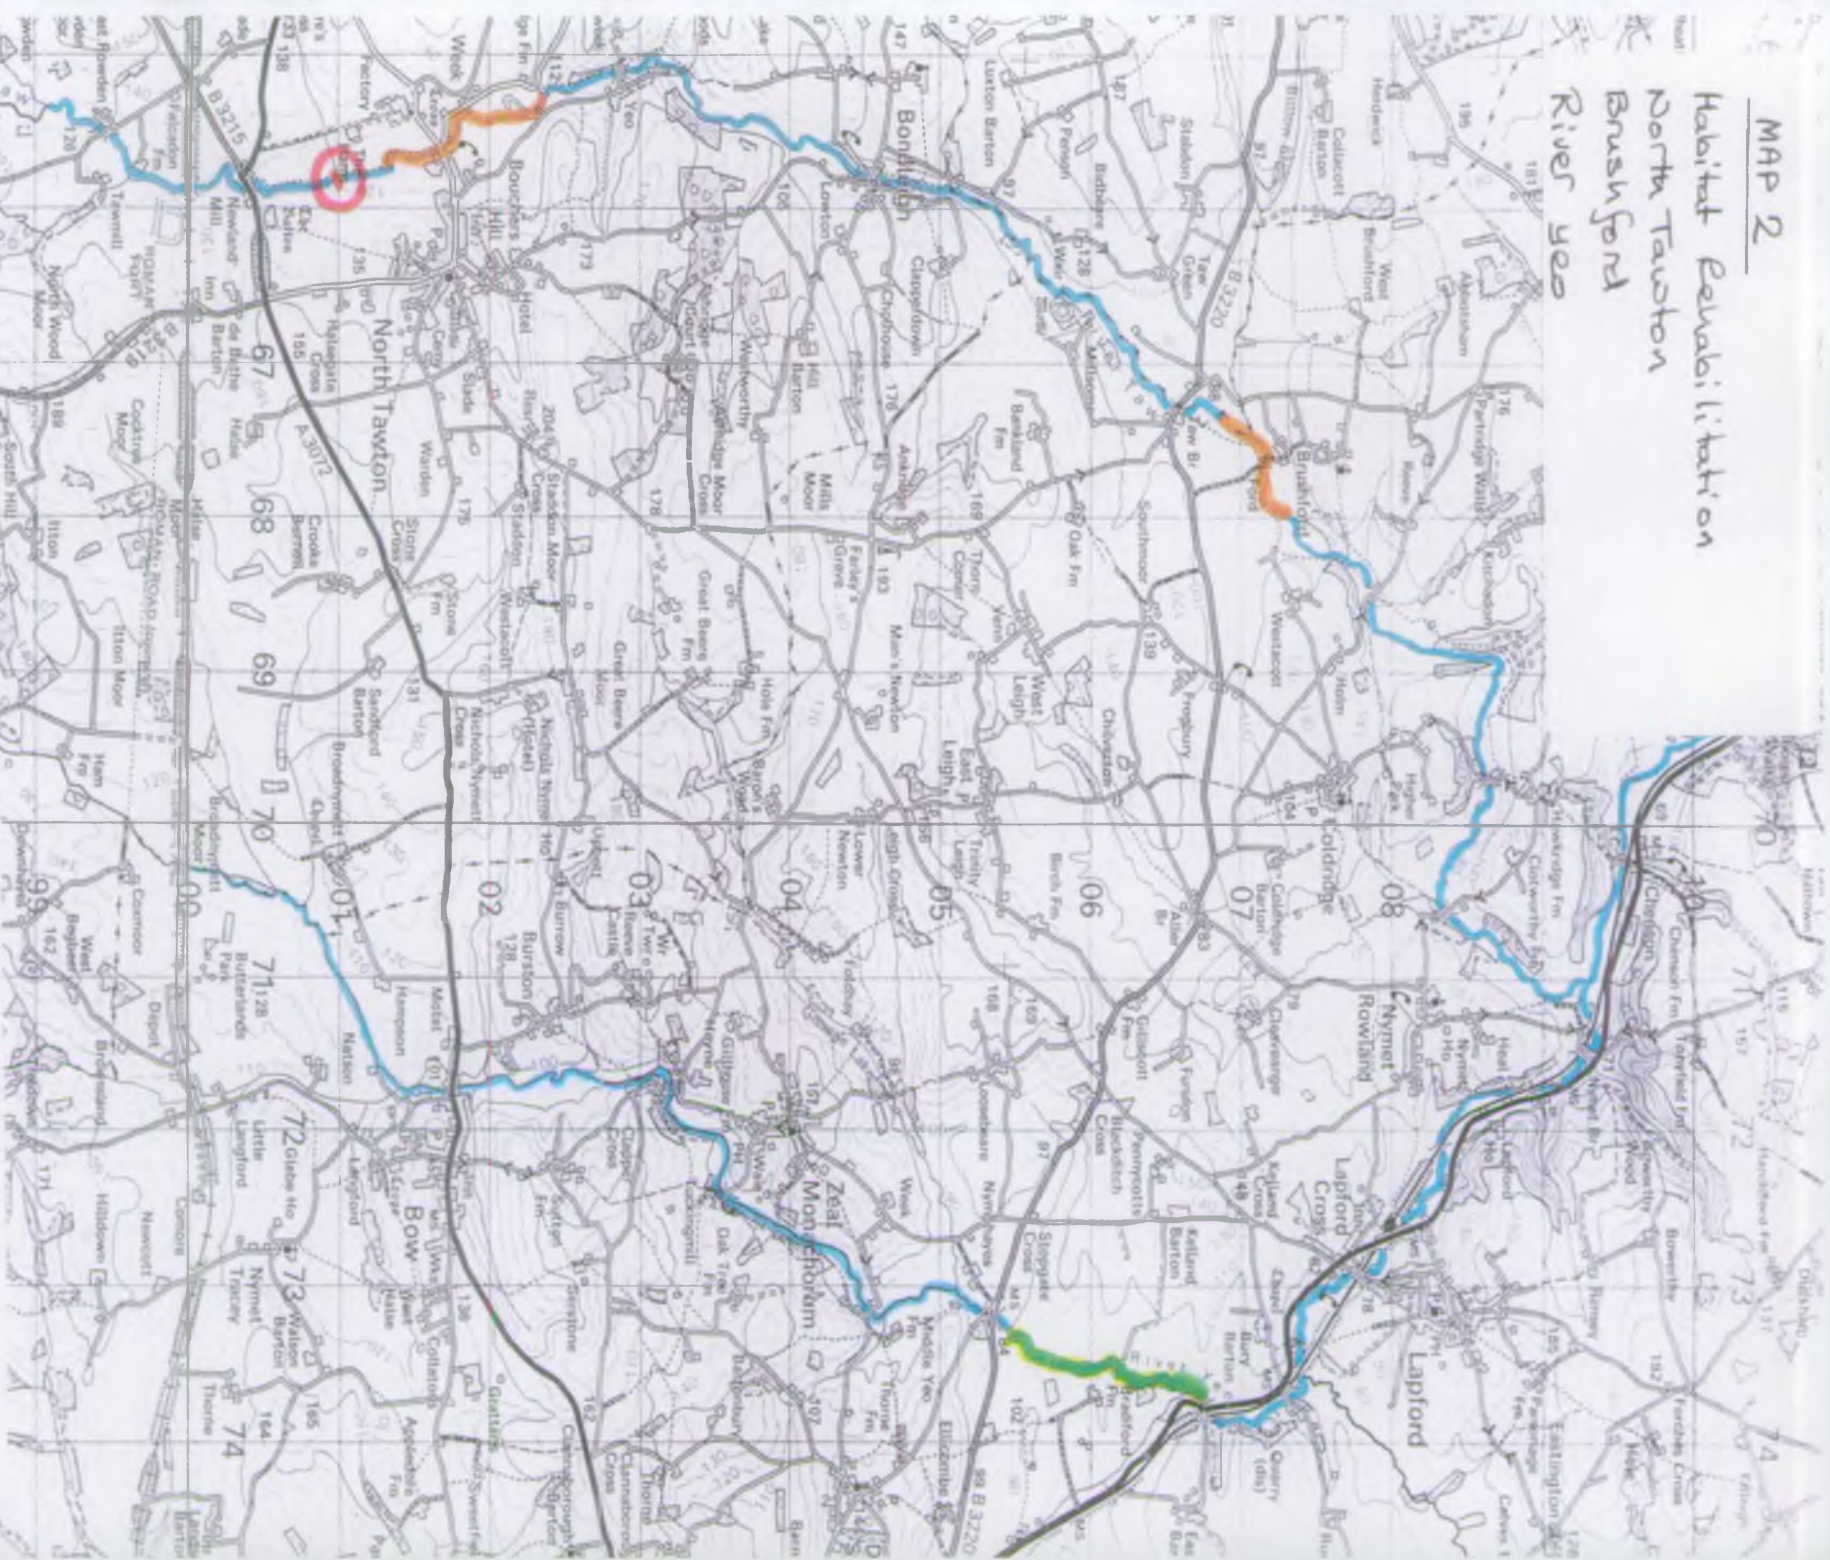
MAP 2

Twelve riffles were worked on in a section of river upstream and downstream of North Tawton Bridge. Most of the work was undertaken using a mechanical digger with a ripping hook device attached to the back actor (see Plate 1). This device was raked through the gravel at each riffle, loosening and releasing silt up to depths of two feet. After raking was complete, the gravel beds were then smoothed over using the front bucket on the machine. The work was carried out by a private contractor under the supervision of Warden Boyd.

Habitat Rehabilitation North Tawton Bushford River Use

- GRAVEL REHABILITATION
- TRASH CLEARANCE
- NORTH TAWTON WEIR

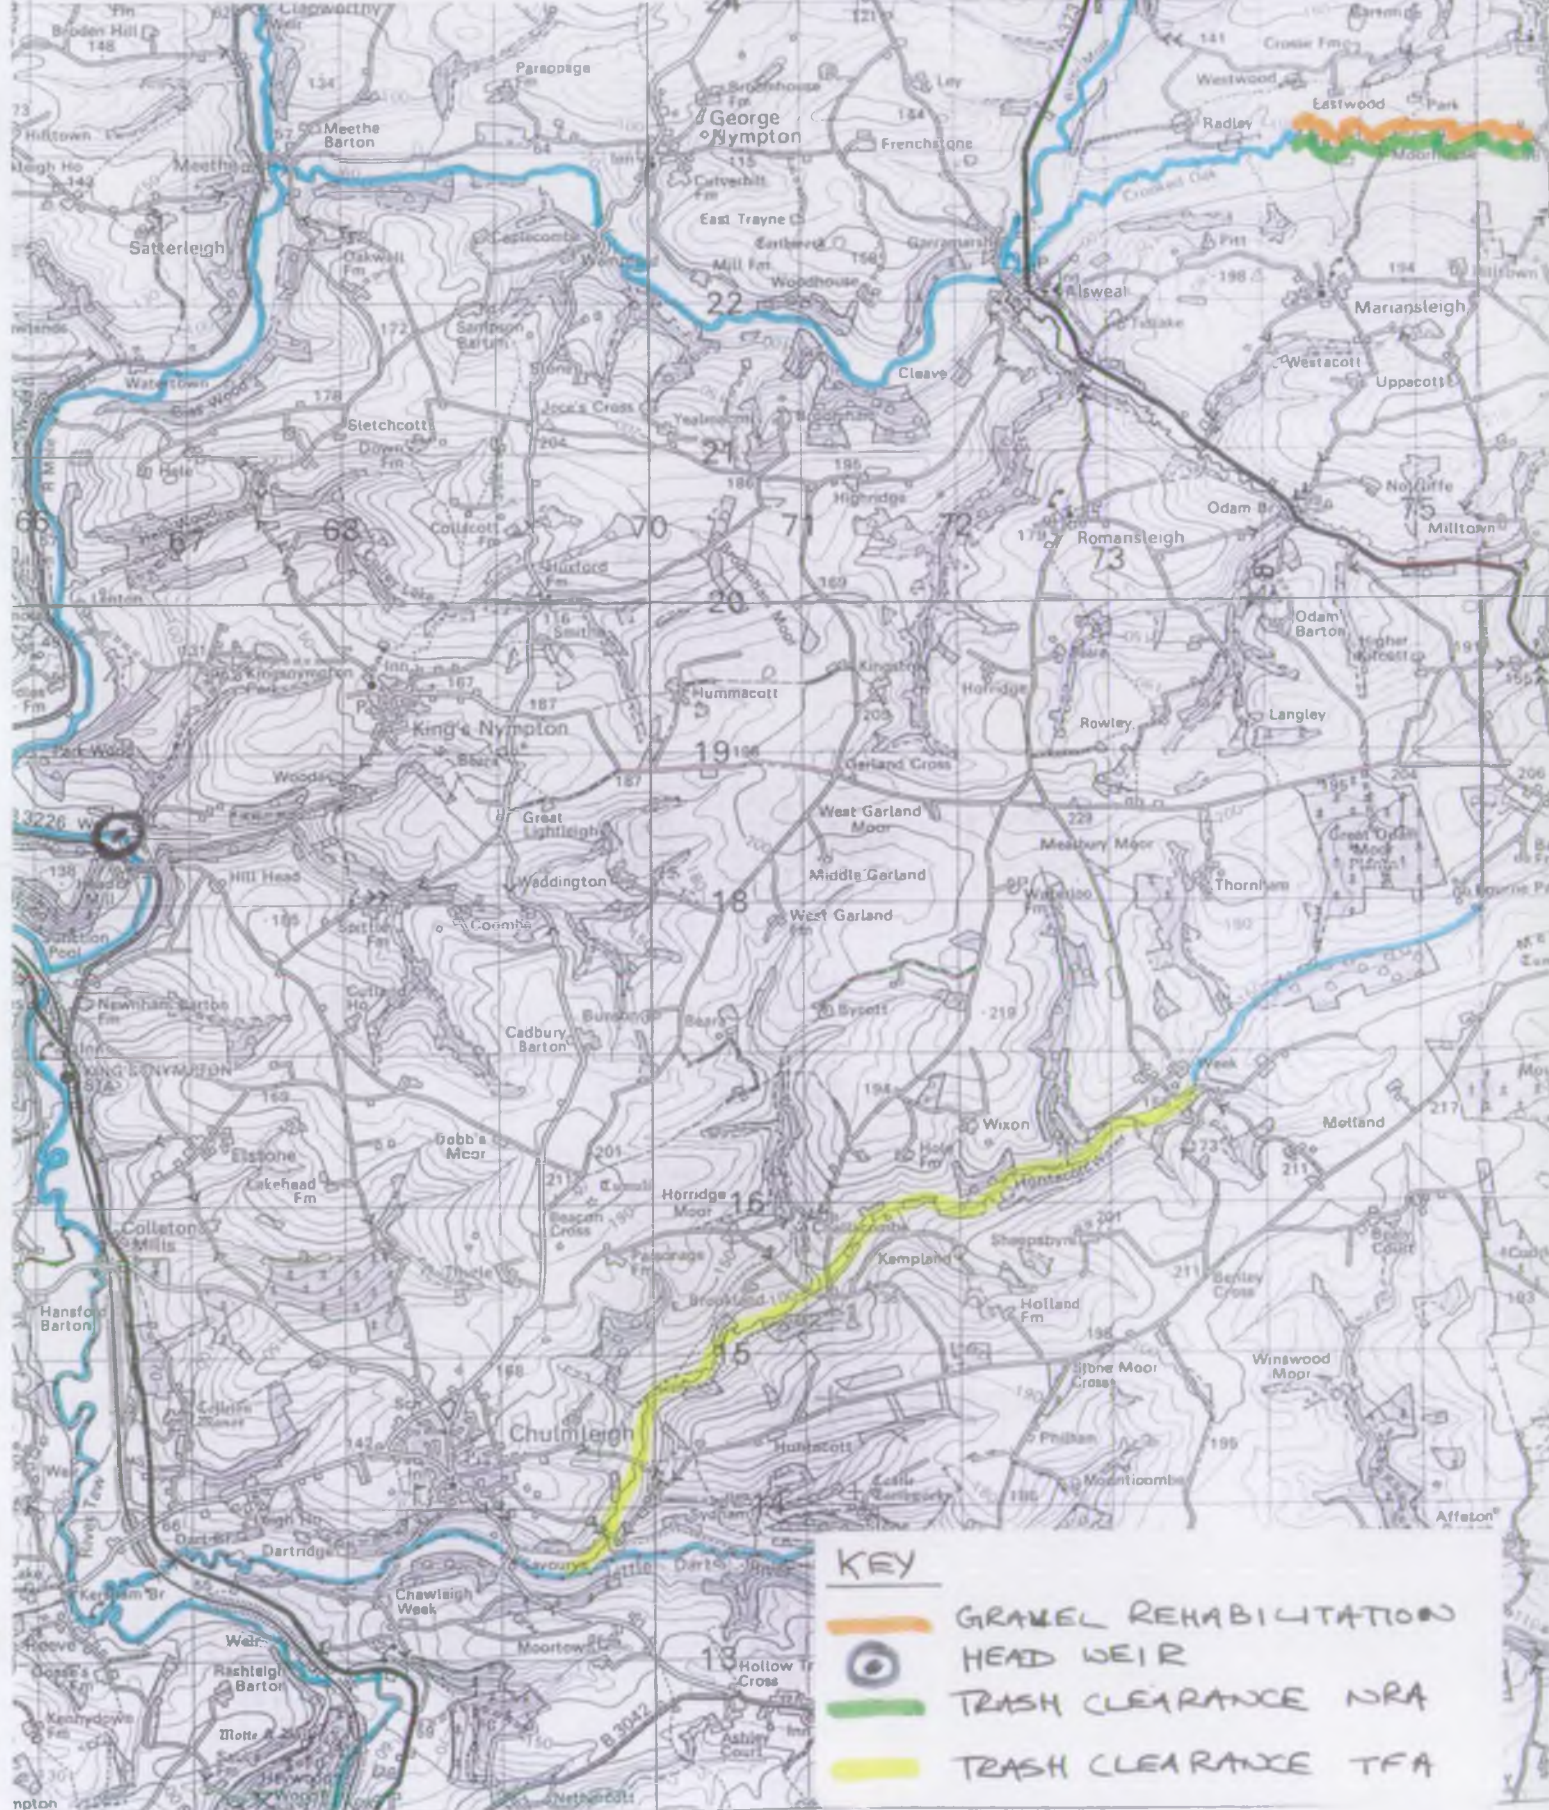
MAP 3

Twenty six riffles were improved in the Crooked Oak downstream of Yeo Bridge. The desilting work was carried out using a water pump. (Restricted access because of bankside tree cover and the small size of the stream precluded the use of a mechanical digger in this location). A portable (2" dia. delivery hose) water pump with a high pressure nozzle on the delivery hose was used to direct a powerful jet of water at the river bed (see Plate 2). This jet of water loosens the gravel and washes out excess silt at the same time. The process was assisted by hand-raking where necessary. This work on the Crooked Oak was completed by Wardens Bickley and Boyd.

Habitat Rehabilitation:
Crooked Oak
Huntacott Water
Head Weir

- GRAVEL REHABILITATION
- TRASH CLEARANCE NRA
- TRASH CLEARANCE TFA
- HEAD WEIR

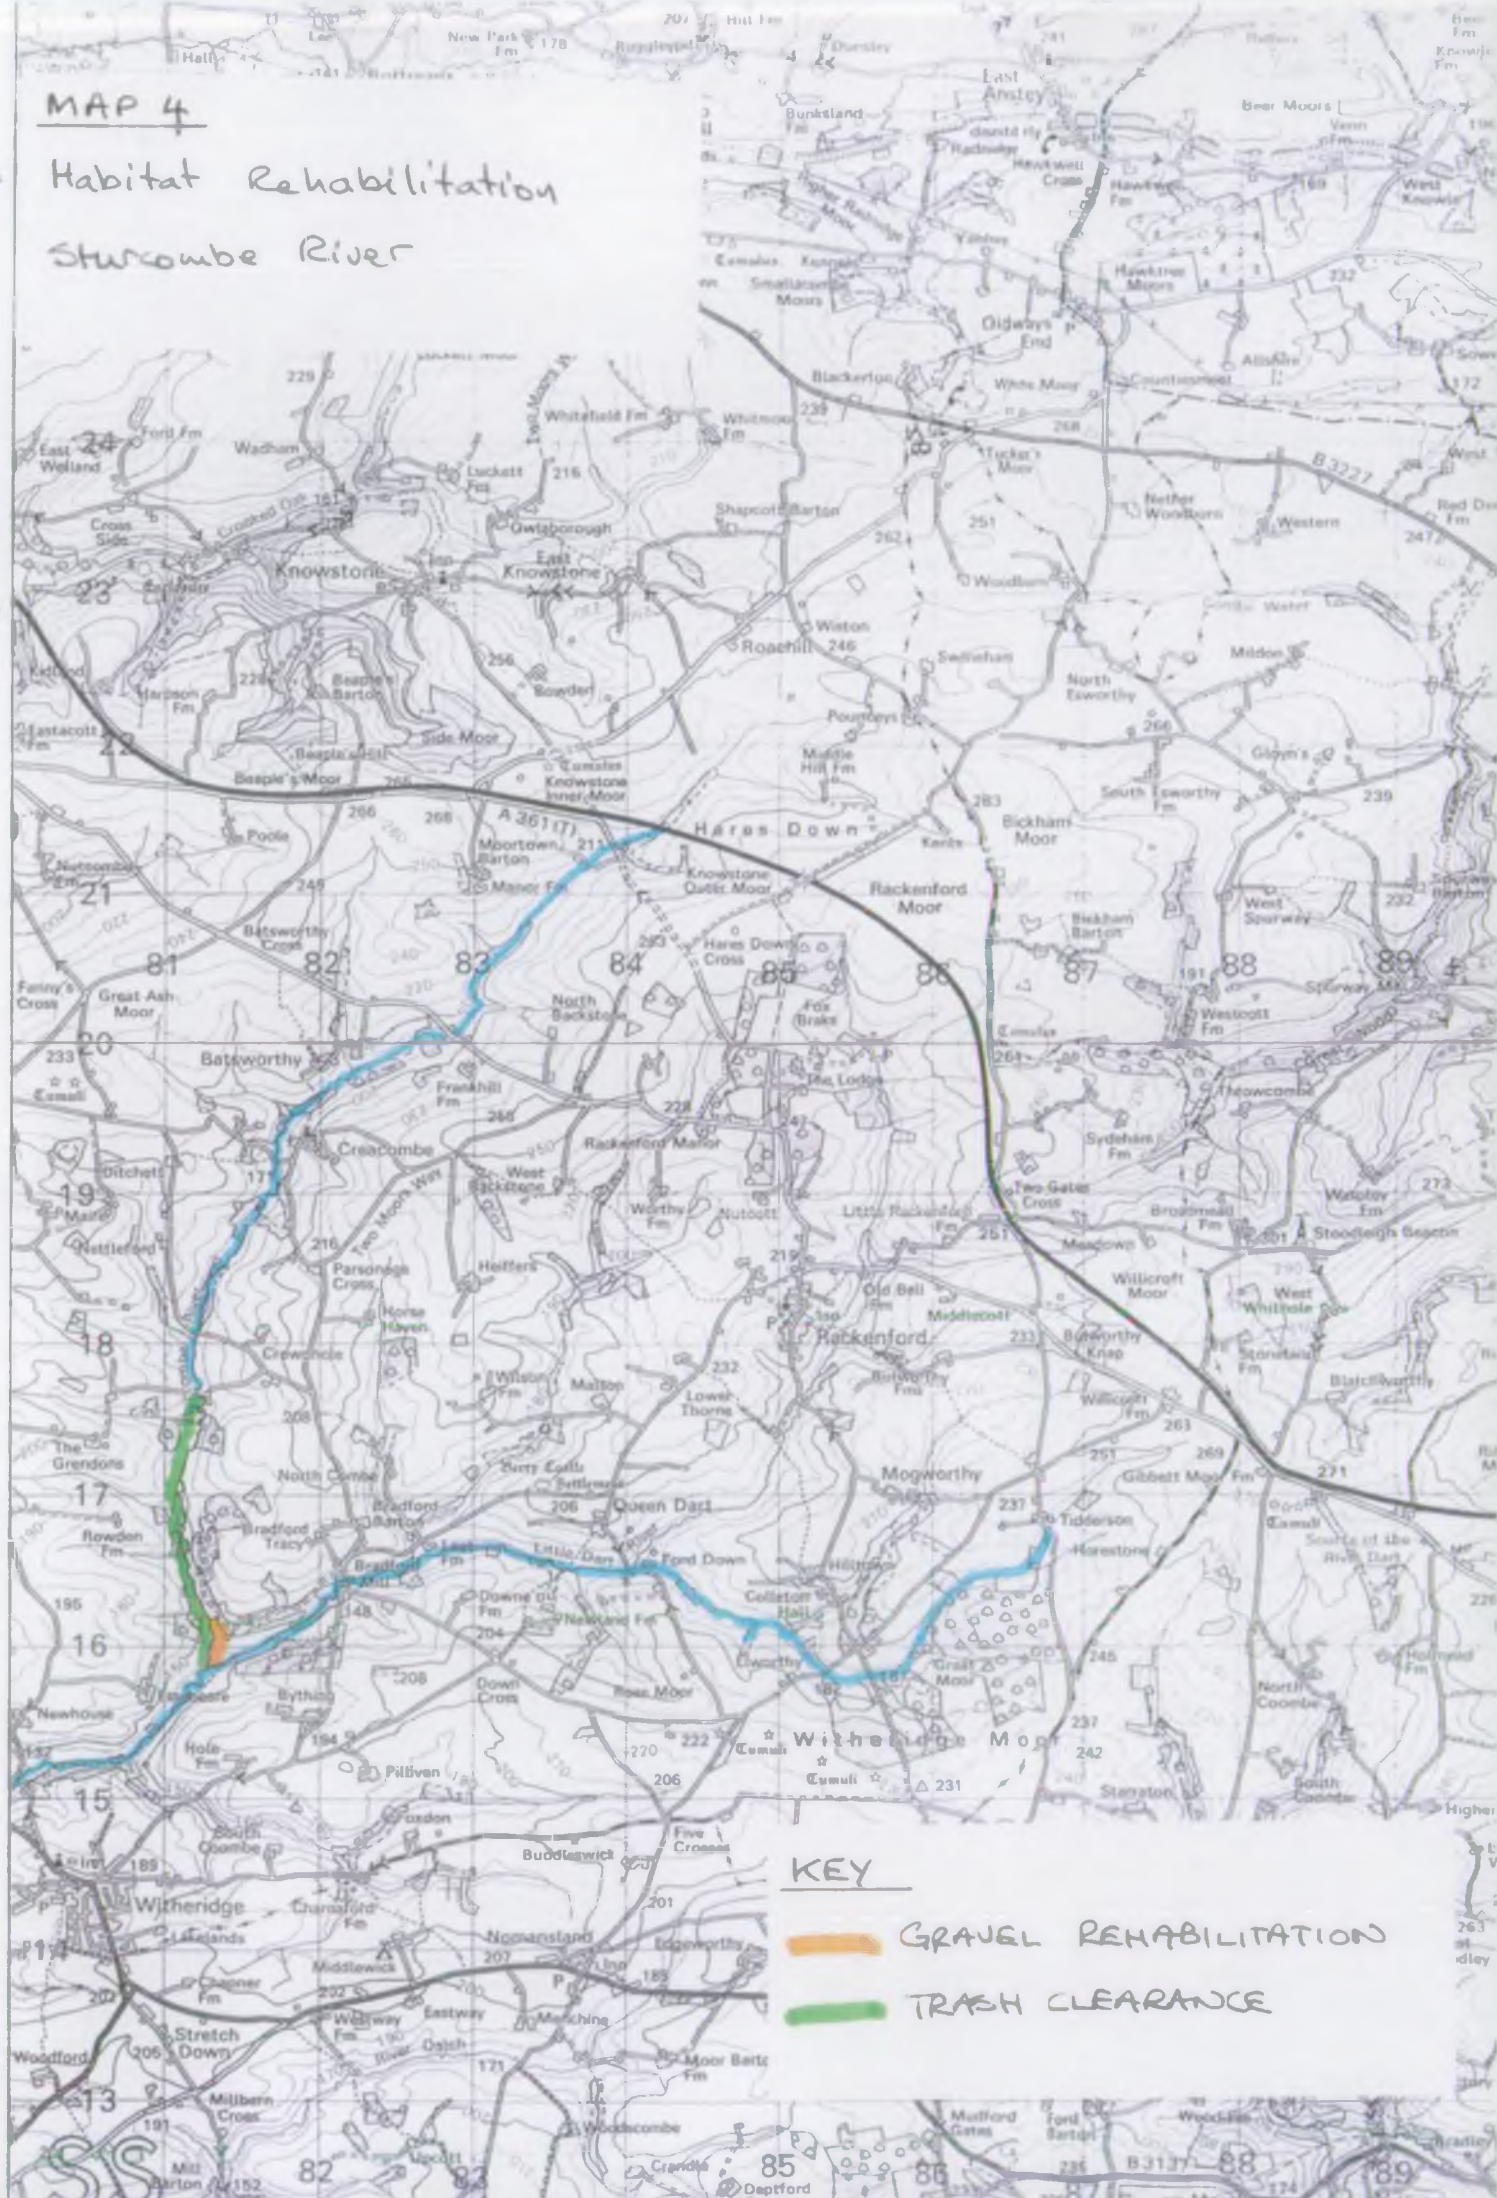
MAP 4

Habitat Rehabilitation

Sturcombe River

- GRAVEL REHABILITATION
- TRASH CLEARANCE

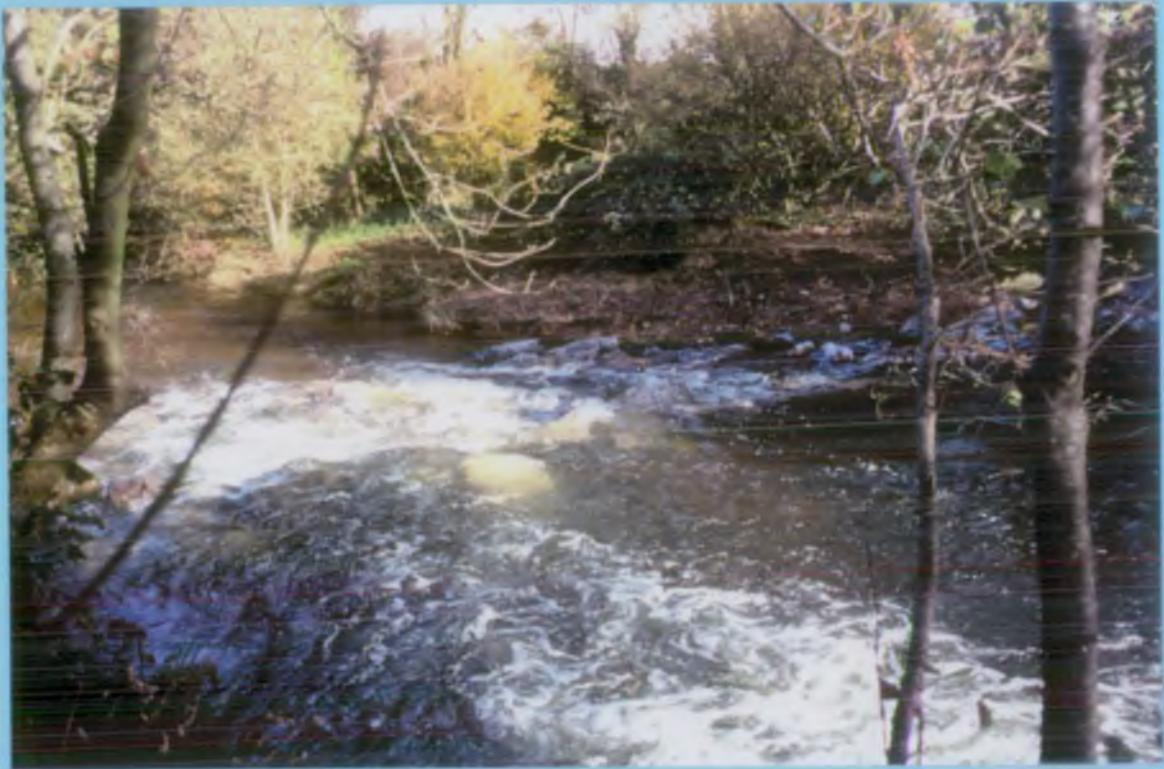
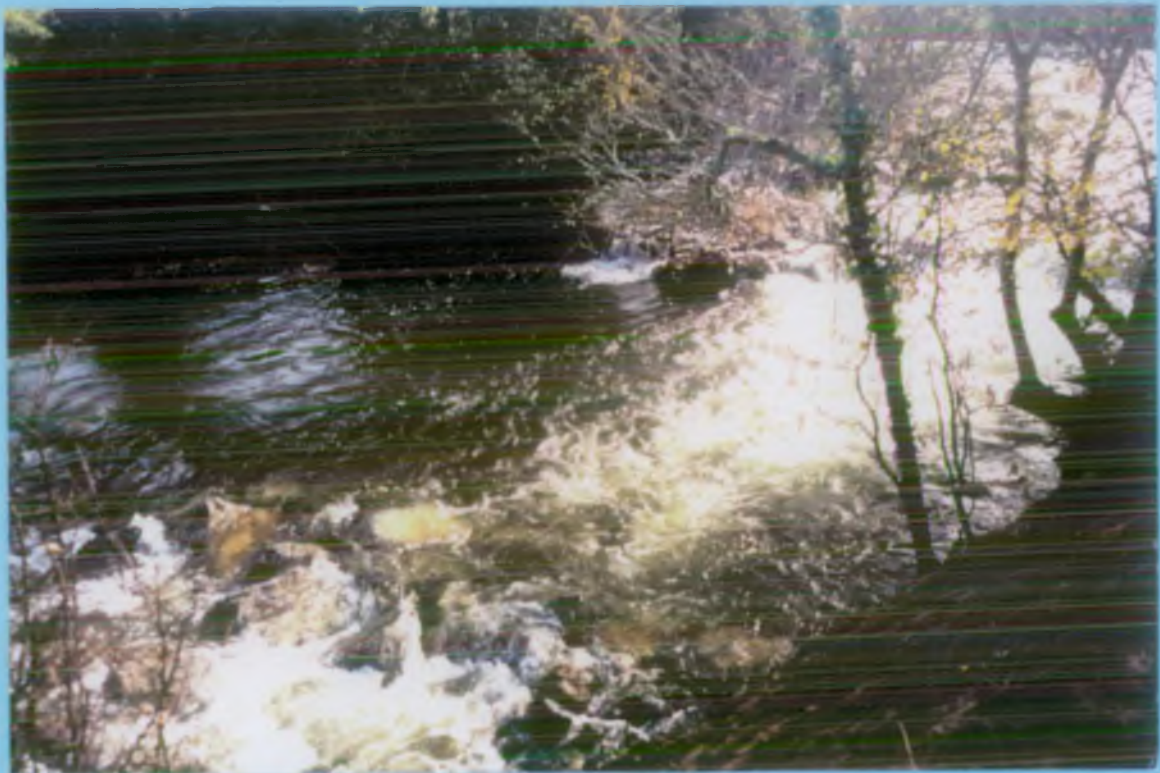
NORTH TAWTON WEIR - DOWNSTREAM CHECK
WEIR,

Fish passage at this weir has long been a problem during low flows (at higher flows, salmon and sea trout have always been able to negotiate the weir to reach the extensive spawning beds upstream to Dartmoor). Impediment to fish passage in low flows has been caused by the step system at the bottom end of the weir, where fish could negotiate the first step out of the weir pool, but were unable to pass the second step (about two feet high) without adequate depth of water to leap from. The solution to this problem was identified as being two-fold. The first stage involved the raising of the weir pool water level using a blockstone check weir, followed by a second stage of cutting a channel through the offending step on the weir and channelling low flows into this channel by means of a deflector system on the face of the weir. Unfortunately, work on the weir was held up by high river flows in the late summer. However, the blockstone check weir (phase one of the work) was completed in mid-October and is already assisting fish over the weir (See Plate 4). It is expected that the second phase of the scheme will be completed before the end of this financial year. The work is being carried out by N. Webber and colleagues of the NRA Engineering Section.

Following extensive discussions between the NRA and the Taw Fisheries Association over the perceived problems with the new fish pass, the large gravel shoal at the foot of the weir pool on the right bank was removed in the early part of the year. This action had the desired effect of reducing the turbulence and backcurrent in the weir pool which was felt to be inhibiting fish from finding the entrance to the pass in higher flows. The weir and fish pass are still the subject of intensive observations by the NRA and the Fisheries Association.

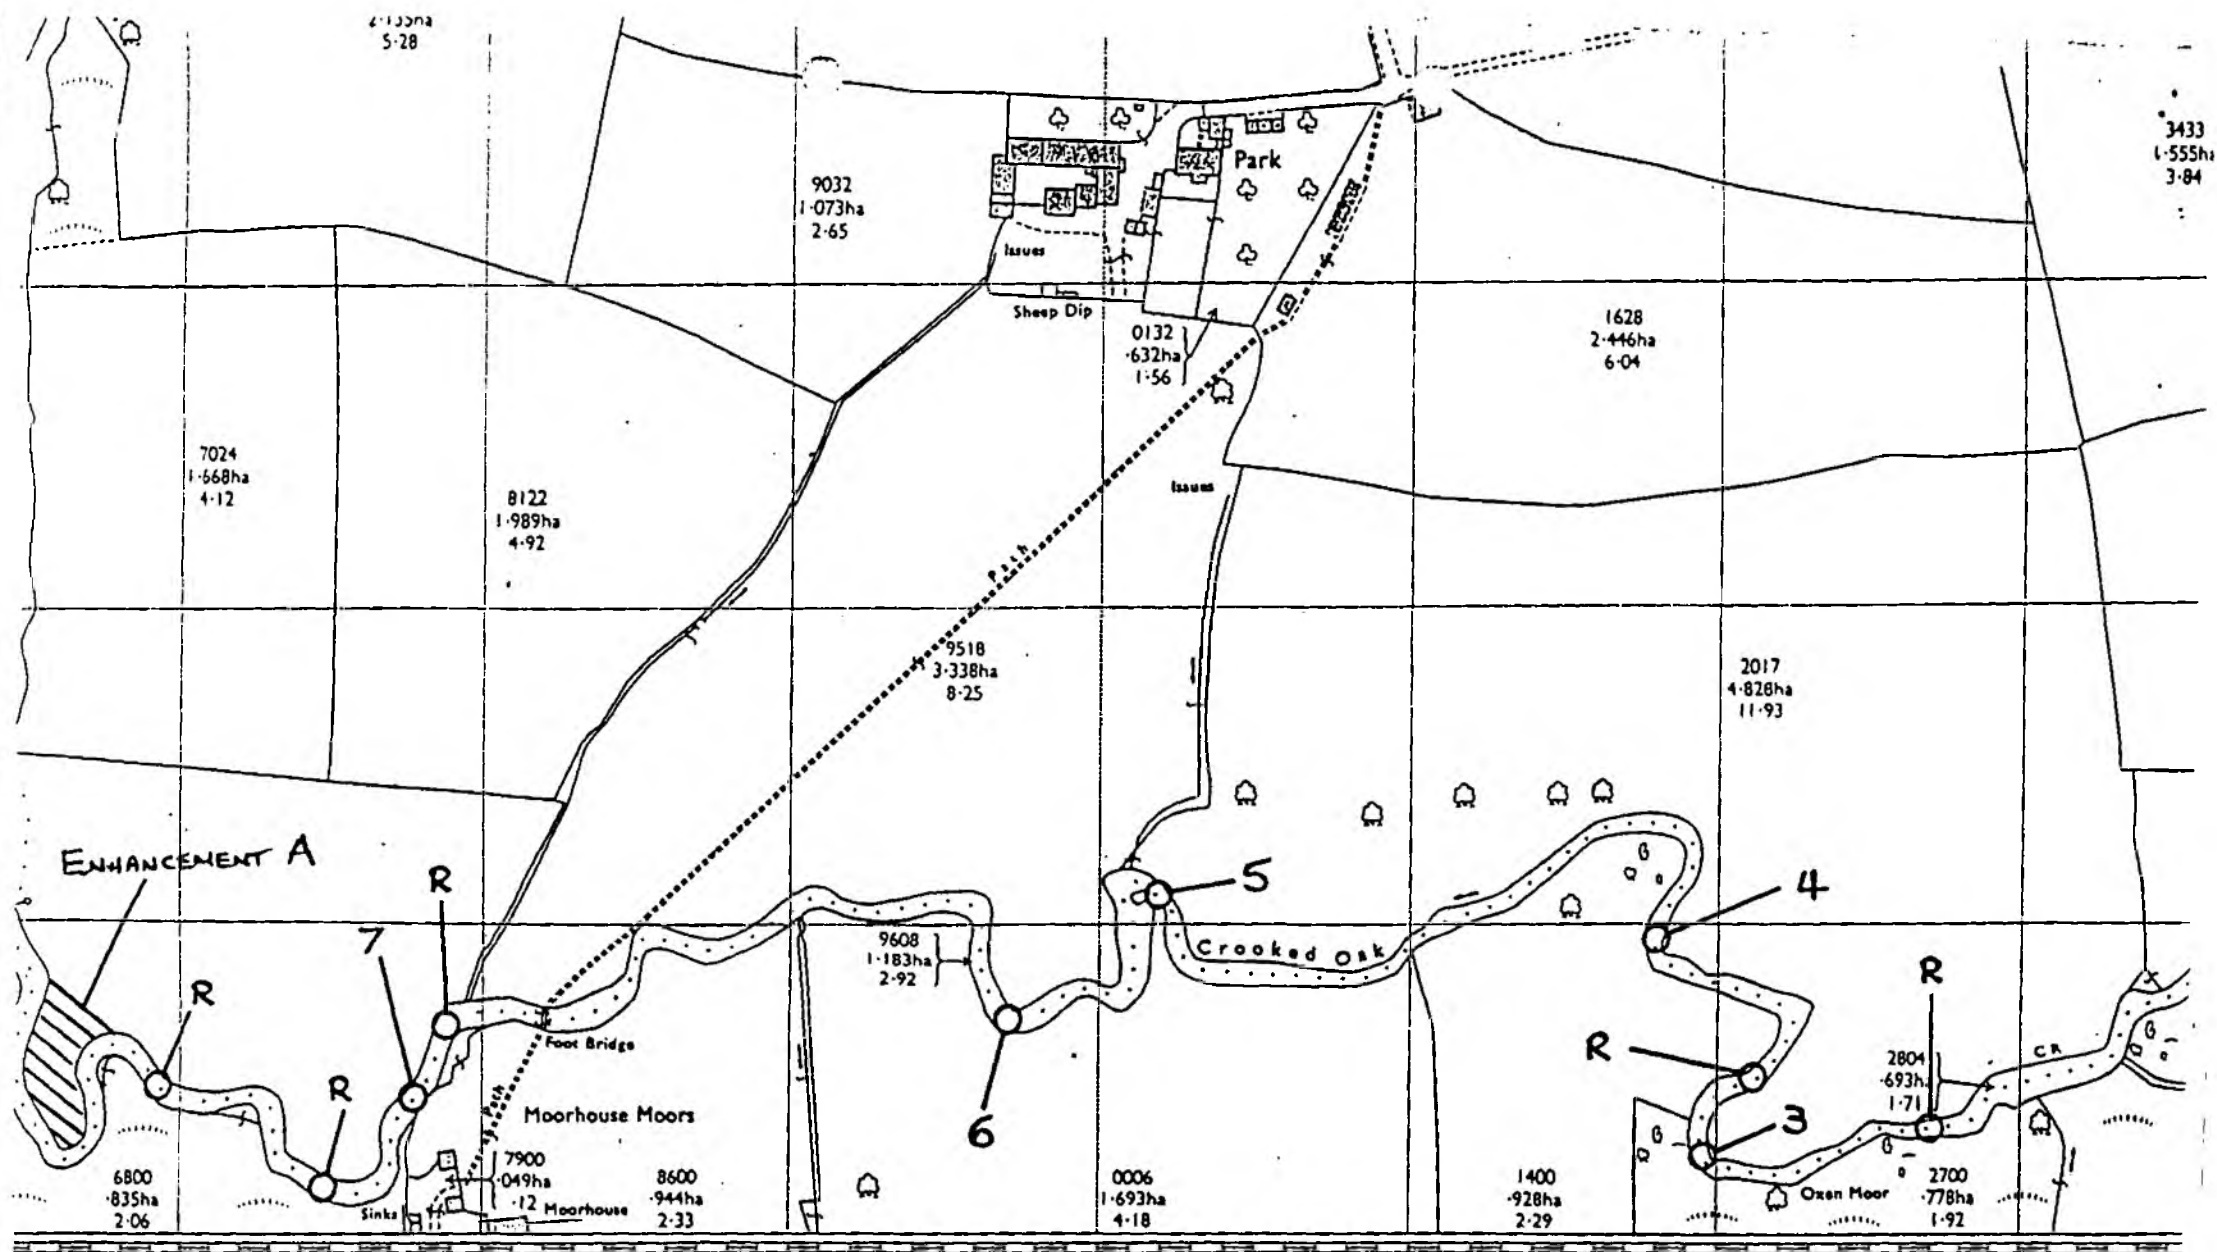
P.2

In the Bishops Nympton area the following actions were identified and approved. Numbers relate to the attached map. In addition, riffles marked R on the plan were selected for gravel rehabilitation.

CROOKED OAK
NR. BISHOPS NYMPION

1. Large ash across river. Cut off flush with left bank and remove section from channel.
2. Trim back small bush catching trash.
3. Large shoal to be broken up and redistributed. Access exists via ramp/cattle drink. Some light tree trimming required if plant to be used.
4. Remove small, dead alder.
5. Large trash dam. Break up and remove material to form stick pile on left bank.
6. Remove small stump
7. Trim overhanging trees lightly and cut off old stump.
8. Trim dead branches.
9. Remove trash and coppice overhanging willows.
10. Remove loose trash from channel.
11. Remove stumps and coppice willow.
12. Remove trash.
13. Cut alder stump back hard.
14. Cut back branches and remove.
15. Remove debris and coppice willow.
