NATIONAL RIVERS AUTHORITY  
(THAMES REGION)

BRIDGE MILL - WHEATHAMPSTEAD

SURVEY AND ANALYSIS OF CULVERTS

February 1990

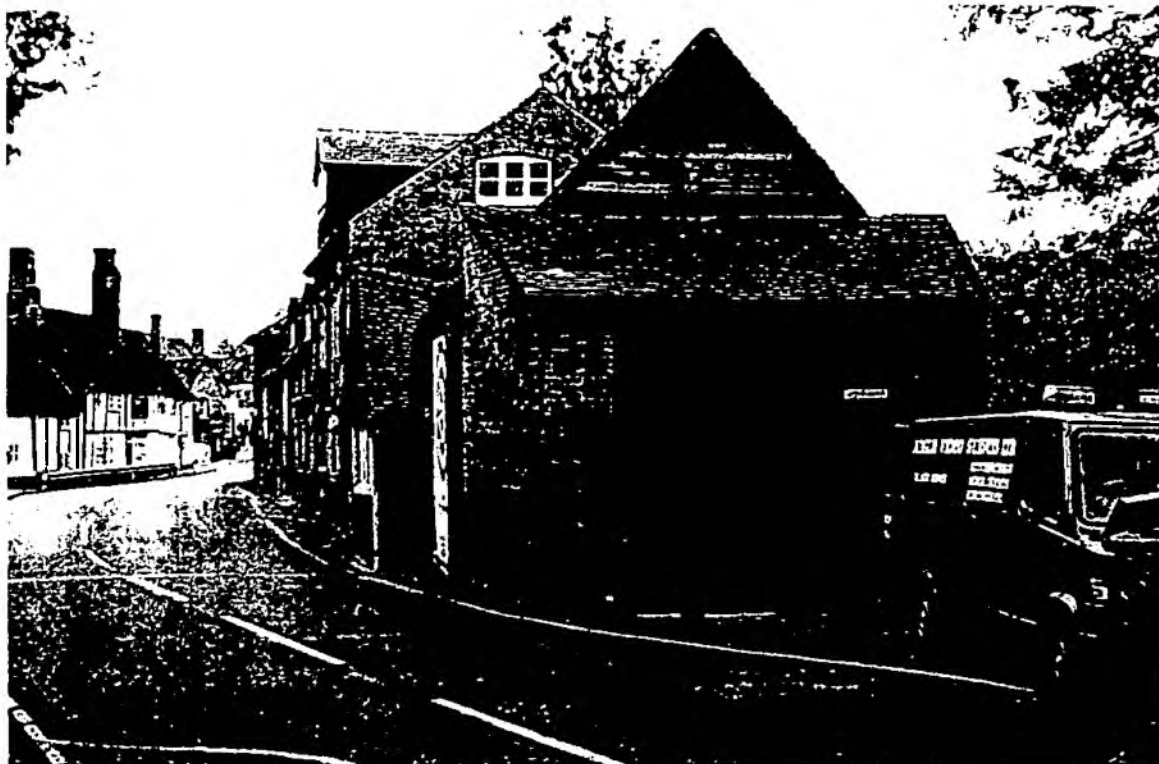
FIG. (1) General view of Bridge Mill looking along the B651 from North to South

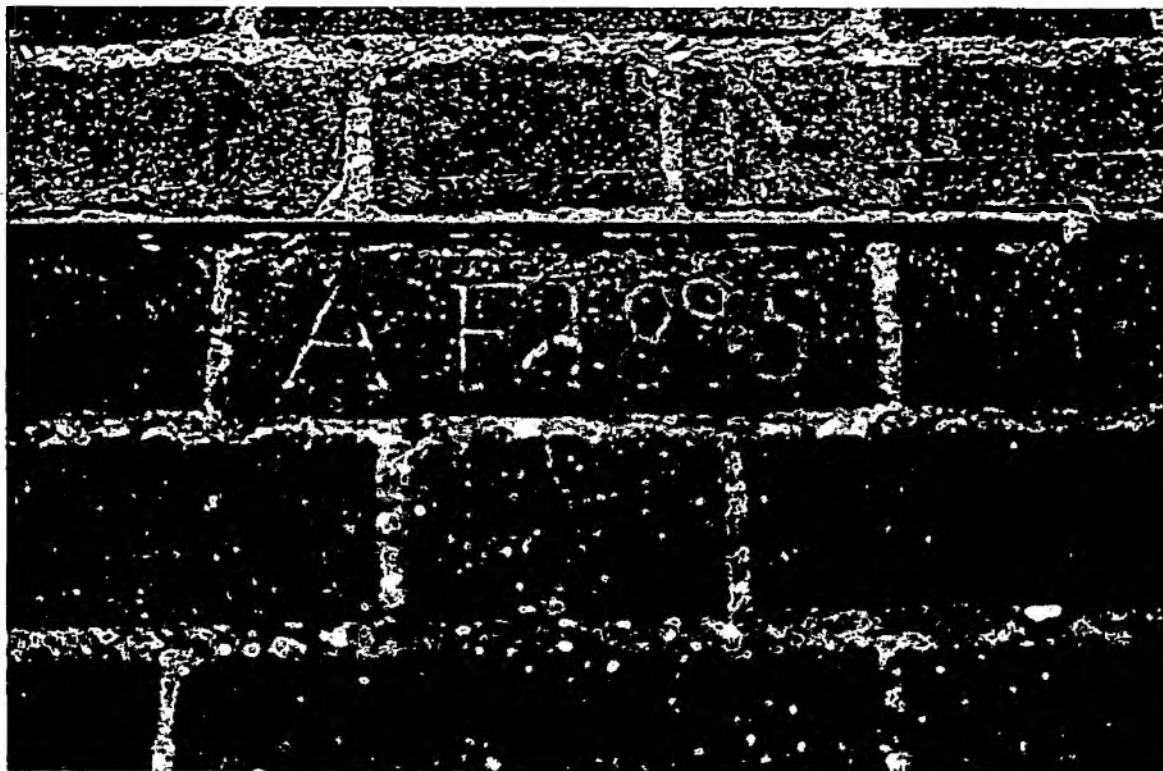
- 3.02 Although the damp wall on the east face is separated from the shops and offices by a 1.0 m wide corridor, provision for remedial treatment is recommended for other than short term (up to two years) occupation.

FIG. (2) The wall on the east face is dated 1895
