SOUTH LINCOLNSHIRE LIMESTONE AQUIFER: SEALING OF WILD BOREHOLES

Final Report

April 1993

HALCROW

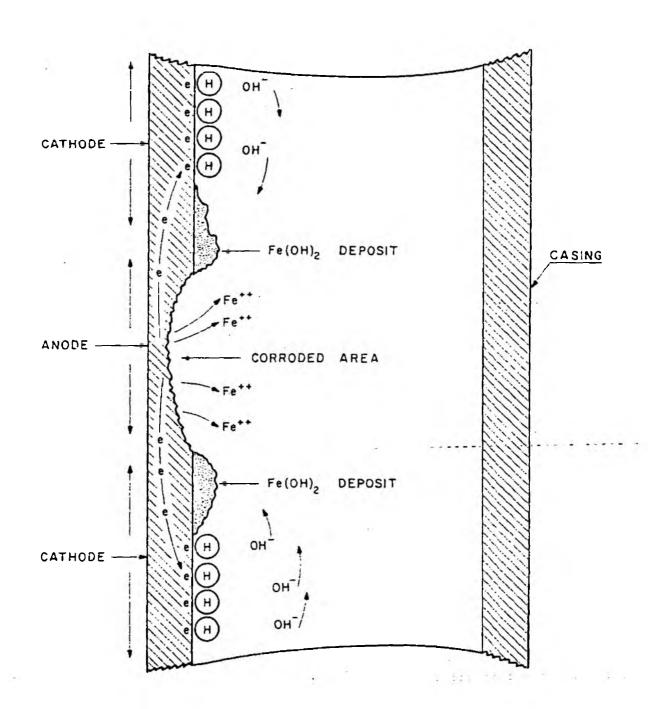
Electrolytic Corrosion Process

Corrosion of steel in groundwater results from the establishment of anodic and cathodic areas on the metal surface (Clarke, 1980). These areas known as corrosion cells exist on both a micro and macro scale, and anode and cathode within a cell may be close to each other or far removed. The cell is completed by current lines ie an electric current flowing through the earth from the anodic to the cathodic area and returning along the well casing.

Regardless of the source and size of the corrosion cell the basic corrosion process is the same, commencing with metal dissolution at the anode to form ions and release electrons which pass through the metal to the cathode and react with hydrogen ions in the water to form atomic hydrogen. This deposits on the cathode and tends to protect it. The deposition of atomic hydrogen on the cathodic area leaves an excess of hydroxyl ions in surrounding water. These react with iron ions to form ferrous hydroxide, a relatively insoluble product which deposits in the cathodic area. This is shown diagrammatically in Figure C1. These processes result in the lacework casing phenomenon already described. In extreme cases such as seen at Connants (L19) the original casing is totally removed, apart from the thicker casing collars, and the borehole is well supported by the iron and manganese encrustations that built up around the original casing.

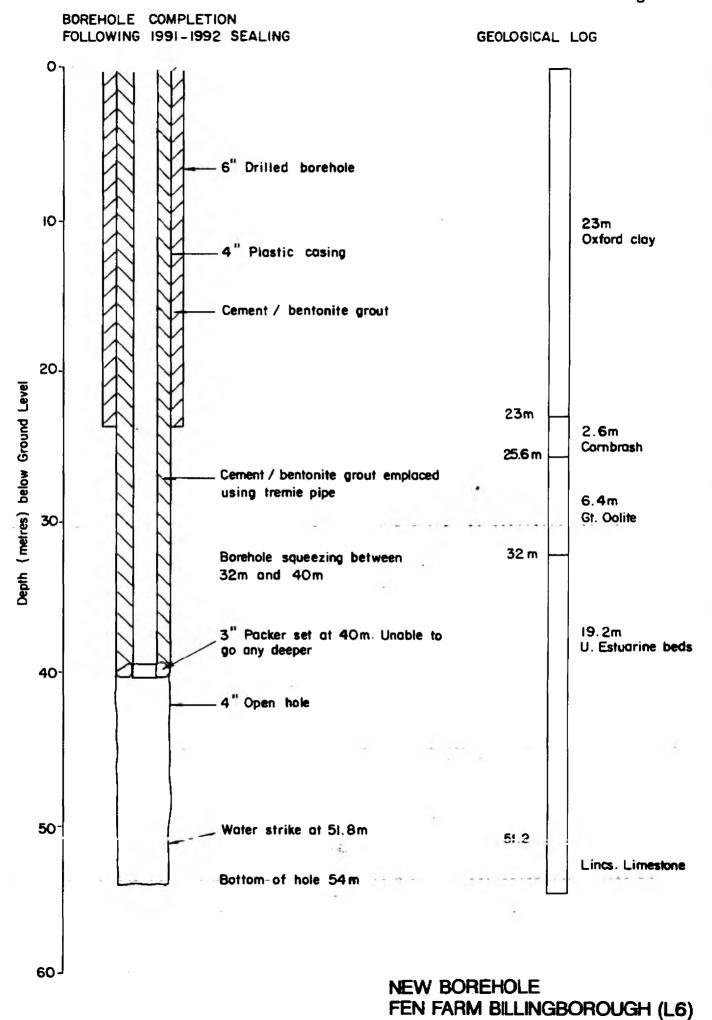
NGR TF 154 339

BOREHOLE COMPLETION FOLLOWING 1991 - 1992 SEALING

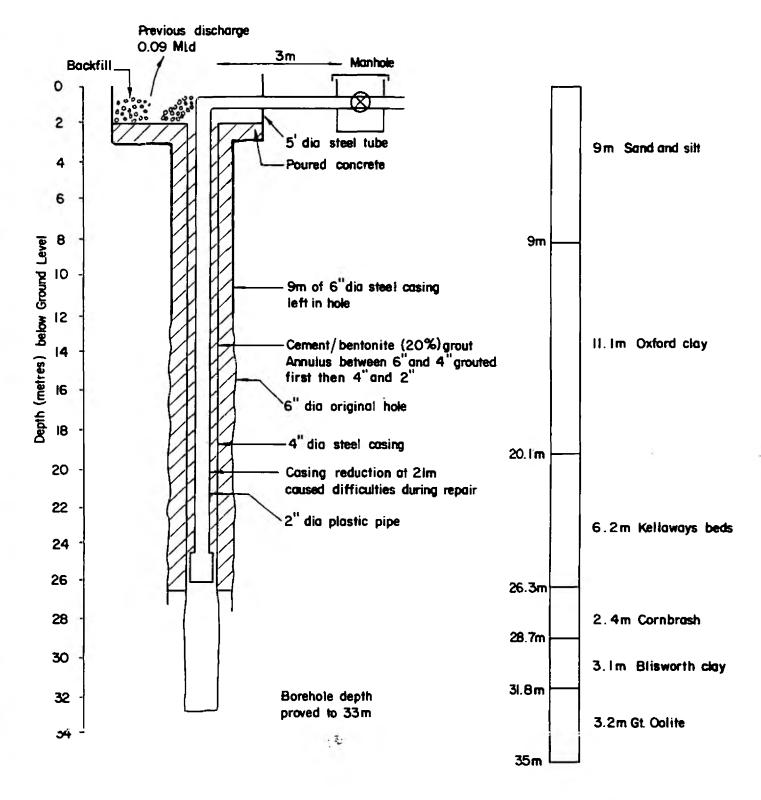
BOREHOLE DUNSBY FEN I (L23) N.G.R. 163 274

BOREHOLE WORK COMMENCED BUT ABANDONED
