# CORRIDOR SURVEY : RIVER TEIGN

RIVER TEIGN CORRIDOR SURVEY

Prepared by Eclogue  
for the  
National Rivers Authority  
(South West Region)

December 1990

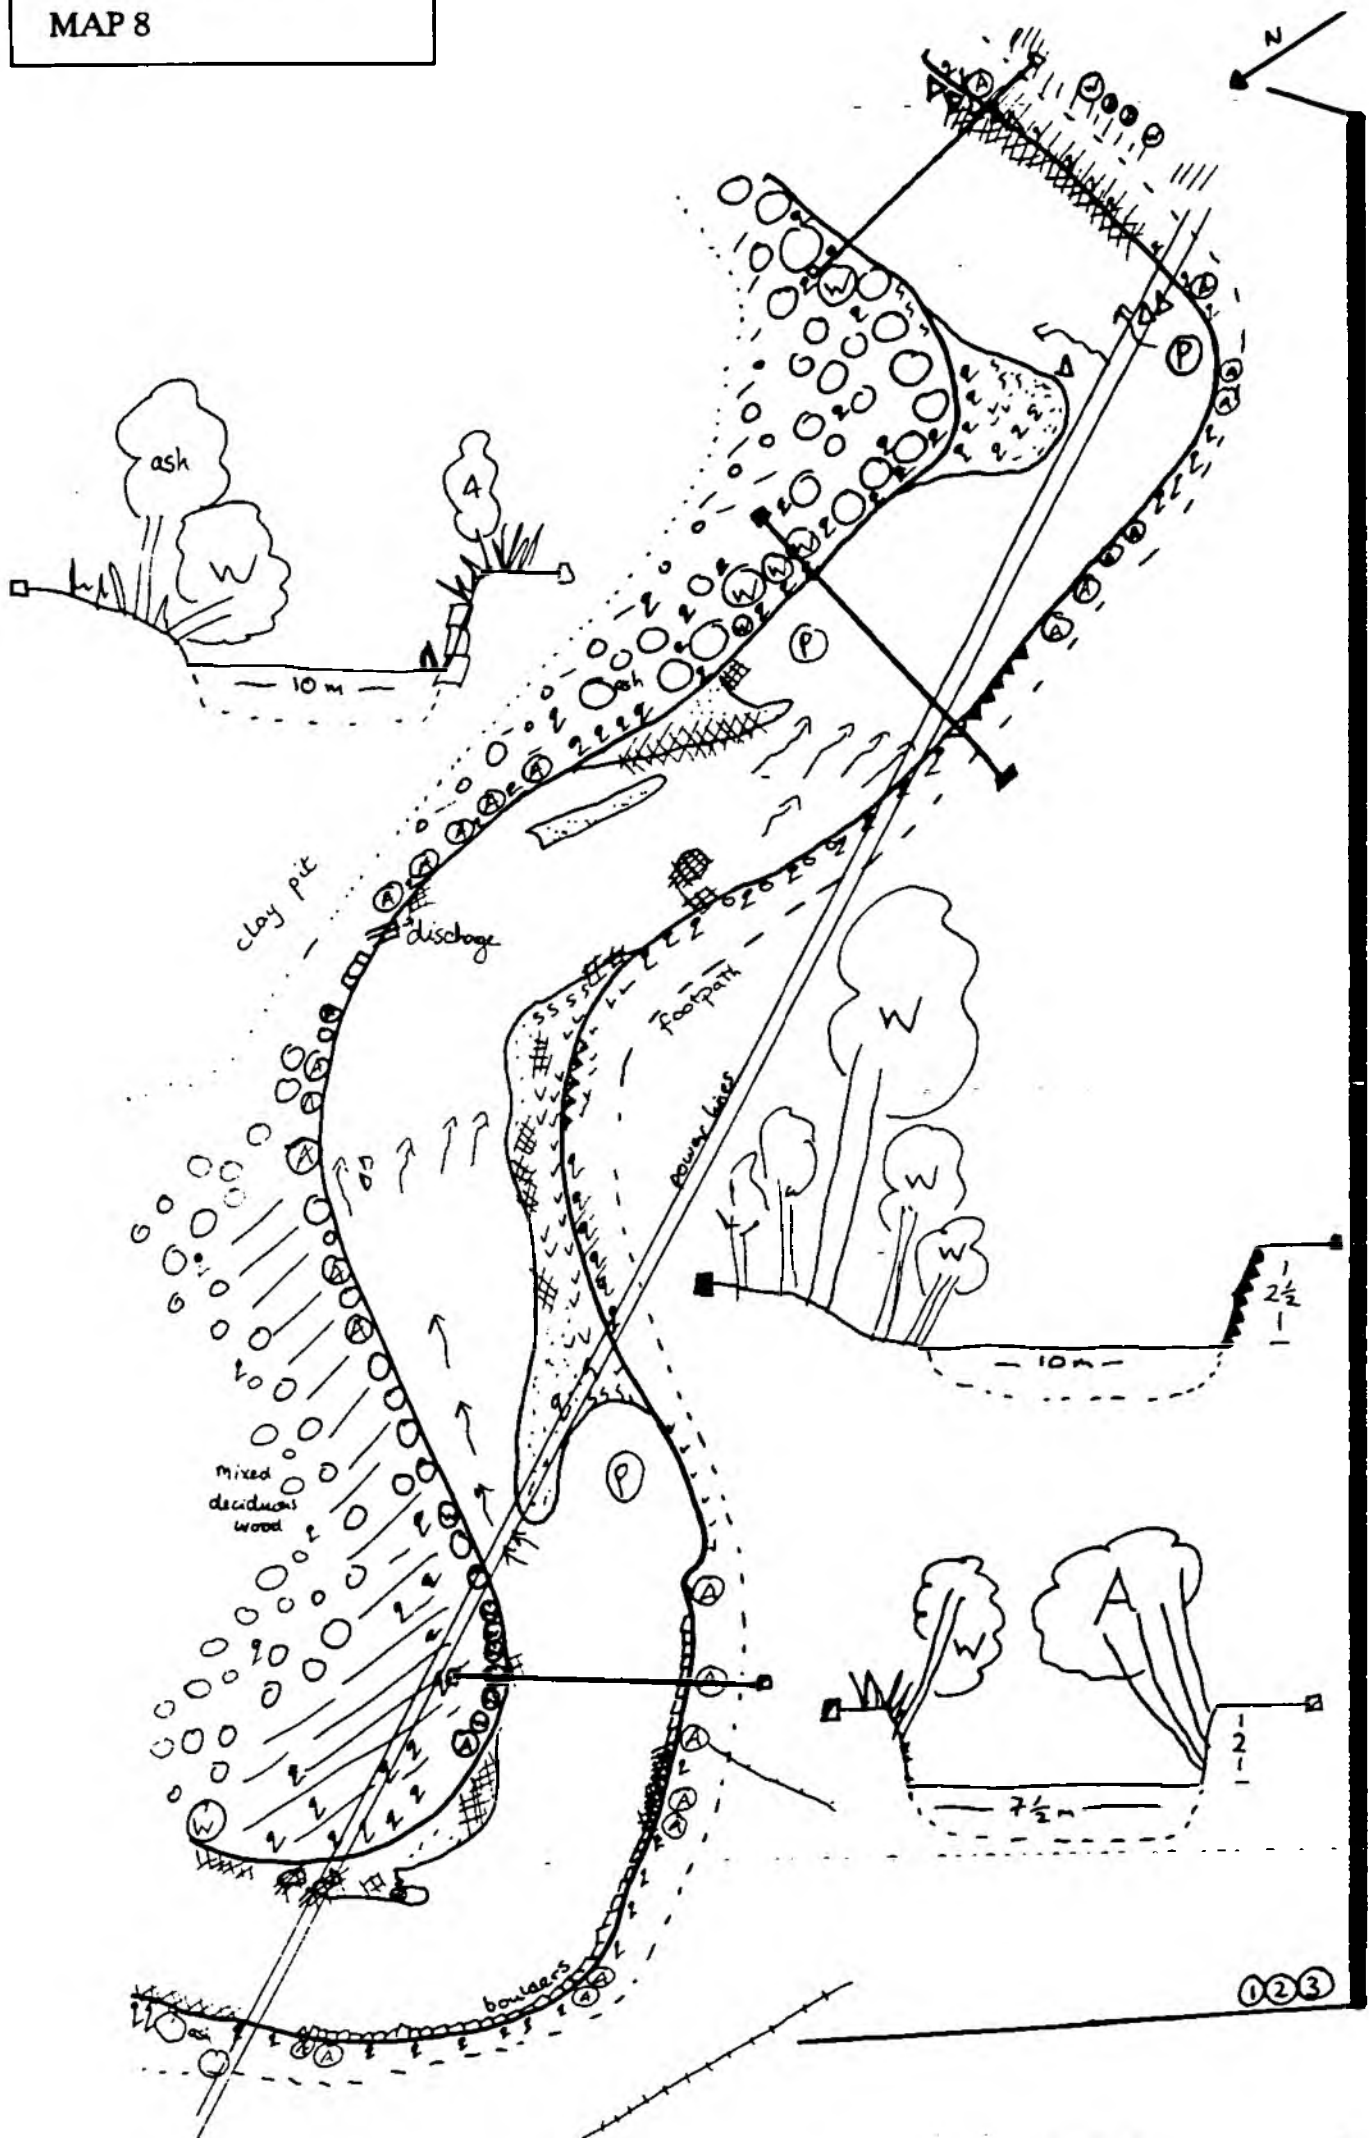
MAP 8

Chainage 10.5-11.0

Map 8 Chainage 10.5-11.0 Grid ref: SX 8585 7351-8556 7386

A winding section with heavy tree cover on one bank.
