**WATER QUALITY SECTION
CORNWALL AREA**

**INVESTIGATE EC DANGEROUS
SUBSTANCE FAILURE AT R18A007
FOR 1994**

**November 1996
COR/96/008**

INVESTIGATE EC DANGEROUS SUBSTANCE FAILURE AT R18A007 FOR 1994

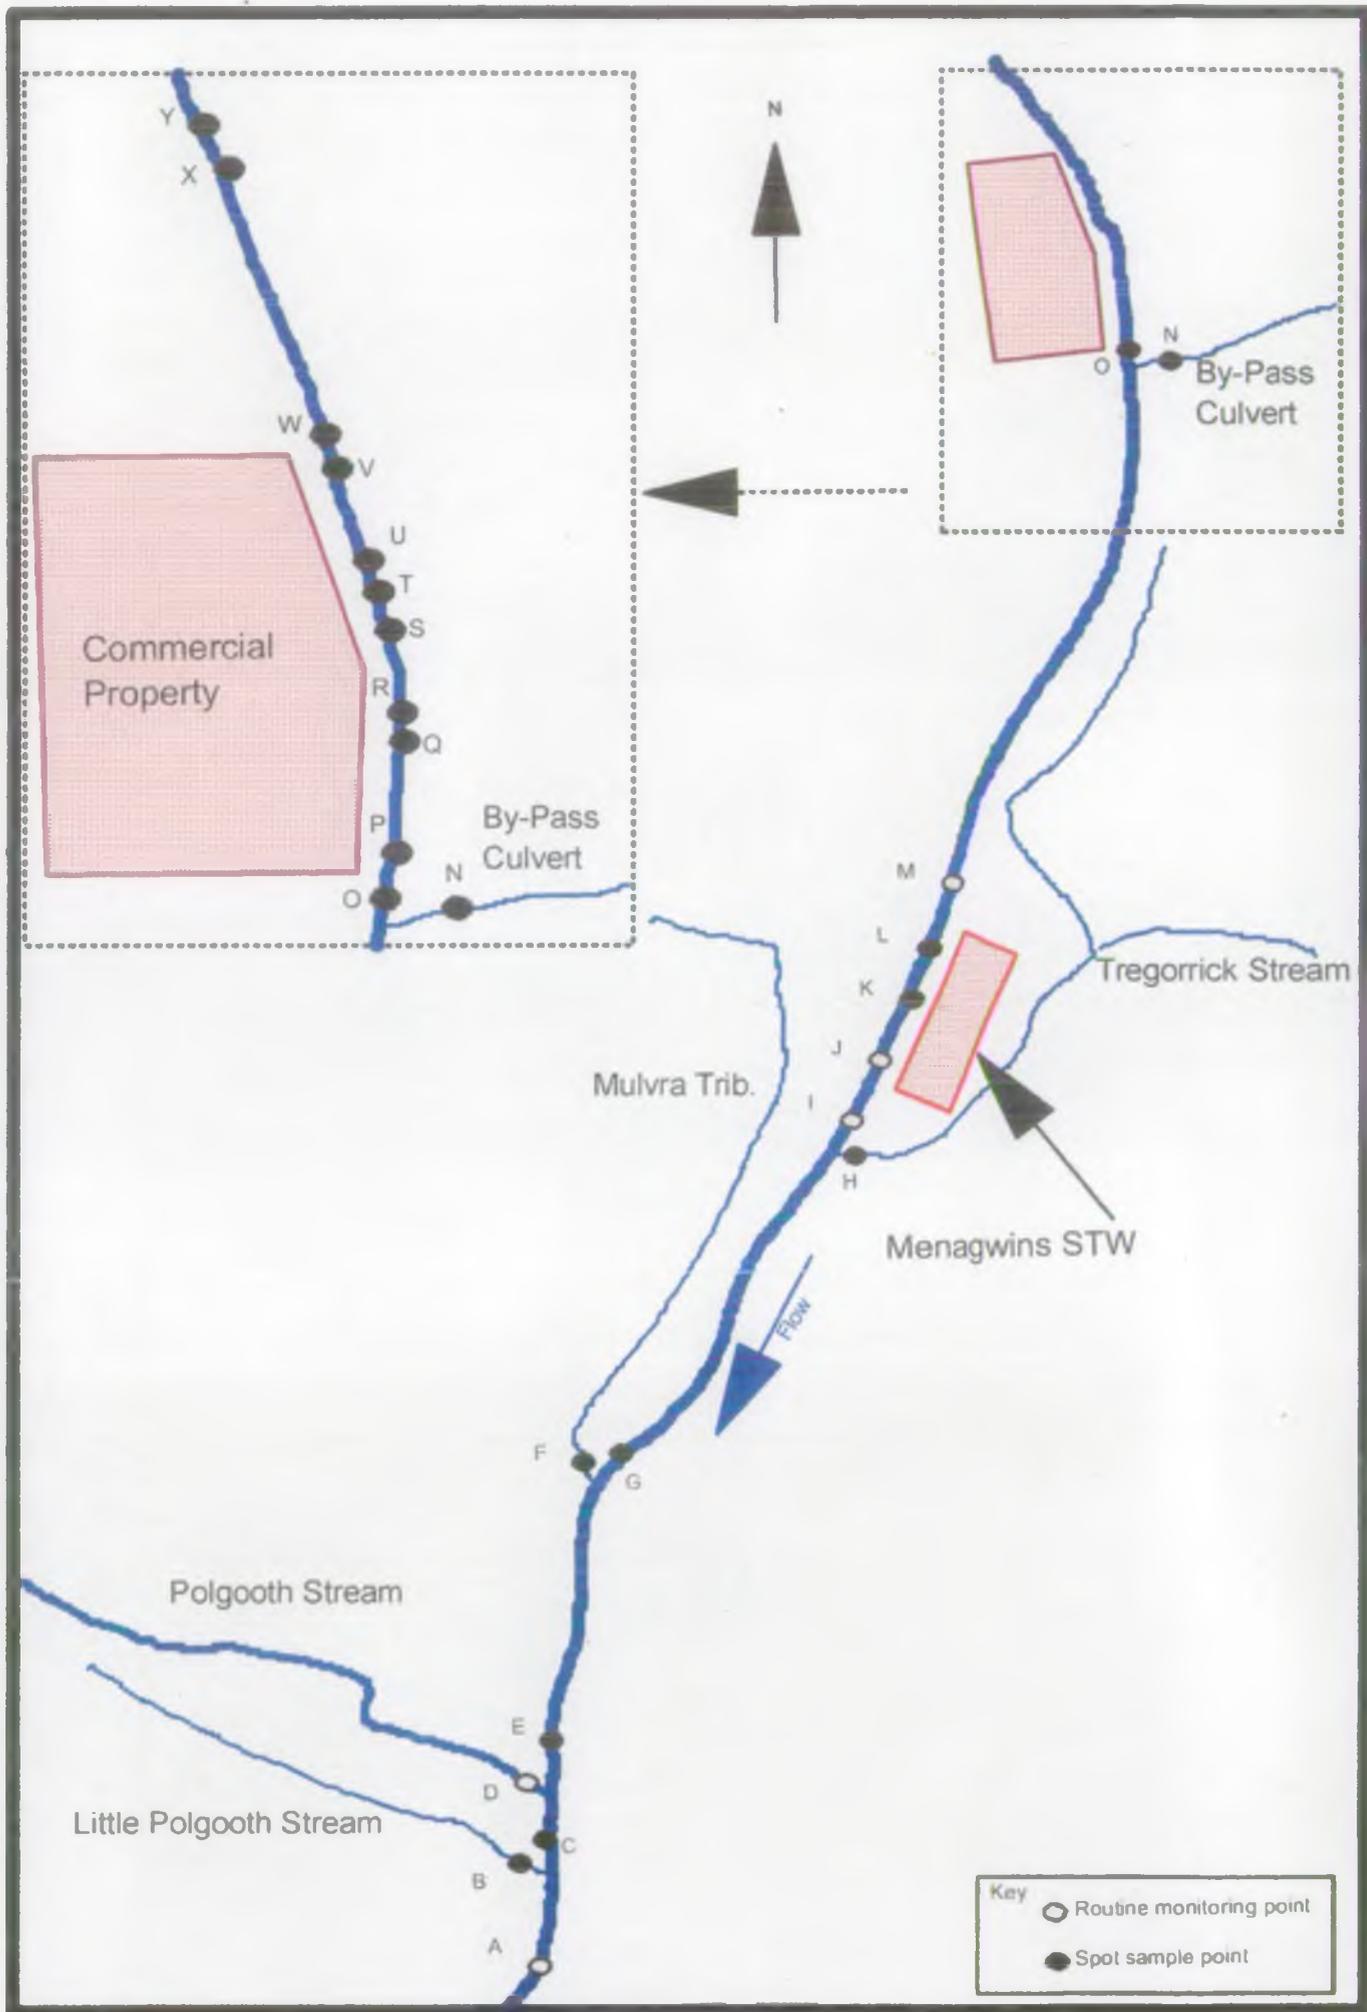
Figure 1. St. Austell River Water Quality Investigation

A summary of the data collected from both surveys is contained in Table 1. A map of the middle section of the St. Austell river showing the sampling points used is shown in Figure 1.

The St. Austell River at Moliney Gauging Station (R18A007) failed the Environmental Quality Standard (EQS) for Dieldrin on 31st October 1994. The failure coincided with high rainfall on the day (30mm) and high BOD's at both the gauging station and Pentewan Bridge (R18A008) which is located downstream. No other Dieldrin data was collected that day. Commercial property has been developed on an area once used as a joinery near St. Austell (figure 1).
