**ENVIRONMENT PROTECTION SECTION
CORNWALL AREA**

FINAL REPORT

**INVESTIGATION INTO ELEVATED
BACTERIAL LEVELS AT STENNACK
CULVERT**

COR/2001/17

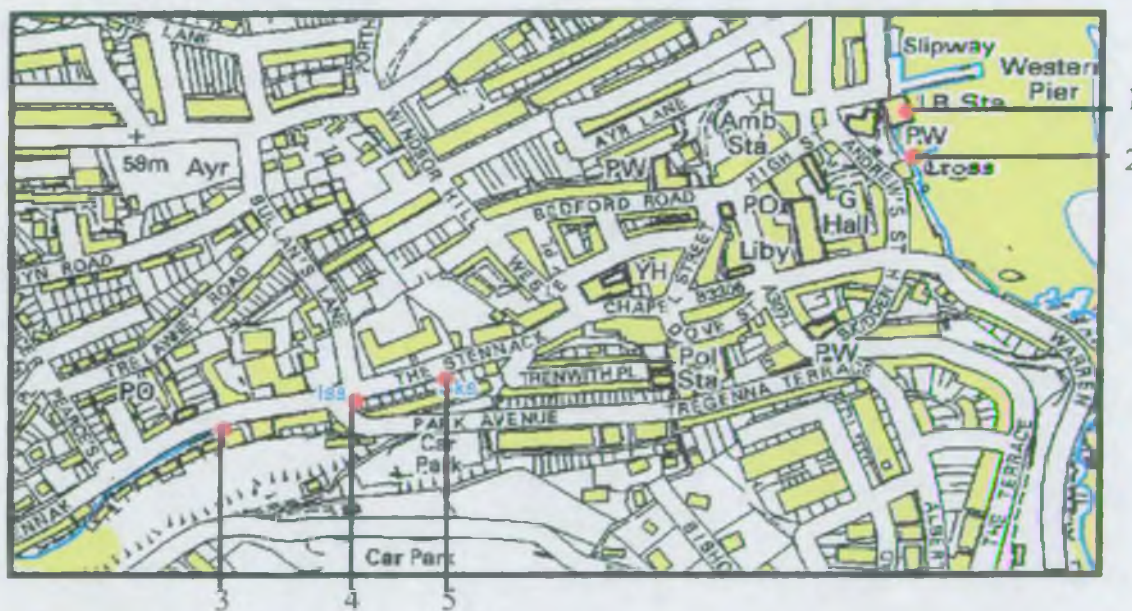
Fig.1. St Ives showing course of Stennack Stream above ground, sampling points and outfall.

- 1 Lifeboat station
- 2 Stream outfall
- 3 Upstream end of Rosewell Terrace culvert (opp. Post Office)
- 4 Downstream end of Rosewell Terrace culvert
- 5 Stennack School

The Stennack stream rises a short distance South of Bussow Reservoir and continues for approximately four kilometres, through St Ives and issues onto Porthminster Beach (URN 82215326), close to the lifeboat station (points 1 & 2 Fig.1.). Through the town of St Ives, most of the stream is culverted. Routine monitoring during the 2000 bathing season revealed exceptionally high bacterial counts in the stream water flowing from the culvert onto Porthminster Beach. Subsequent samples taken in November 2000 and March 2001 (Table 1), revealed a potential area of contamination between Stennack Post Office (NGR SW 51335 40274) (point 3 Fig.1.) and Stennack School (NGR SW51508 40322) (point 5 Fig.1.).

- 2.1. A desk top study of existing data indicated elevated bacterial counts (Table 1) from a possible area of contamination between Stennack Post Office and Stennack School (points 3 & 5 Fig.1.).
- 2.2. A subsequent walkover of the area indicated a likely source of contamination in a short (ca. 100 m) culverted section, adjacent to Rosewell Terrace (NGR SW5135040279 to NGR SW5144640300).
- 2.3. An investigation was carried out on 04/10/01 to ascertain whether the source of contamination was within this culverted section. A series of samples were taken from upstream and downstream of the culvert (points 3 & 4 Fig.1.), between 08:30 hrs and 10:30 hrs.
