*National Rivers Authority
South West Region*

**INVESTIGATION OF
TECHNAZENE CONTAMINATION
IN THE CHYANDOUR BROOK
WEST CORNWALL
DURING SPRING 1990**

JUNE 1990

FW1/90/015

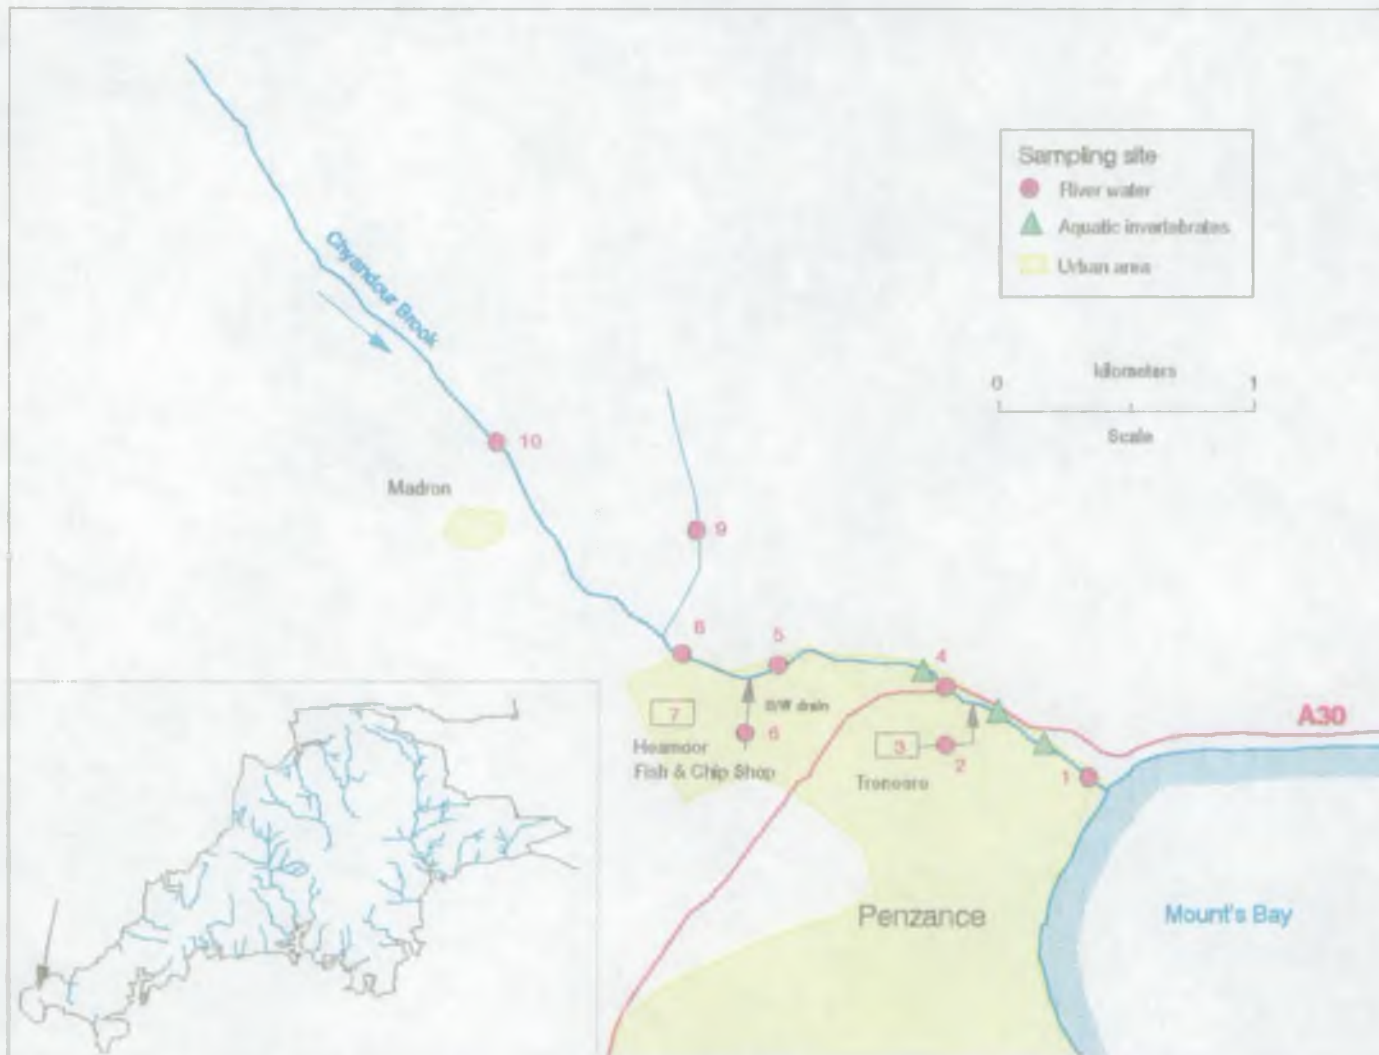
Fig. 1 Location of sampling sites on the Chyandour Brook

The Chyandour Brook lies to the north-west of Penzance on the Lands End peninsula (see Fig. 1). It is a small watercourse (width 2 to 3m) flowing 7 kilometres from its source near Boskedan (NGR SW 442341) to the tidal limit at Mount's Bay.

Once the point of entry of tecnazene had been isolated, the aquatic invertebrate community was surveyed on 30 March 1990. Three sites were sampled to assess the impact of the discharge (see Report FWI/90/?). Sites were located 50m and 3.7 km downstream of the discharge and 100m upstream (see Fig. 1).
