## **Beneath the town**

Safeguarding Bodmin from flooding

# Beneath the town

## Safeguarding Bodmin from flooding

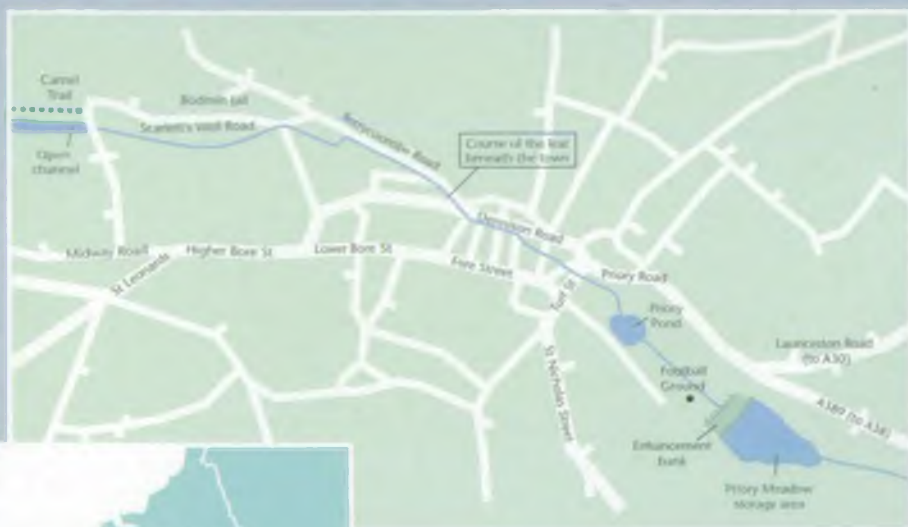
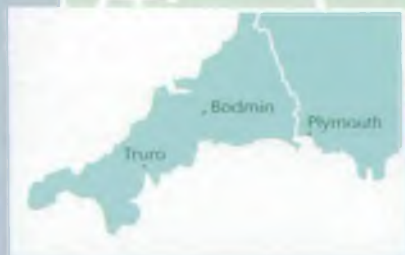
▲ Map of Bodmin showing the course of the leat

The town leat - a tributary of the River Camel - is a watercourse which rises to the east of the town.

The leat springs from the Castle Canyke area and flows in a northwesterly direction through the town centre to join the Camel approximately one kilometre west of the town.

The leat is not visible for much of its course through Bodmin - running through man-made pipes or culverts beneath the town. Upstream and downstream of the town the leat is visible as an open stream.

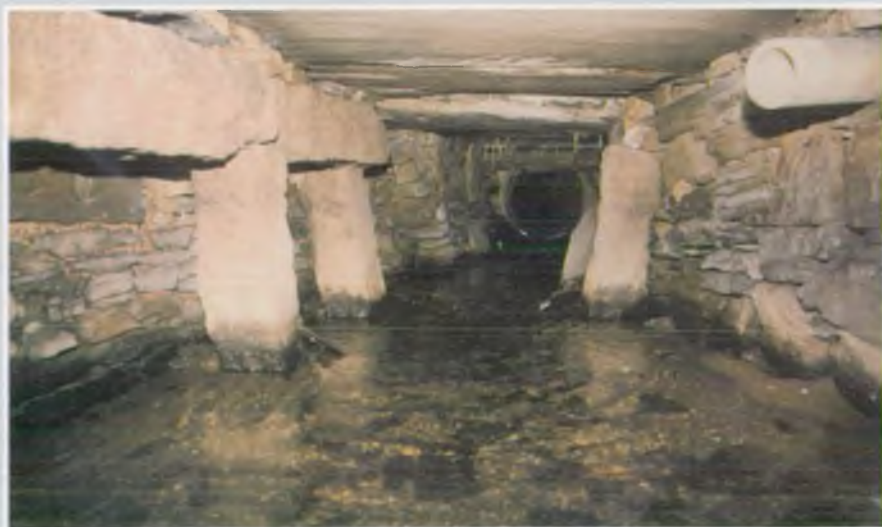
▲ Beneath Crockwell Street, Bodmin

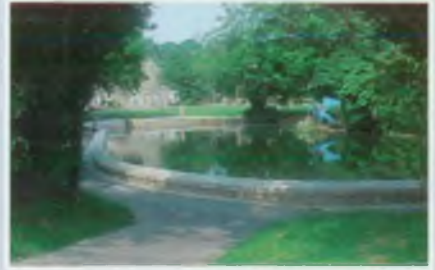
▲ Priors Pond

The scheme - designed and supervised on behalf of the Agency by William Halcrow & Partners Ltd - comprised a combination of rehabilitation and online culvert replacement. Retention facilities - where floodwaters are held back until flows subside - have been built at the Priors Pond and in the Gilbert Road area. Services have been diverted from the leat wherever these caused an obstruction to flows.

- Installation of a new 900-millimetre diameter pipe and trash screen in the vicinity of Cummings Garage.
- Construction of a new culvert beneath Gilbert Road.
- Works to increase the channel capacity in the vicinity of Priory Cottage.
- Provision of a flood storage pond in the recreation field including reopening the leat which was previously buried in a pipe.
- Construction of a new length of culvert at Bodmin town football club.
- The volume of Priory Pond increased by 1500 cubic metres (330 thousand gallons) to help store flood water. This has been achieved by building a new

low wall at the edge of the pond. The wall has been faced with local stone.

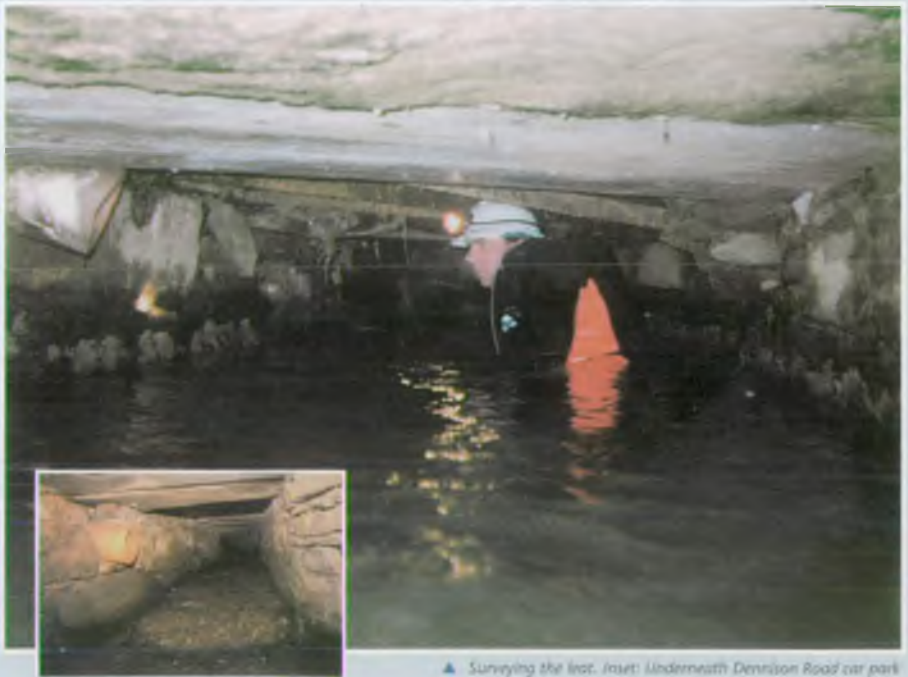
▲ Surveying the leat. Inset: Underneath Demisson Road car park

Following an intensive survey of the leat - including a close circuit television survey - the Agency prepared a scheme to help reduce the risk of flooding to Bodmin. The purpose of the scheme was to:

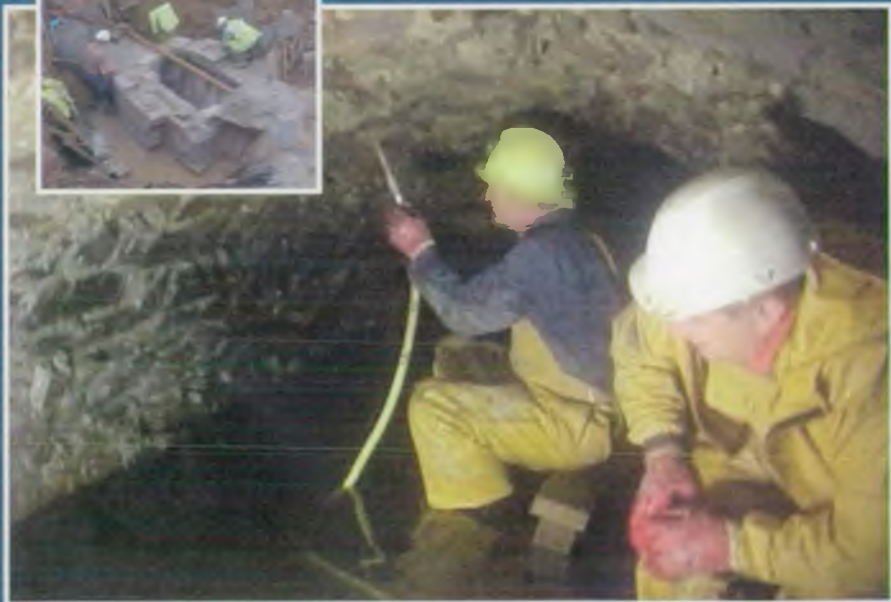
▲ Painting the culvert walls beneath Berrycoombe Road, Bodmin. Inset: Constructing a manhole near Scarlett's Well Road, Bodmin

- Surface water sewers diverted away from the vicinity of Church Square and into Priory Pond. Hydrocarbon interceptors were installed to prevent the pond being polluted with oil.
- Structural rehabilitation of the culverted sections of the leat, which were in poor condition, as identified by the internal structural survey of the culvert.

A combination of techniques were used:

- Laying new pipes;
- Inserting a liner into the old pipe to act as a new pipe;
- Localised repairs of the culvert by man entry;
- Inserting a resin - impregnated 'sock' liner into the culvert.
- Removal of blockages and services in the culvert.

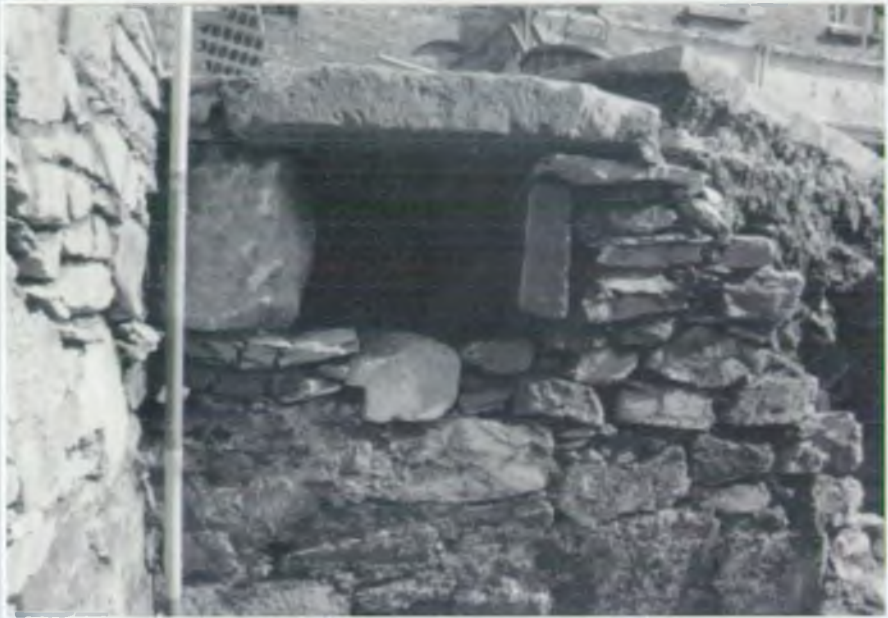
▲ The grave stone was discovered where it lay as a lintel

found. The wall contained an alcove, with a re-used 12th-13th century cross slab grave cover as its lintel.

Three walls of a corner of a building – thought to be an 18th century outbuilding associated with Priory House - were also

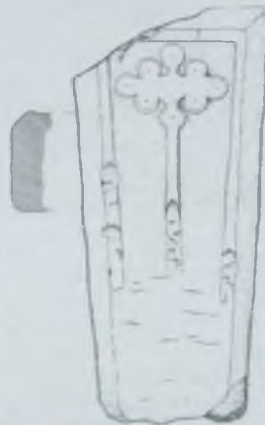
◀ Drawing of the 12th-13th century grave cover
